# FIELD SERVICE CAMPAIGN BULLETIN

Subject: **Field Service Campaign D18M2 – REVISION 1**  
**GHG17 Detroit™ DD13® Software Reprogramming and Emission  
Label Replacement for Motor Coach Industries, Inc. (MCI®)**

## Field Service Campaign Bulletin D18M2

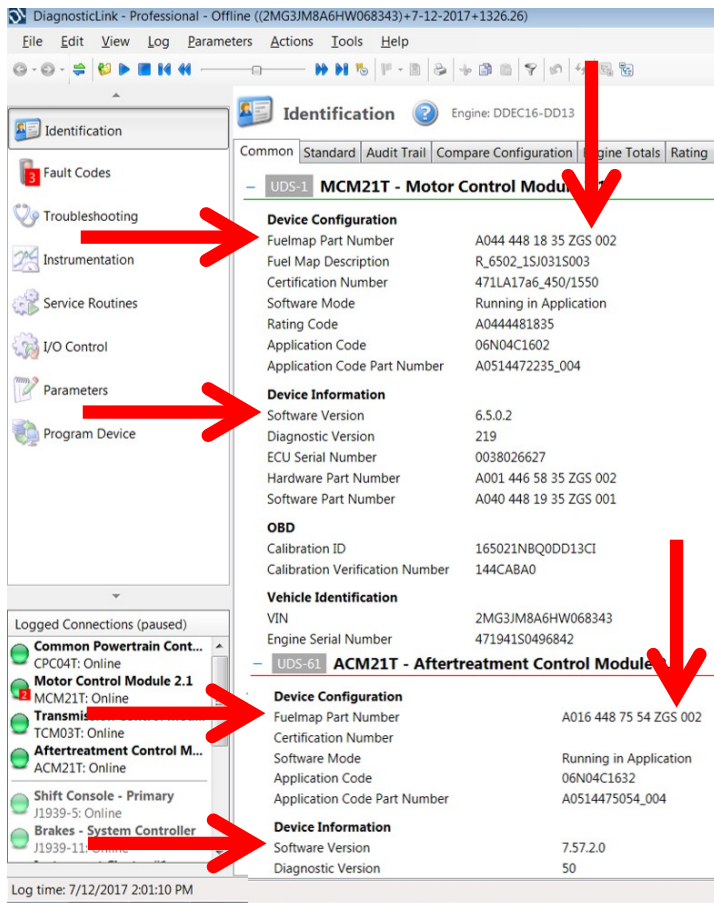
Figure 4 – DiagnosticLink® Identification Screen

6. Is the **software** level for all modules less than, equal to, or higher than the software levels listed in step 5? For example in Figure 4, MCM software 6.5.0.2 and ACM software 7.57.2.0 are both less than 6.6.0.1 and 7.58.2.0, and thus would require programming regardless of fuel map part number.
  - a. If less than the required software levels, proceed to step 8.
  - b. If equal to the required software levels, proceed to step 7.
  - c. If greater than the required software levels, no programming is necessary. Proceed to step 13.

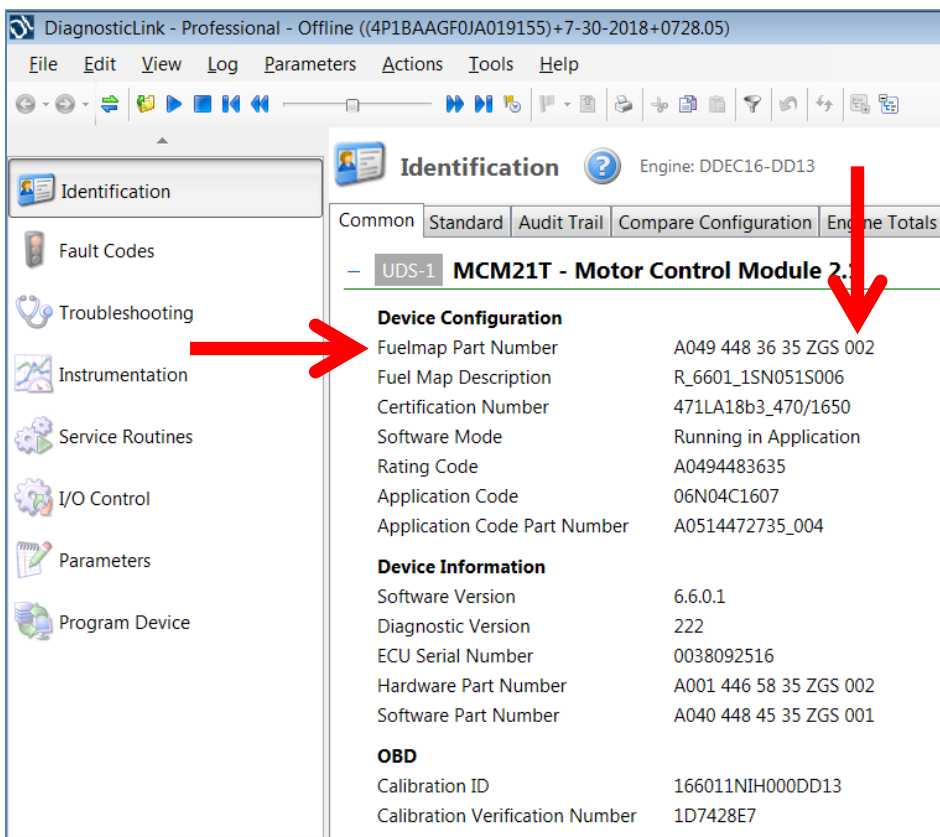
**Figure 5 – DiagnosticLink® Identification Screen**

7. Are the fuel map part numbers for the MCM and ACM equal to the fuel map part numbers listed in step 5? For example in Figure 5, the MCM software meets the necessary requirement of 6.6.0.1, but the fuel map part number does not match the numbers in step 5, and thus would require programming.
- Note that any fuel map part number ZGS level in the MCM or ACM that starts with the number 9 will require reprogramming.**
- If No, proceed to step 8.
  - If Yes, no programming is necessary. Proceed to step 13.
