SERVICE INFORMATION BULLETIN

APPLICABILITY: 2015-19MY Legacy and Outback **NUMBER:** 16-124-19
SUBJECT: Torque Converter Assembly- Design Change **DATE:** 8/26/19

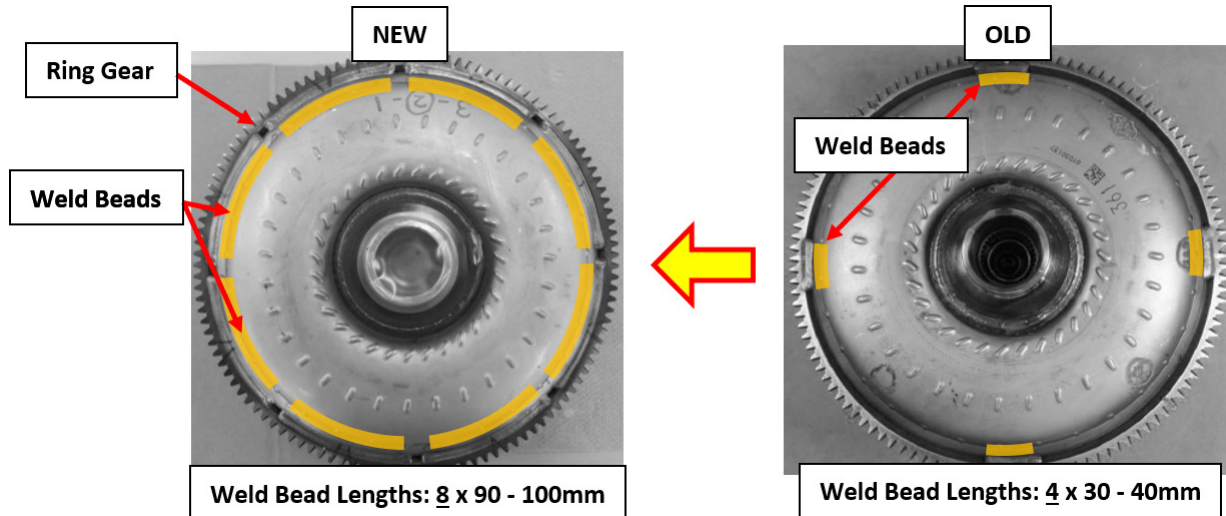
This Service Information Bulletin announces a design change to the CVT torque converter assembly made to address a small number of reports describing a squeaking -type sound heard while the engine is being cranked over. The sound results from contact between the starter pinion gear and the converter ring gear. Both the number and length of the welds securing the ring gear to the converter shell have been increased significantly. Comparison images between the new and old design parts showing the changes are provided below.

The new torque converter assembly part number is: **31100AB353**.
