SERVICE BULLETIN

APPLICABILITY: 2010-**19MY** Legacy and Outback
 2014-**19MY** Forester
2012-19MY Impreza
2013-19MY Crosstrek
 2015-**19MY** WRX
2019-20MY Ascent

NUMBER: **16-103-16R**

SUBJECT: Transmission Fluid Seepage

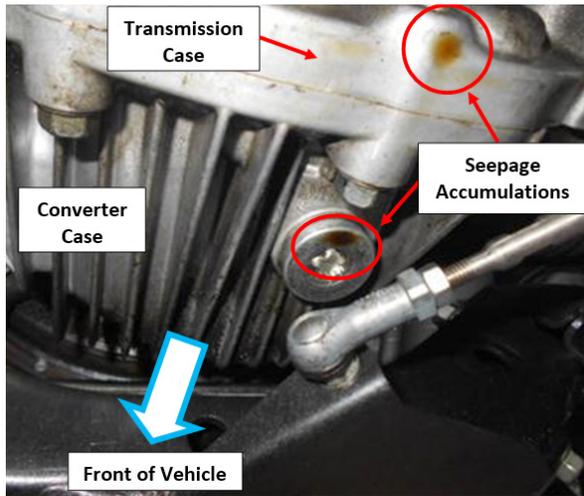
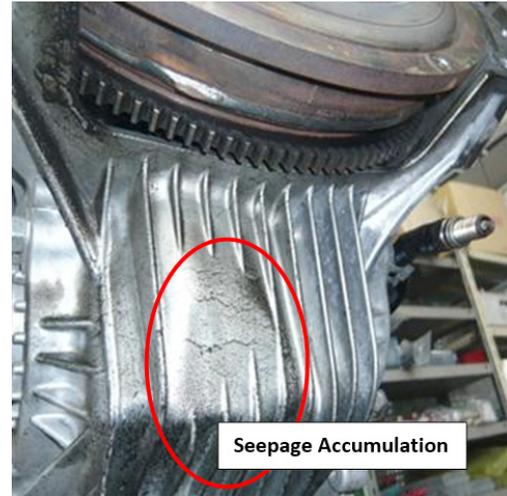
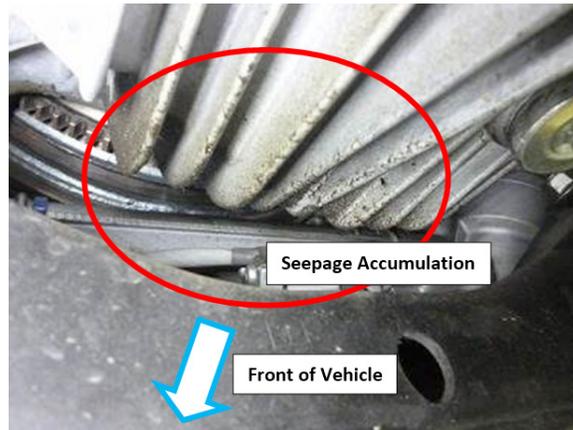
As a first step, during inspection of the customer's concern, confirm the fluid found to be seeping is CVT fluid (CVTF) and not engine oil. The photos below are examples of where CVTF seepage may be evident.

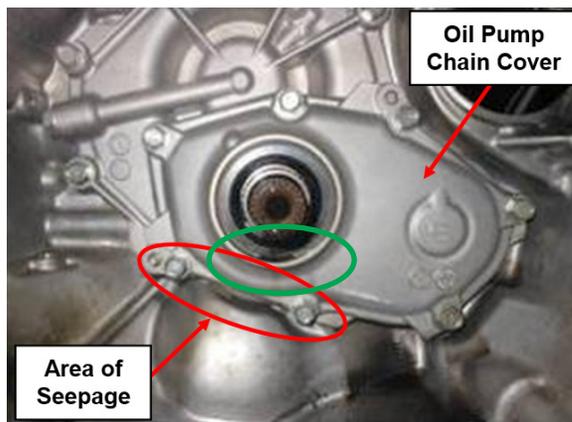
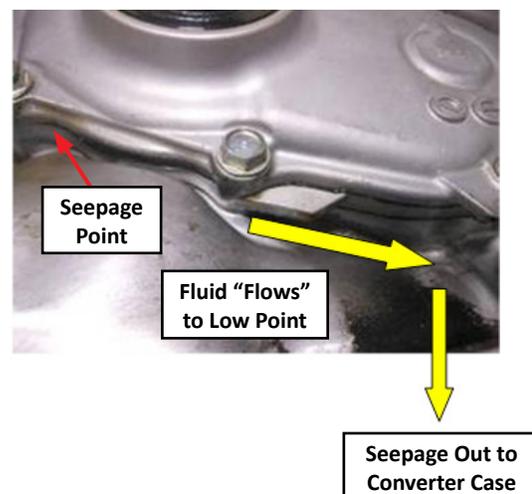
- Once the inspection has confirmed the seepage is CVTF, remove the CVT assembly following the procedure outlined in the applicable Service Manual.
- **CAREFULLY** remove the torque converter from the CVT and inspect the area of the oil pump chain cover as indicated in the photo below for any accumulation of CVTF and road dirt which may also have collected in the area.

NOTE: A small amount of fresh CVT fluid may appear near the 6:00 position of the seal area during removal of the torque converter (GREEN circle).

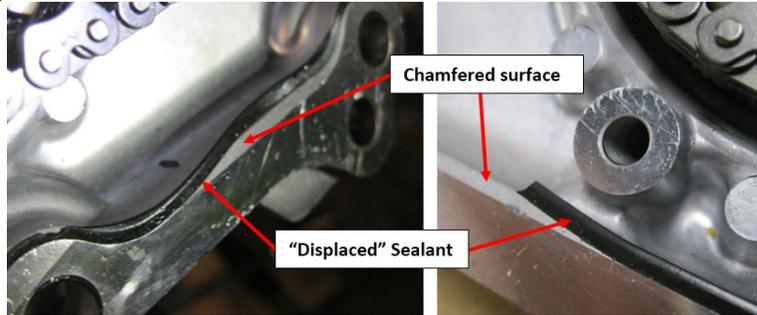
- Take note of how the sealant on the removed cover forms an additional “seal” when it becomes displaced into the chamfer around the inside edge of the case’s machined surface at assembly.

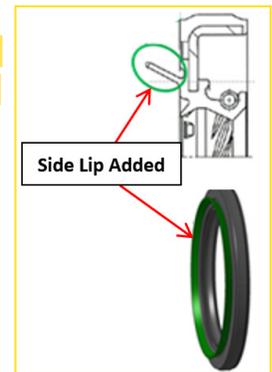
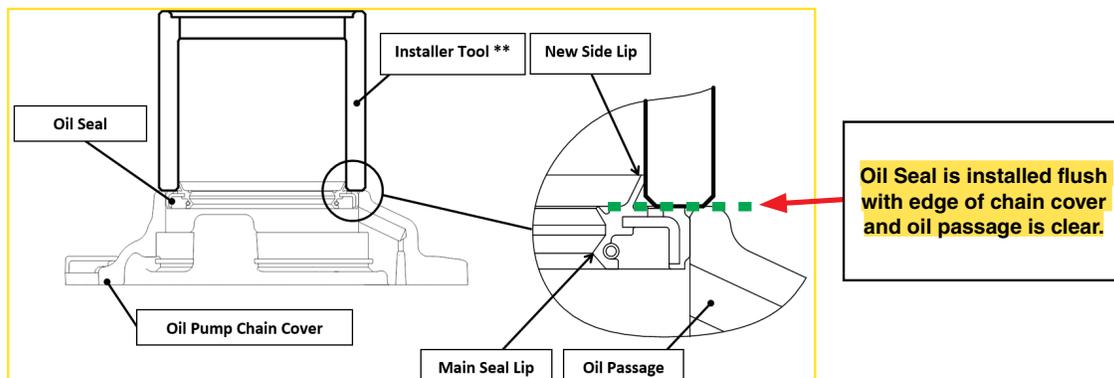
- The re-designed input shaft oil seal has a new side lip added to supplement the existing main seal lip. The purpose of the additional side lip is to direct the flow of dust and water around the seal and away from the sealing surfaces.
- Apply CVT fluid to the main seal lip **only** before installation.
- When installing this new seal, it is **STRONGLY** recommended to use the proper installer tool ****OPTIONAL Special Tool 927890000** as shown in the illustration below. Otherwise, If the seal were to be installed too deep into the bore of the chain cover (beyond flush with the chain cover edge as shown below), the oil passage may become restricted or blocked.

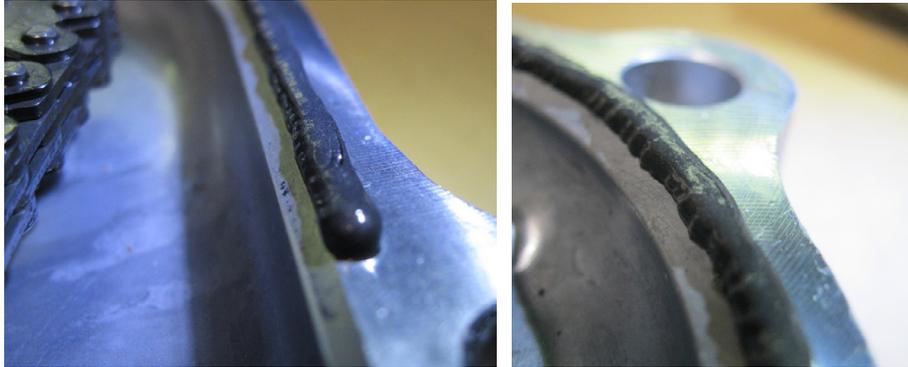
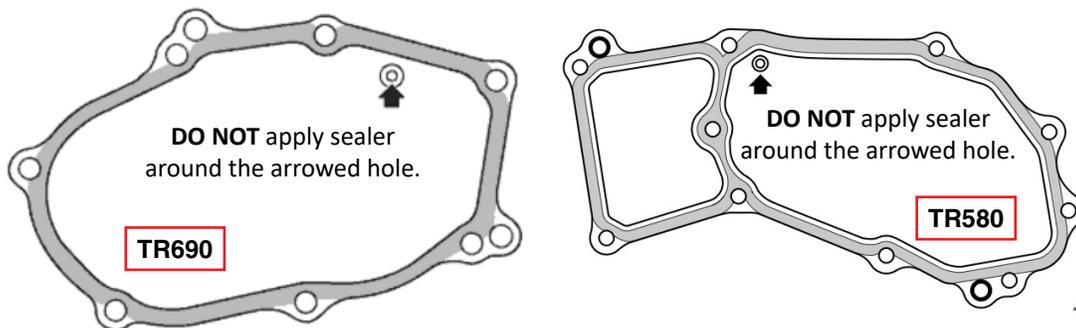
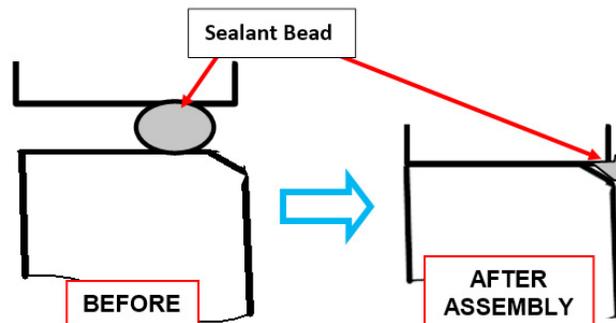
NOTE: As shown above, a properly applied, small bead of sealant will fill in the chamfered portion after the cover is installed. Do not use an excessive amount of sealant.

- Once both surfaces and the area surrounding the cover are completely clean, dry and the new input seal is properly installed, CAREFULLY apply the new sealant bead to the cover along the edge of the chamfer as shown below.
