First Release

MODIFICATION OF THE SMALL A/C COMPRESSOR HARNESS – VOLTA COMPRESSOR

Prevost vehicles

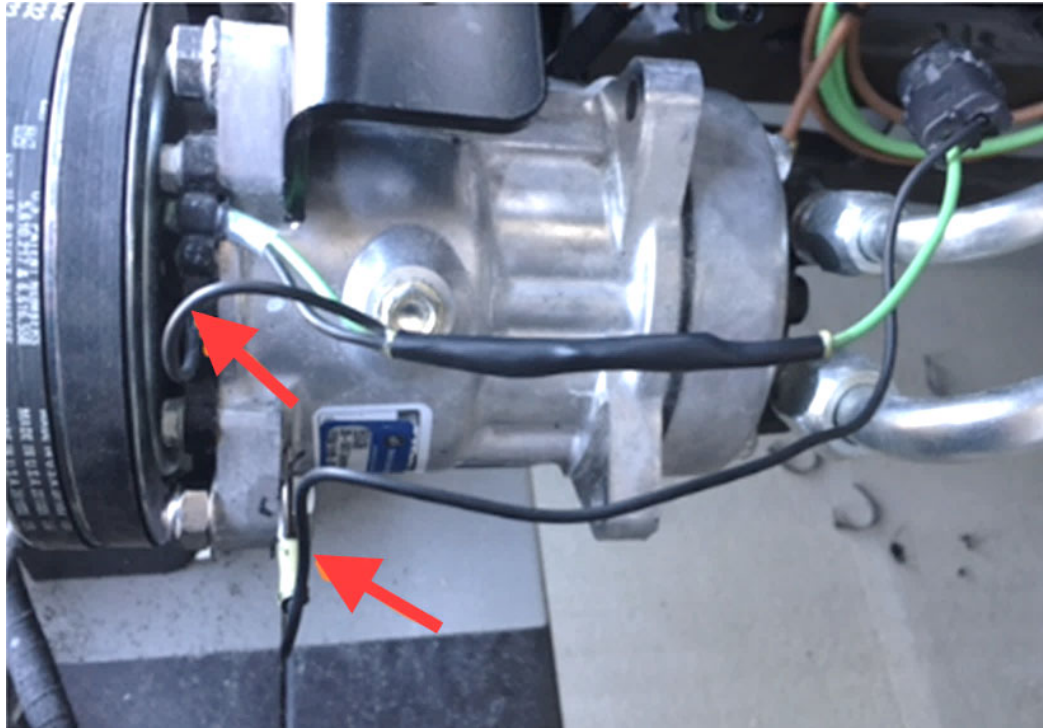
FIGURE 1: ORIGINAL HARNESS

On the vehicles affected by this bulletin, a modification of the small A/C compressor harness is necessary.

1. Modify the harness as described in the following steps.
 - You will discard the diode. The clutch coil black wire will be routed directly to the connector while eliminating the two ground terminal connections identified with red arrows (figure 1).
 - You will need a PED connector extraction tool (figure 2).
