TECHNICAL SERVICE BULLETIN

2.7L EcoBoost - Oil Pan Leaking

19-2205
06 August 2019

| Ford 2015-2017 F-150 |

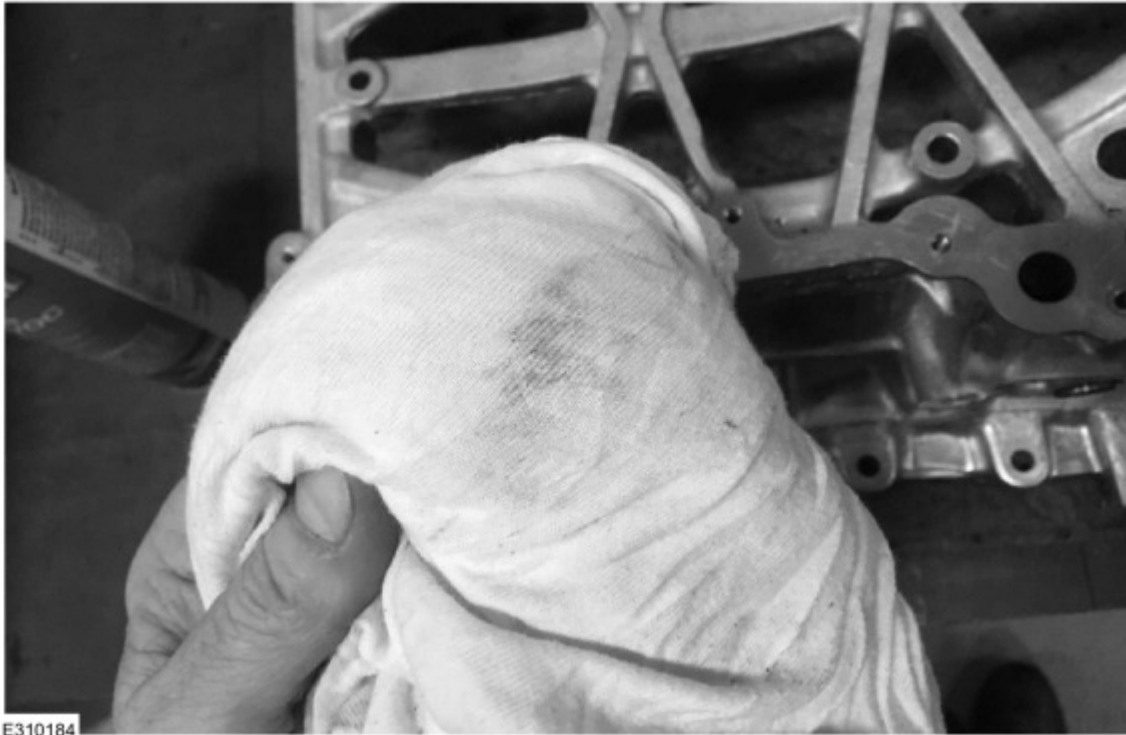
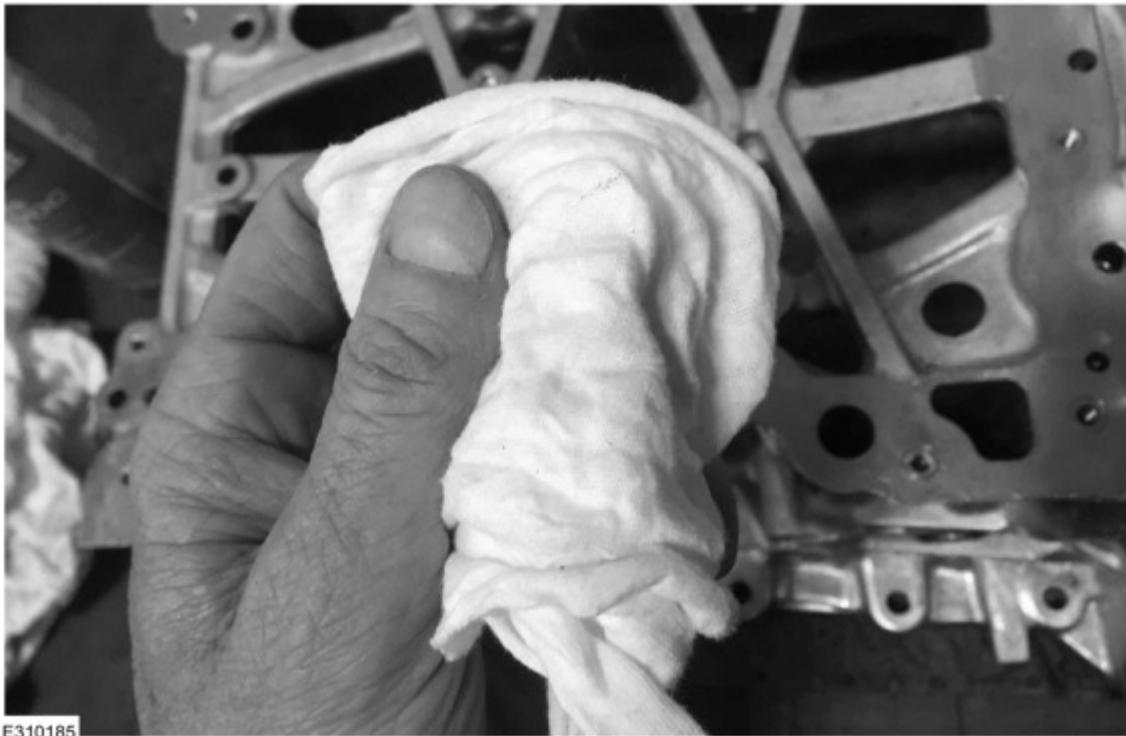
NOTE: When cleaning the engine sealing surface it must be wiped clean using a lint free cloth. Spraying the surface with brake cleaner and air drying will not adequately remove the oil and other contaminants from the surface and may leave residue from the brake cleaner behind that may interfere with RTV adhesion.

(1). Use only Motorcraft® Metal Brake Parts Cleaner to clean the engine sealing surface. Some unapproved brake parts cleaners contain chemicals that will inhibit RTV adhesion or may evaporate without removing all of the residual oil from the sealing surface which will result in a repeat leak condition.

3. Use a lint free towel and Motorcraft® Metal Brake Parts Cleaner to remove all residual sealant and oil from the engine sealing surface until a clean lint free towel no longer shows any residual oil when wiping the surface. (Figures 1-2)

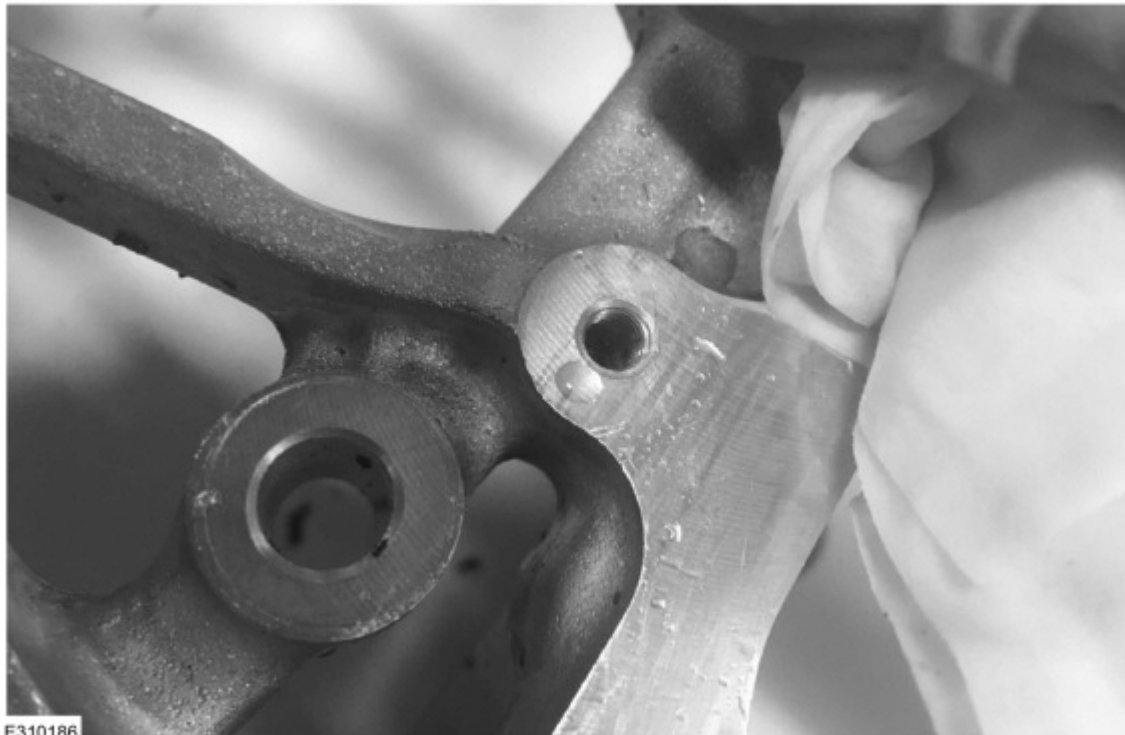
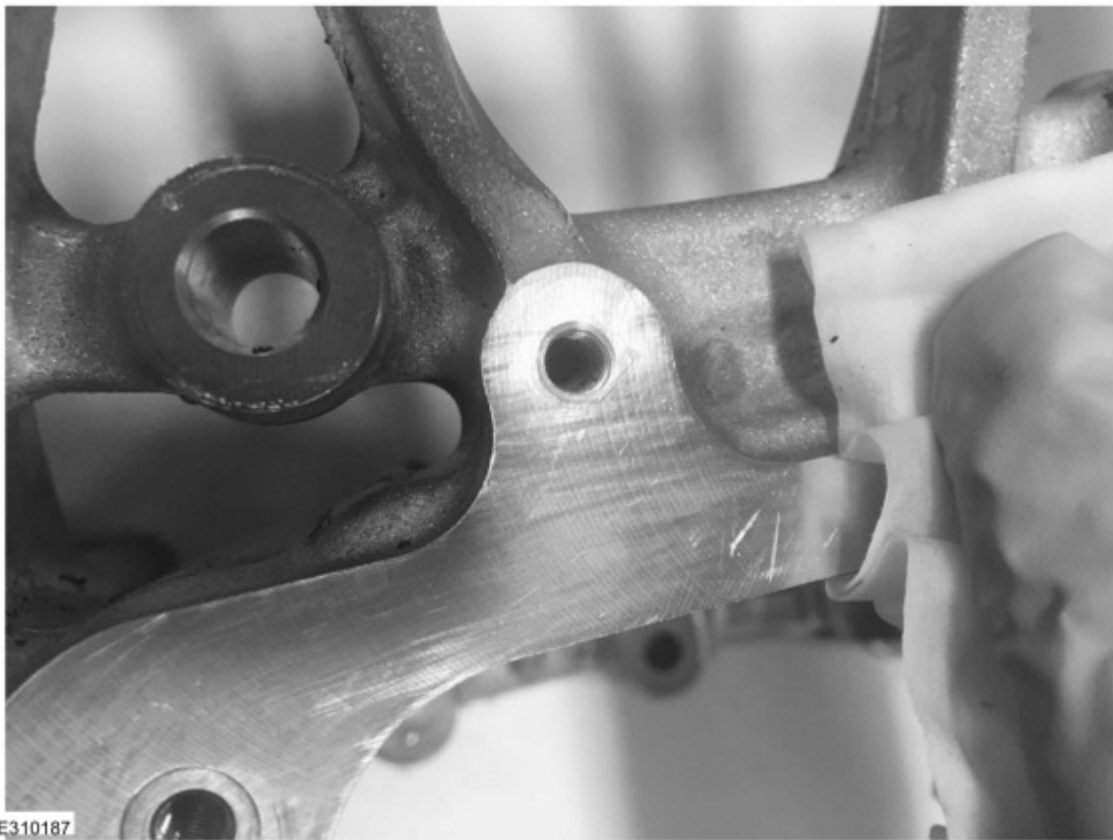
(1). Motorcraft® Metal Surface Prep Wipes create a conversion coating providing an improved base for RTV sealing. The fluid is a water-based, slightly acidic solution that will etch and bond to the metal to provide a microscopic layer to which the RTV can adhere. If the surface is oily, the solution will bead and the surface will not be treated properly. If the solution beads when applied to the sealing surface, the surface must be cleaned again and then the Motorcraft® Metal Surface Prep Wipes reapplied. (Figures 3-4)

5. Wipe the metal engine block skirt stiffener sealing surface using Motorcraft® Metal Surface Prep Wipes. Thoroughly coat the surface with the fluid. Discard wipes after a single use.

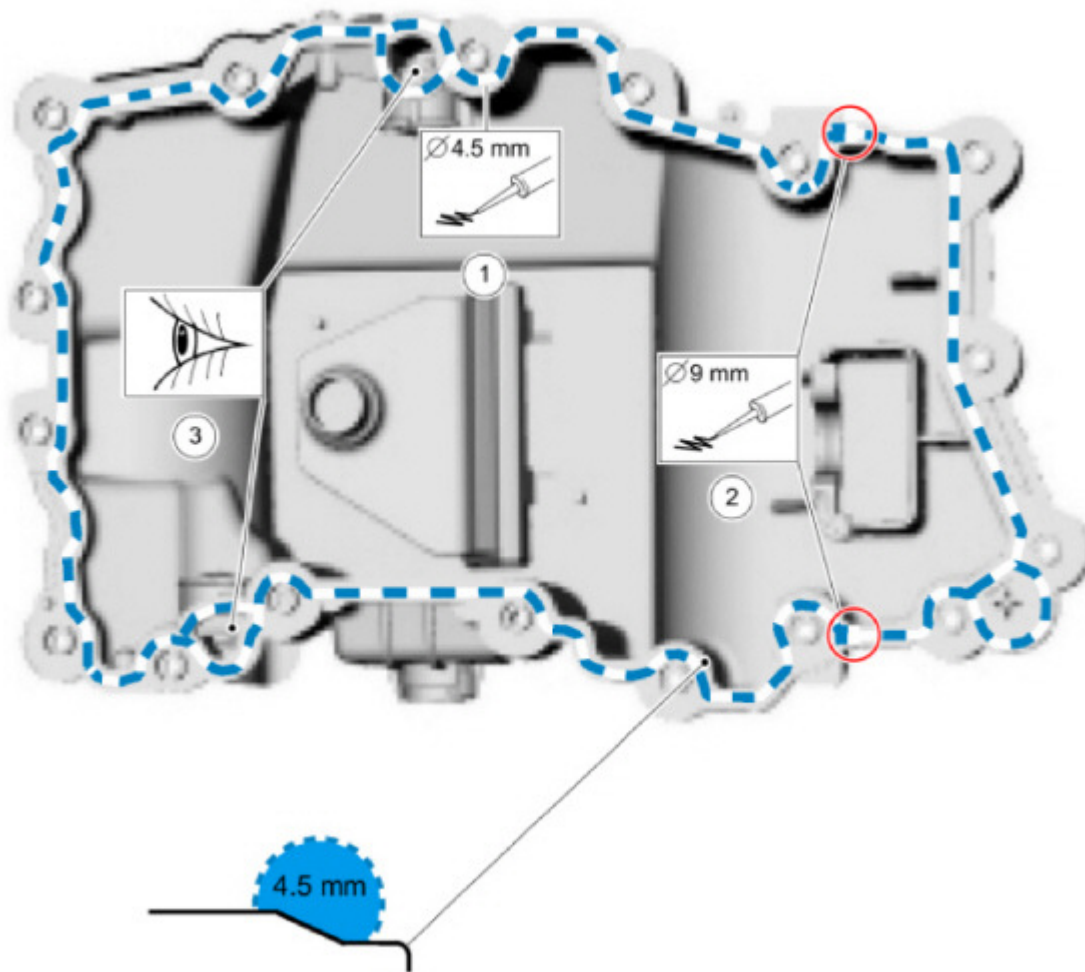
Figure 5

(1). Using too little sealant may result in oil leaks and using too much sealant may result in oil contamination and engine damage.

8. Apply a 4.5 mm (0.18 in) bead of Motorcraft® High Performance Engine RTV Silicone to the new oil pan. The RTV bead must be applied to straddle the step chamfer and sealing face. (Figures 5-6)

9. Apply a 9 mm (0.35 in) bead of Motorcraft® High Performance Engine RTV Silicone to the engine front cover-to-cylinder block joint areas on the new oil pan as shown in Figure 5.
10. Install the new oil pan. Refer to the WSM, Section 303-01.
