Technical Service Bulletin

39 Transfer case leaks

39 19 24 2016880/7 August 29, 2019. Supersedes Technical Service Bulletin Group 39 number 10-05 dated August 3, 2010 for reasons listed below.

Model(s)	Year	VIN Range	Vehicle-Specific Equipment
Q7	2007	000001 – 055095	Not Applicable
	2008	000001 – 011586	Not Applicable

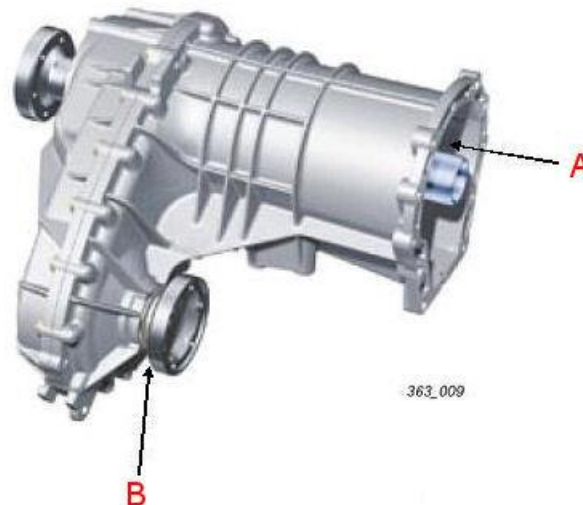
- Oil leak between automatic transmission and transfer case (Figure 1, A).
- Oil leak at front driveshaft output flange on transfer case (Figure 1, B).

Figure 1. The input shaft seal (A), and the front driveshaft output flange seal (B).

- Transfer case input shaft seal is damaged during installation.
- The internal circlip of the output flange shaft has come loose, allowing the output flange to move out slightly, causing seal to leak.

1. Replace the transfer case input shaft seal (Figure 1, A). Refer to Elsa for seal installation instructions.
2. Replace the complete transfer case assembly if the front driveshaft output flange seal is leaking (Figure 1, B). Refer to Elsa for transfer case removal and installation instructions.
