Daimler Trucks North America  
Gordon Scherdnik  
Service Engineering

### Subject: Corroded Battery Cables

Models Affected: Specific Freightliner New Cascadia vehicles manufactured with sales datacode 290-1D3

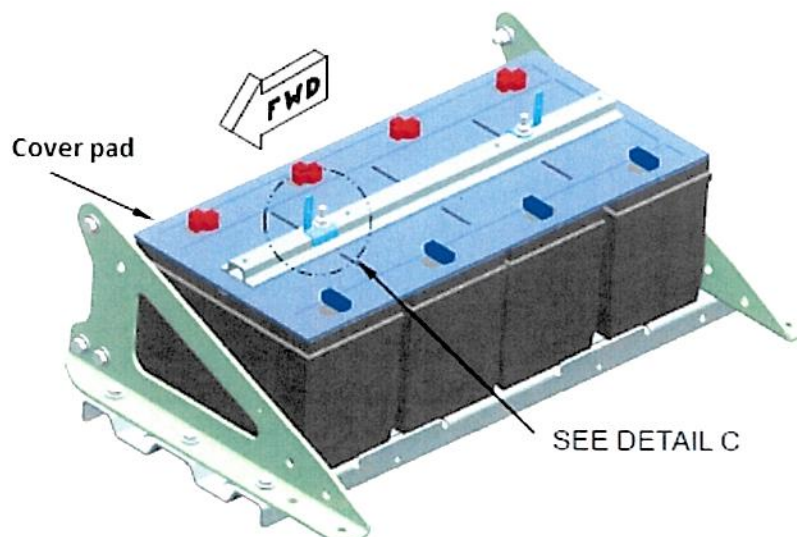
Fig. 1 Batteries with cover pad

**IMPORTANT:** This document is intended for use only for an "as needed" guide for vehicles operating in conditions of extreme road salt. The current datacode of 290-1D3, Steel battery box with enclosed tray, utilizes a pad on top of the batteries. This mentioned pad will be relocated under the batteries to avoid moisture entrapment and resulting cable corrosion.

1. Park the vehicle on a level surface, shut down the engine, and set the parking brake. Chock the rear tires.
2. See the diagram below. Note the pad, part number 66-01226-000:

4. Remove battery cover pad part number 66-01226-000. Remove batteries. Ensure that the battery box base is clean of debris, and place the pad on the battery box base. Reinstall the batteries over the top of the pad.

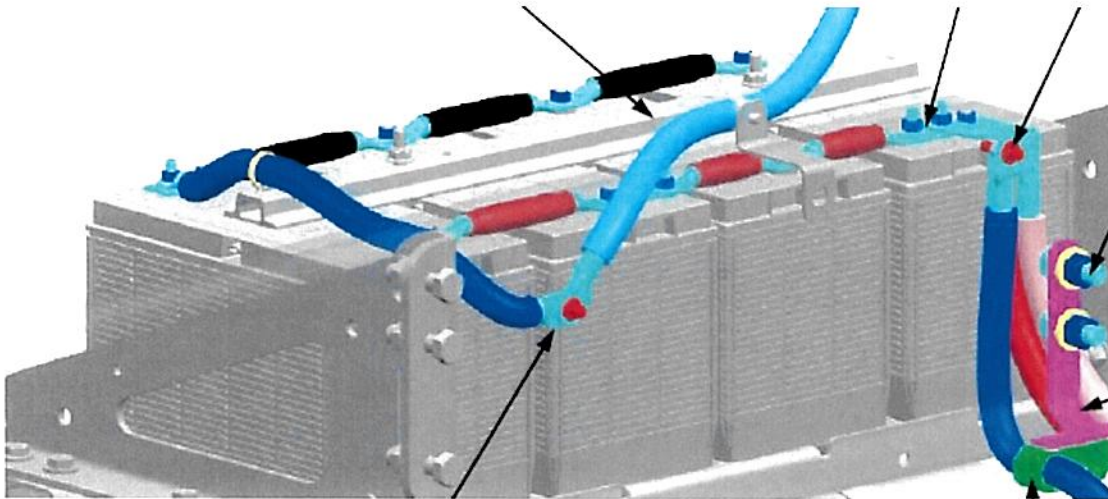
Fig. 3 Battery Cables

3. Remove the battery hold-down bracket. Remove battery cables, beginning with the negative side and inspect for corrosion:

If the battery cable jumpers are found to be excessively corroded, replace them as necessary with the same part listed in module 281 in Parts Pro.
