Countries: CANADA, UNITED STATES Document ID: IK1201440
 Availability: ISIS, FleetISIS, IsSIR Revision: 0
 Major System: ENGINES Created: 8/25/2019
 Current Language: English Last Modified: 8/27/2019
 Other Languages: NONE Author: Greg Scheff
 Viewed: 54

Title: A26 Fuel Delivery Pressure Sensor (FDP) and Harness Pigtail Eliminated

Applies To: All A26 Engines

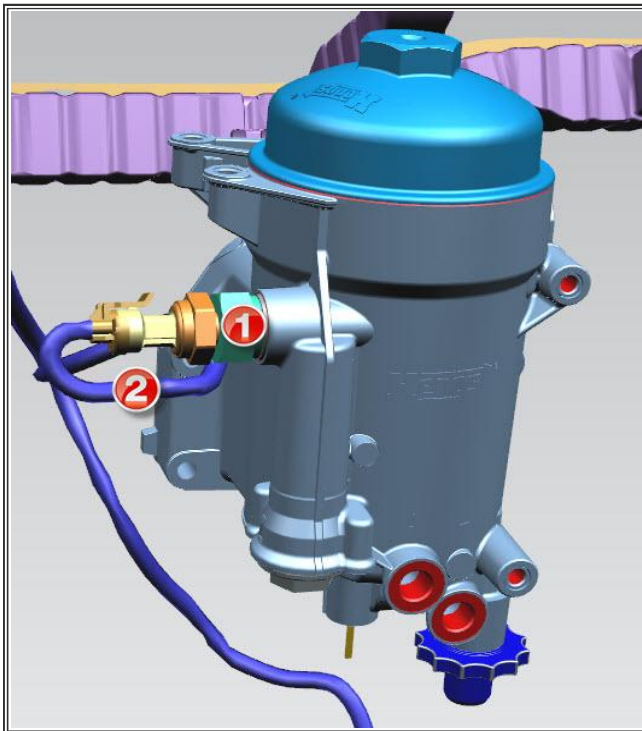
Figure #1: Engine Mounted Fuel Filter Housing

This document will explain the removal of the fuel delivery pressure sensor and harness pigtail on the A26 engine. The early built A26 engines had the fuel delivery pressure sensor installed in the engine mounted fuel filter housing (Figure #1) however, the ECM never monitored the signal from it. Later the sensor was removed, the port was plugged, and the engine harness was modified to remove the pigtail and the connector for it.

Item 1: Fuel Delivery Pressure Sensor (FDP)

Item 2: FDP harness pigtail and sensor connector

IT IS ACCEPTABLE to install a C92 harness on a newer engine not equipped with the FDP sensor.

- The unused pigtail (Figure #1 item 2) and connector for the FDP sensor can simply be tied off and tucked out of the way OR
- The pigtail (Figure #1 item 2) can be cut off, and apply heat shrink tubing at the wire ends
- The wiring for those circuits to the ECM are not used
