Title: 8600/TranStar Hood Latches Do Not Fit Correctly

Applies To: All 8600/TranStar models that have had or will have the hood latches and/or the fender extensions replaced.

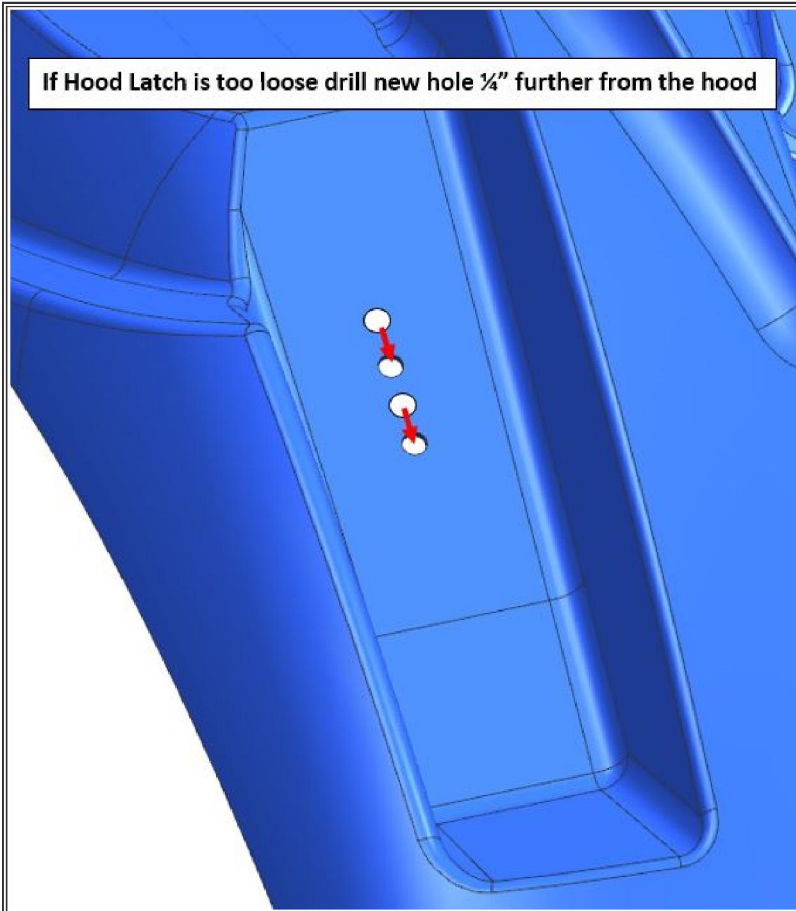
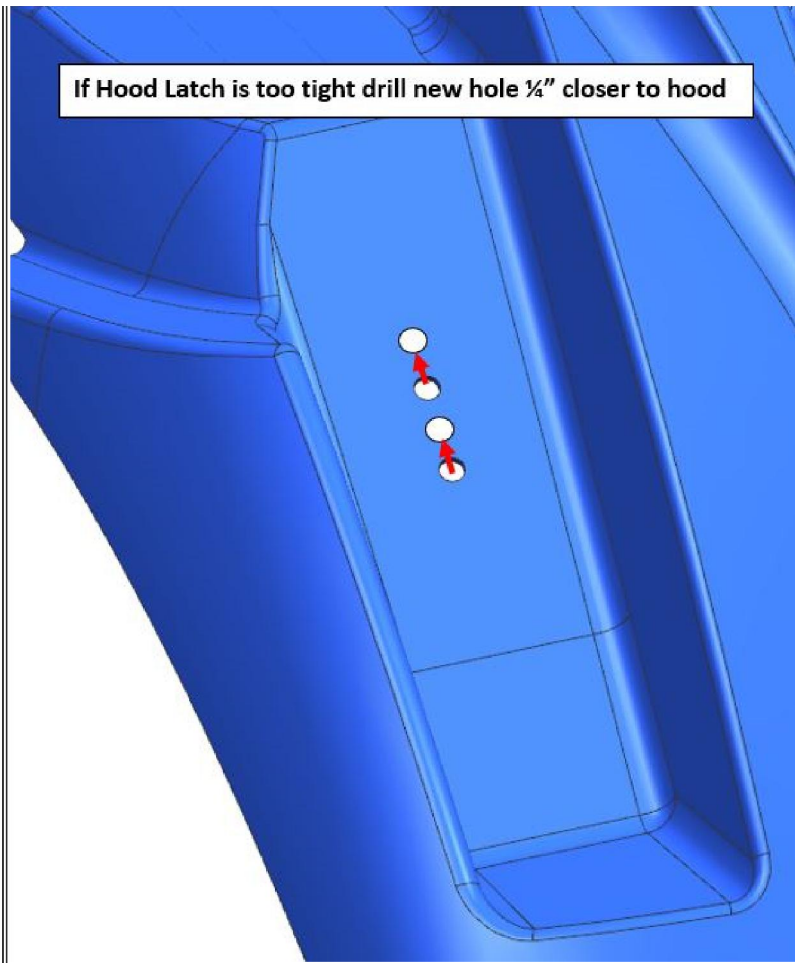
Due to a design change between the hood latch and fender extension, the latch may be too loose OR too tight, depending on the age/revision level of the latch and/or fender extension.

Condition 1: If the latch is too tight, mark & drill new holes up ¼" closer to the hood.

Condition 2: If the latch is too loose, mark & drill new holes down ¼" further away from the hood.

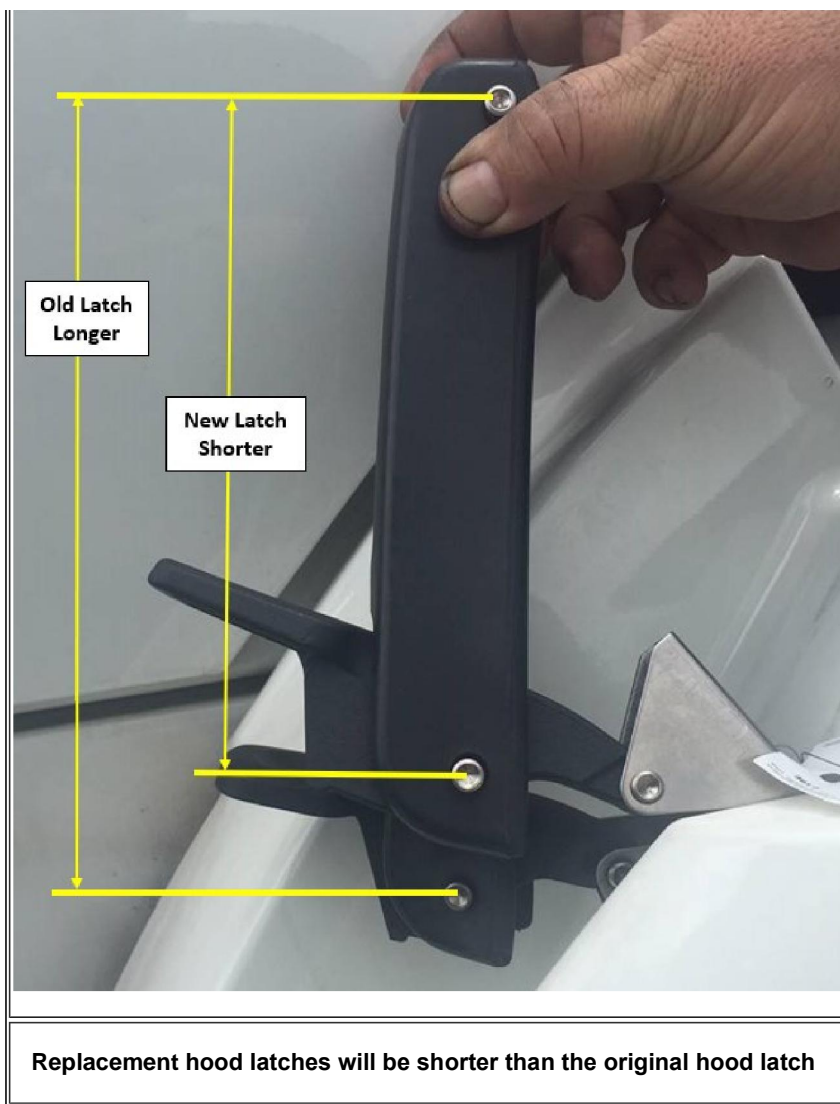
New mounting holes for the latches may need to be added to the fender extensions

If there is a mismatch between the age/revision levels of the latch and fender extension and the latch is either too loose or too tight, new latch mounting holes must be drilled in the fender extension to change the position of the latch.
