FIELD SERVICE CAMPAIGN BULLETIN

Subject: **Field Service Campaign D19M2**
GHG17 Detroit™ DD5™ Fan Hub Bolt Torque Inspection

Field Service Campaign Bulletin D19M2

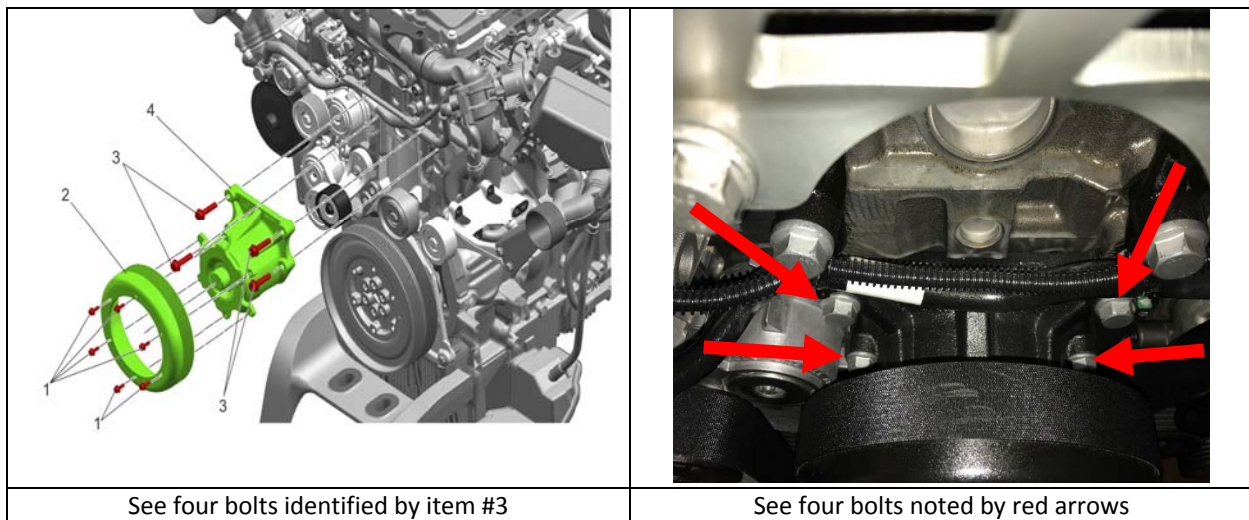
Figure 1 – Fan Hub Mounting Bolt Location

1. Apply the parking brake, turn off the ignition, disconnect vehicle battery power, chock the wheels, and perform any other applicable safety steps.
2. Remove the fan hub pulley. **REFERENCE** chapter “Belt Drive” and section “Removal of the Fan Hub Pulley” in the *GHG17 DD5 934912(C) Workshop Manual* (DDC-SVC-MAN-0194).
3. Inspect the four fan hub mounting bolts to see if they are all present. See Figure 1, and note the fan hub pulley is also pictured. Are all four fan hub mounting bolts present?
 - a. If Yes, then proceed to step 4.
 - b. If No, then proceed to step 5.

4. Re-torque the four fan hub mounting bolts to 50 N·m (37 lb·ft). Proceed to step 15.
5. For any fan hub bolts missing, did they break off and leave a portion of the bolt in the block? See Figure 2.
 - a. If Yes (bolt broken off), then proceed to step 6.
 - b. If No (bolt missing), then proceed to step 13.
