# FIELD SERVICE CAMPAIGN BULLETIN

Subject: **Field Service Campaign D19M3**  
**GHG17 Detroit™ DD5™ Software Reprogramming**

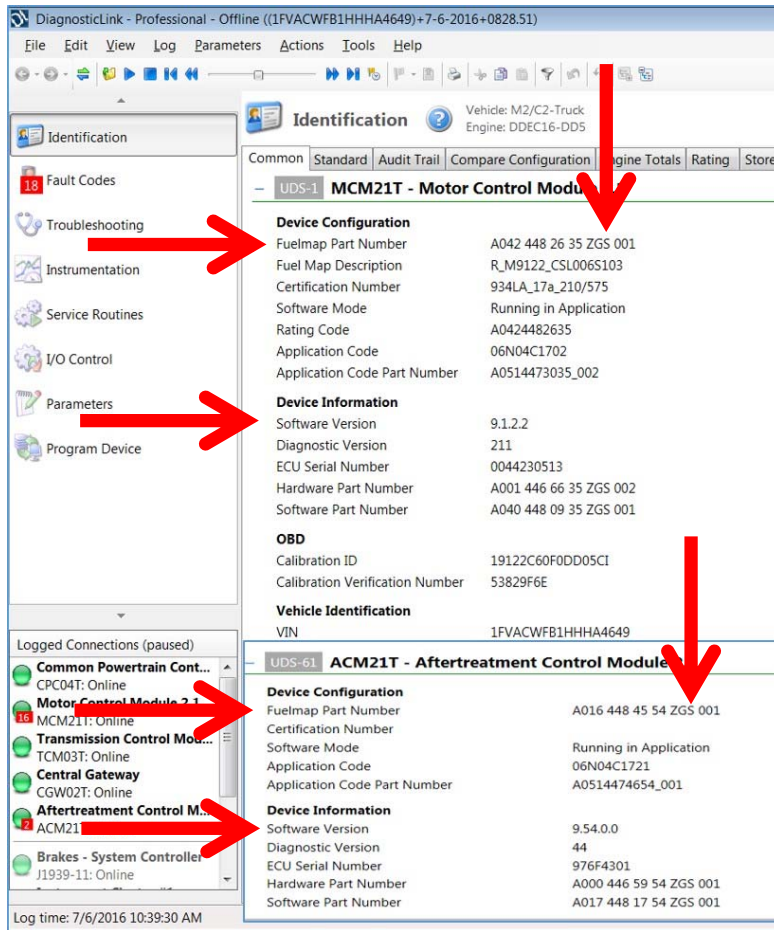
Figure 1 – DiagnosticLink® Identification Screen

6. Is the **software** level for all modules less than, equal to, or higher than the minimum software levels listed in step 5? All modules must meet the **MINIMUM** requirements. For example in Figure 1, MCM software 9.1.2.2 and ACM software 9.54.0.0 are both less than the minimum levels of 9.1.2.3 and 9.57.1.0 and thus would require programming regardless of fuel map part number ZGS level.
  - a. If equal to the minimum software levels, proceed to step 7.
  - b. If less than the minimum software levels, proceed to step 8.
  - c. If greater than the minimum software levels, no programming is necessary. Proceed to step 13.

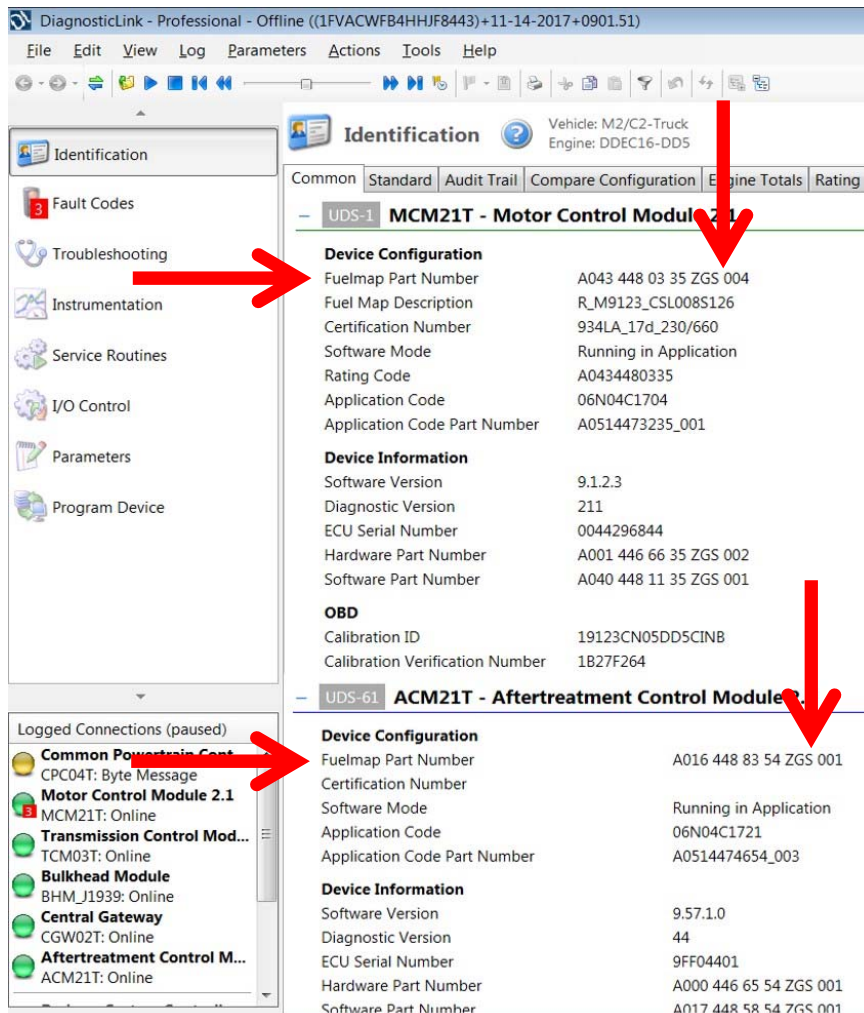
**Figure 2 – DiagnosticLink® Identification Screen**

7. Is the fuel map part number ZGS level for the MCM and ACM less than, equal to, or higher than the fuel map part number ZGS levels listed in step 5? The MCM and ACM fuel map part number ZGS levels must meet the **MINIMUM** requirements. For example in Figure 2, the MCM and ACM software levels meet the minimum required levels of 9.1.2.3 and 9.57.1.0, but the MCM fuel map part number ZGS level of 004 is less than the minimum level of 004, and ACM fuel map part number ZGS level of 001 is less than the minimum level of 002, and thus would require programming.
  - a. If less than the minimum fuel map part number ZGS levels, proceed to step 8.
  - b. If equal to or greater than the minimum fuel map part number ZGS levels, no programming is necessary. Proceed to step 13.
