N330NAS1

# TECHNICAL BULLETIN

04 JUN 2019

Service Action: Emergency Call (eCall) And Breakdown Call (bCall) Functions Missing

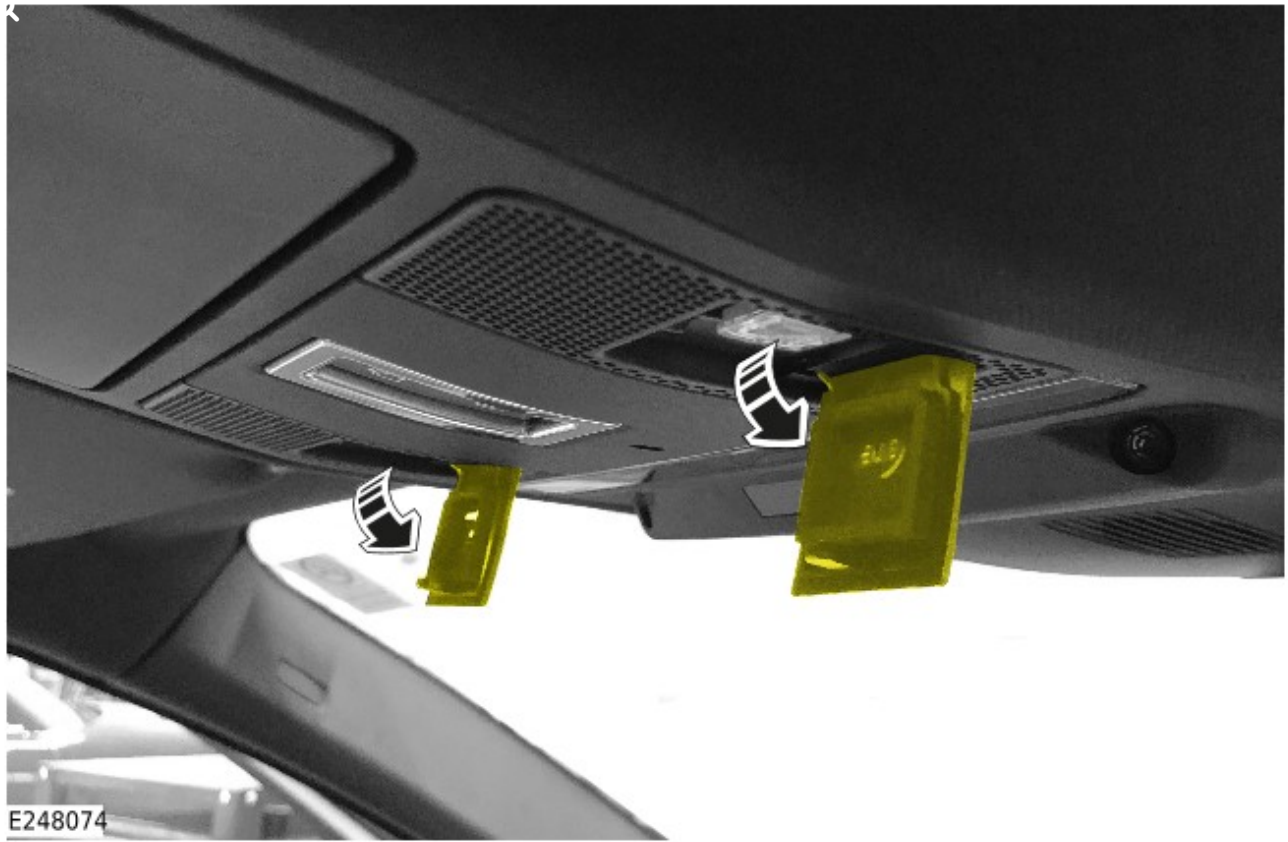
1

Open the Emergency Call (eCall) and the Breakdown call (bCall) buttons.

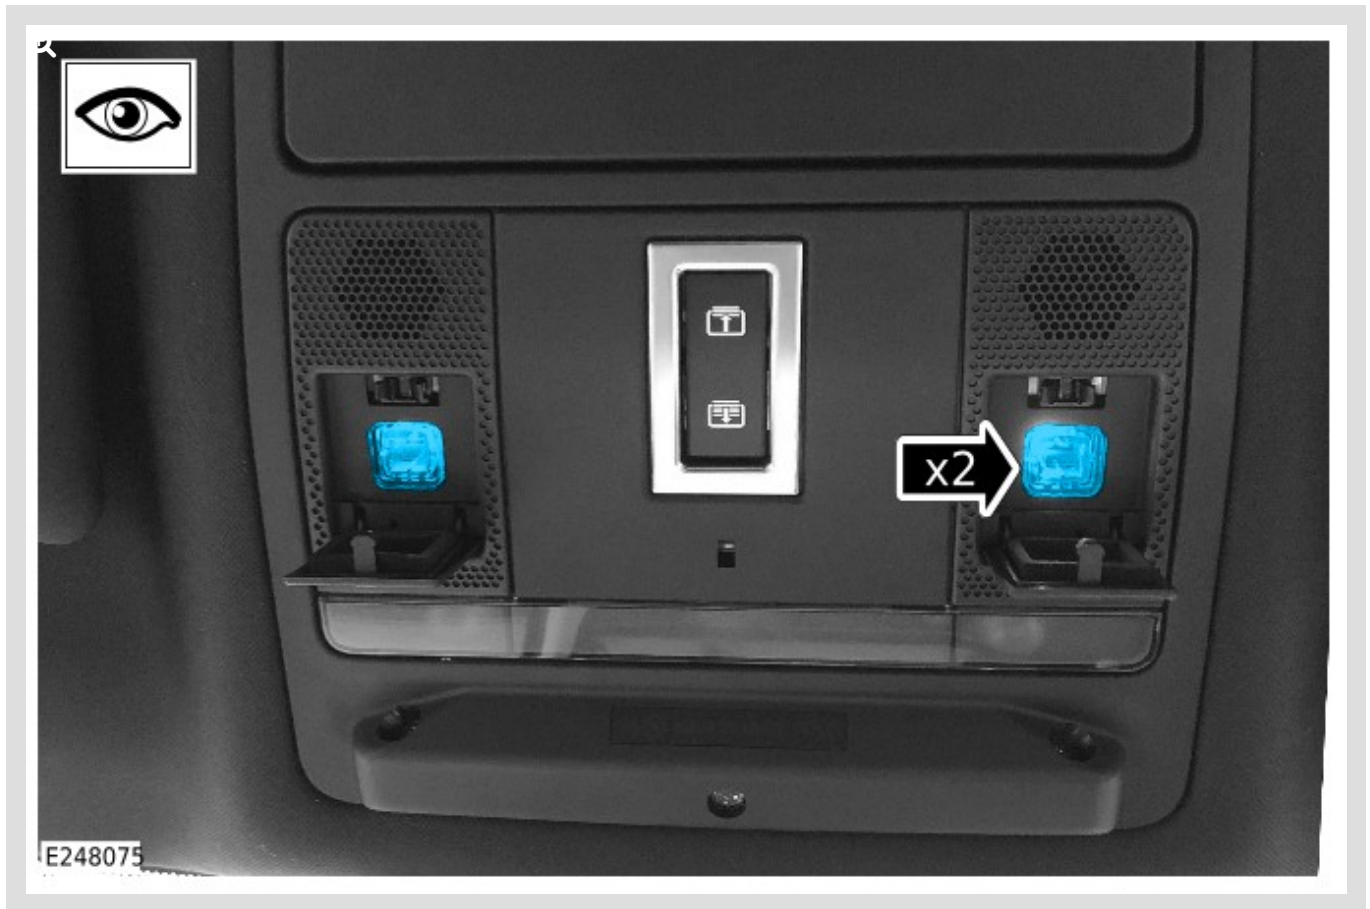
2

Visually inspect the front overhead console.

- If the front overhead console does have the eCall and the bCall buttons installed, go to Step 4.
- If the front overhead console does not have the eCall and the bCall buttons installed, go to Step 3.

3 Renew the front overhead console (see TOPIx Workshop Manual section 501-12: Instrument Panel and Console - Front Overhead Console).
