SECTION: 419-02

'Smart key not found' Message Displayed and Poor Smart key Operation

Discovery (LR) Model Year: 2018-2019 VIN: 047448-096625 Assembly Plant: Solihull Range Rover Sport (LW) Model Year: 2018 VIN: 181320-199999 Assembly Plant: Solihull Range Rover Sport (LW) Model Year: 2018 690430-699999 VIN: Assembly Plant: Solihull Range Rover Sport (LW) Model Year: 2018-2019 VIN: 800002-862860 Assembly Plant: Solihull Range Rover Sport (LW) Model Year: 2018-2019 VIN: 400000-427053 Assembly Plant: Solihull Range Rover (LG) Model Year: 2018 VIN: 380217-399999 Assembly Plant: Solihull Range Rover (LG) Model Year: 2018-2019 VIN: 500023-558542 Assembly Plant: Solihull

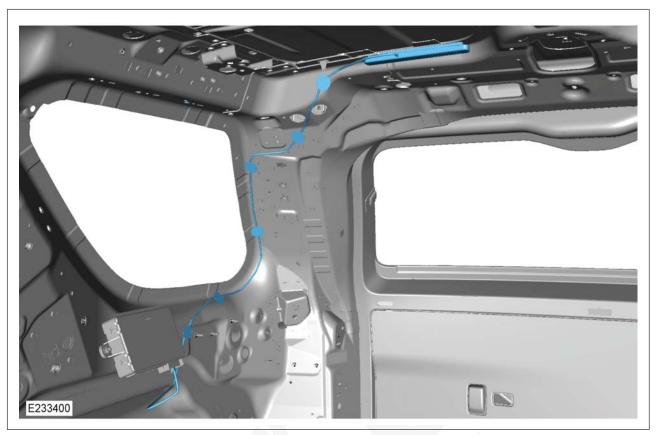
1. **Discovery:** Coaxial cable wiring harness route.

- 4. Verify that the coaxial cable from the Radio Frequency (RF) antenna to the Remote Function Actuator (RFA) is correctly routed, secured in position, and is not trapped. Inspect the condition of the connectors and the connector pins between the RF antenna and RFA for damage. Make sure that connections are secure. Refer to the Service Information section above for wiring harness routes and locations.

Route the coaxial cable as shown in the Service Information section above and secure in place with adhesive pads to make sure the cable will remain in its position.

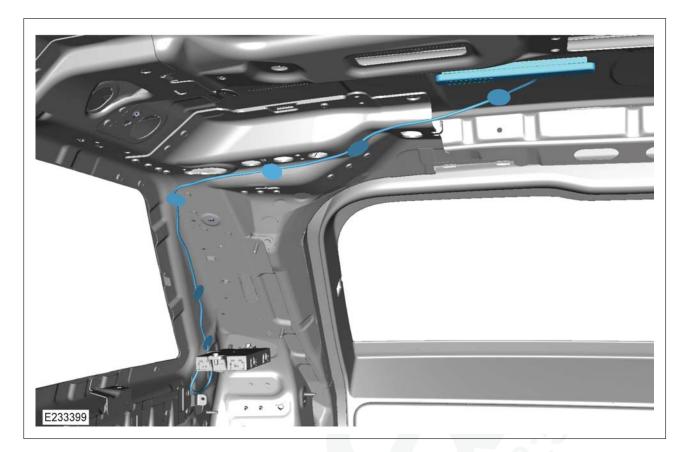
2. Range Rover Sport: Coaxial cable wiring harness route.

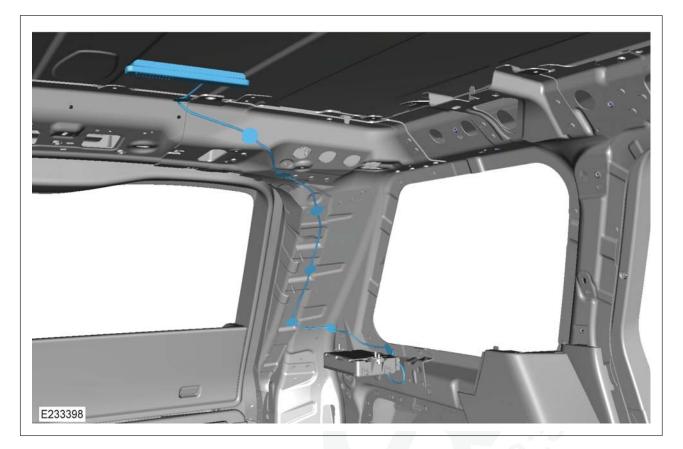
3. Range Rover: Coaxial cable wiring harness route.

- 4. Verify that the coaxial cable from the Radio Frequency (RF) antenna to the Remote Function Actuator (RFA) is correctly routed, secured in position, and is not trapped. Inspect the condition of the connectors and the connector pins between the RF antenna and RFA for damage. Make sure that connections are secure. Refer to the Service Information section above for wiring harness routes and locations.
 - If the coaxial cable is damaged, incorrectly routed, or trapped, go to Step 7.
 - If the coaxial cable and/or connectors and connector pins are damaged, go to Step 6.
 - If the coaxial cable is incorrectly routed or trapped, but no damage has occurred, go to Step 5.
- 5. \triangle NOTE: Re-use the adhesive pads where possible.

Route the coaxial cable as shown in the Service Information section above and secure in place with adhesive pads to make sure the cable will remain in its position.
