SERVICE BULLETIN

NTB18-041c

August 29, 2019

2017-2020 ROGUE, ROGUE HYBRID, AND ROGUE SPORT; FALSE ACTIVATION OF AEB, FEB, OR FCW

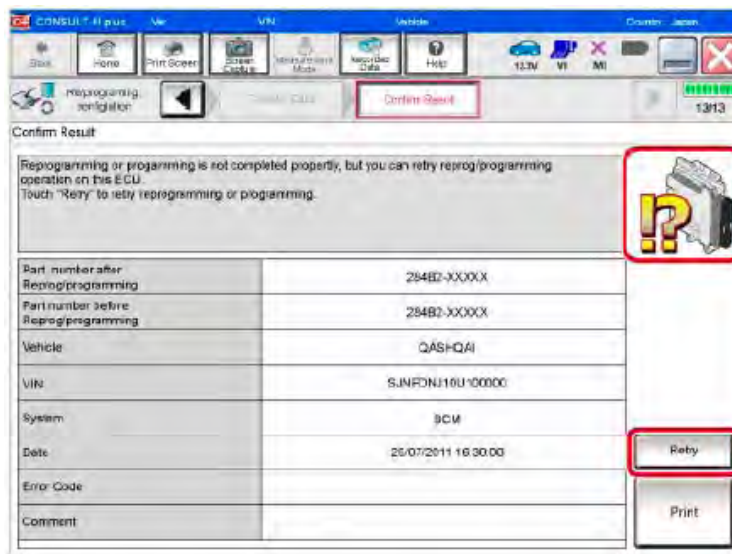
Figure 21

If reprogramming does not complete and the “!?” icon displays as shown in Figure 21:

- Check battery voltage (12.0 - 15.5 V).
- Ignition is ON, engine OFF.
- External Bluetooth® devices are OFF.
- All electrical loads are OFF.
- **Select retry and follow the on screen instructions.**
- **“Retry” may not go through on first attempt and can be selected more than once.**

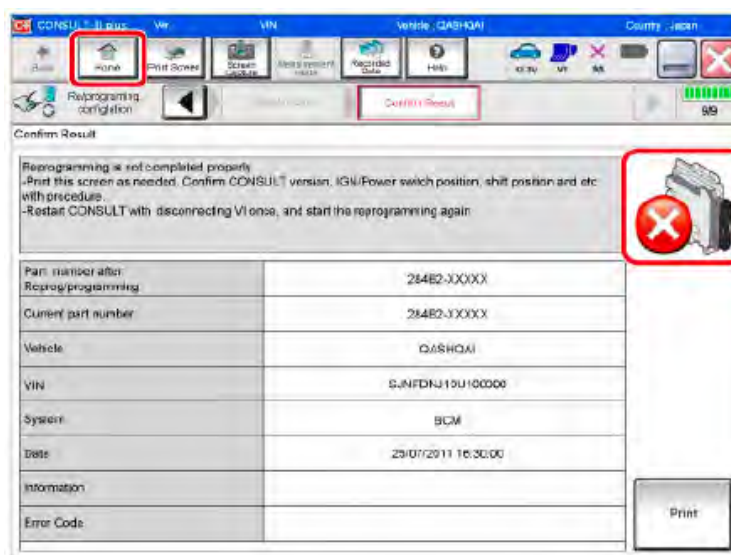
Figure 22

If reprogramming does not complete and the “X” icon displays as shown in Figure 22:

- Check battery voltage (12.0 - 15.5 V).
- CONSULT A/C adapter is plugged in.
- Ignition is ON, engine OFF.
- Transmission is in Park.
- All C-III plus / VI cables are securely connected.
- All C-III plus updates are installed.
- **Select Home, and restart the reprogram procedure from the beginning.**

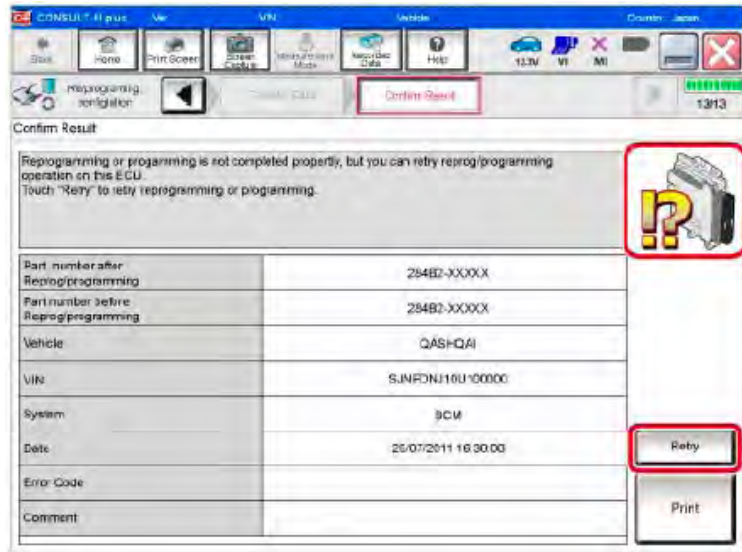
Figure 30

If reprogramming does not complete and the “!?” icon displays as shown in Figure 30:

- Check battery voltage (12.0 - 15.5 V).
- Ignition is ON, engine OFF.
- External Bluetooth® devices are OFF.
- All electrical loads are OFF.
- **Select retry and follow the on screen instructions.**
- **“Retry” may not go through on first attempt and can be selected more than once.**

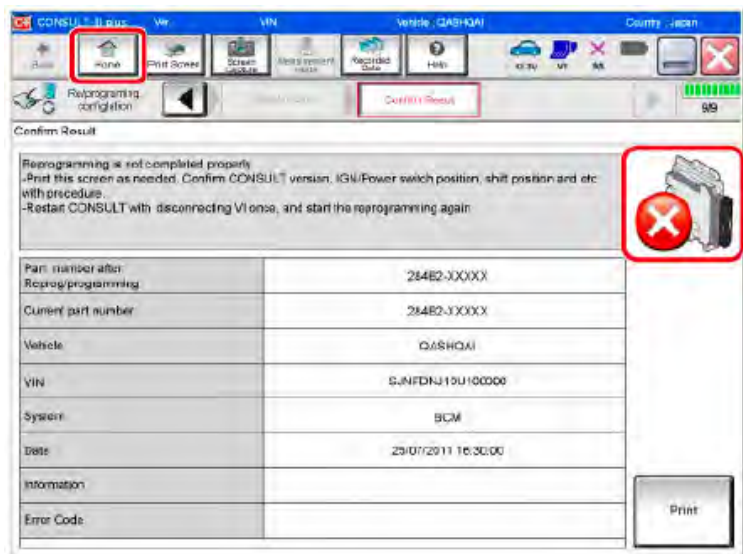
Figure 31

If reprogramming does not complete and the “X” icon displays as shown in Figure 31:

- Check battery voltage (12.0 - 15.5 V).
- CONSULT A/C adapter is plugged in.
- Ignition is ON, engine OFF.
- Transmission is in Park.
- All C-III plus / VI cables are securely connected.
- All C-III plus updates are installed.
- **Select Home, and restart the reprogram procedure from the beginning.**
