SERVICE CAMPAIGN BULLETIN

EL19-016

VOLUNTARY SERVICE CAMPAIGN 2017-2018 ROGUE, ROGUE HYBRID, AND ROGUE SPORT; ICC/ADAS AND LASER/RADAR REPROGRAMMING

CAMPAIGN ID #: P9327

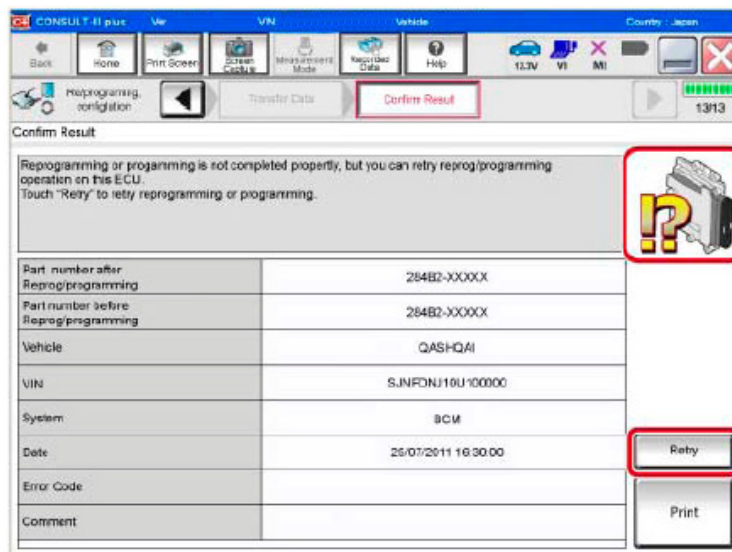
Figure 21

If reprogramming does not complete and the “!?” icon displays as shown in Figure 21:

- Check battery voltage (12.0 - 15.5 V).
- Ignition is ON, engine OFF.
- External Bluetooth® devices are OFF.
- All electrical loads are OFF.
- **Select retry and follow the on screen instructions.**
- **“Retry” may not go through on first attempt and can be selected more than once.**

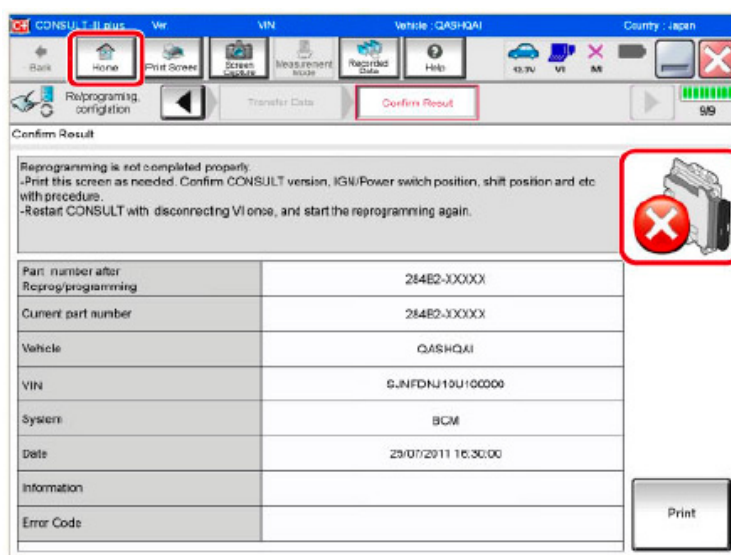
Figure 22

If reprogramming does not complete and the “X” icon displays as shown in Figure 22:

- Check battery voltage (12.0 - 15.5 V).
- CONSULT A/C adapter is plugged in.
- Ignition is ON, engine OFF.
- Transmission is in Park.
- All C-III plus / VI cables are securely connected.
- All C-III plus updates are installed.
- **Select Home, and restart the reprogram procedure from the beginning.**

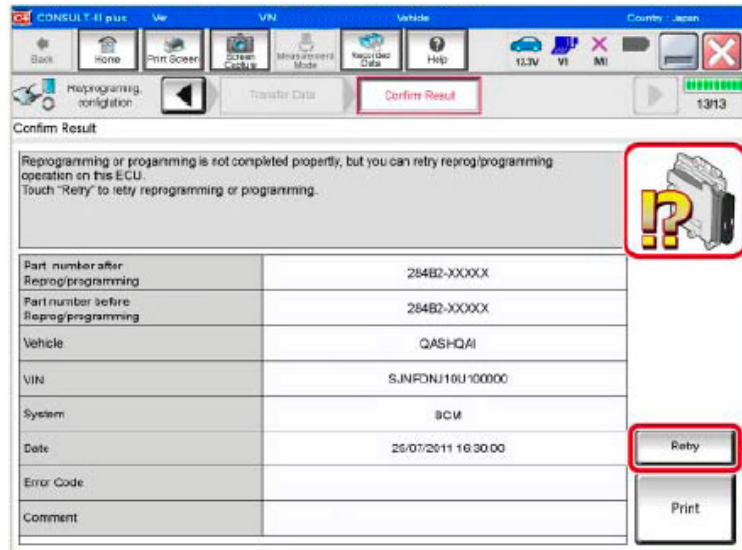
Figure 30

If reprogramming does not complete and the “!?” icon displays as shown in Figure 30:

- Check battery voltage (12.0 - 15.5 V).
- Ignition is ON, engine OFF.
- External Bluetooth® devices are OFF.
- All electrical loads are OFF.
- **Select retry and follow the on screen instructions.**
- **“Retry” may not go through on first attempt and can be selected more than once.**

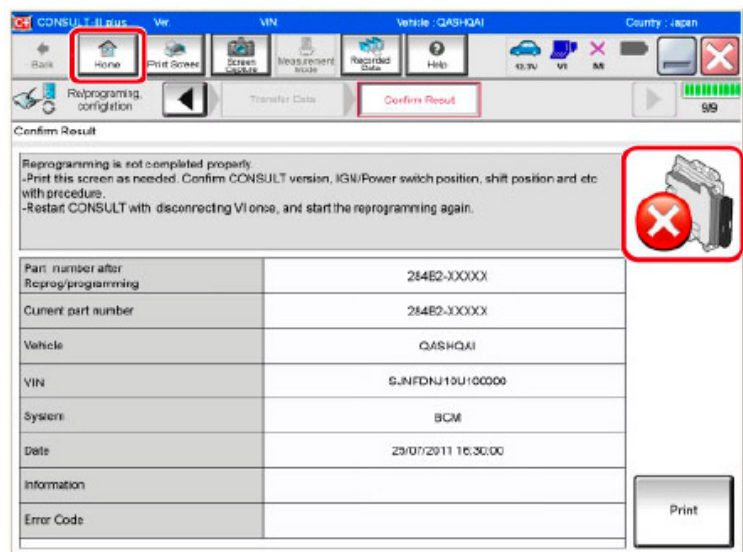
Figure 31

If reprogramming does not complete and the “X” icon displays as shown in Figure 31:

- Check battery voltage (12.0 - 15.5 V).
- CONSULT A/C adapter is plugged in.
- Ignition is ON, engine OFF.
- Transmission is in Park.
- All C-III plus / VI cables are securely connected.
- All C-III plus updates are installed.
- **Select Home, and restart the reprogram procedure from the beginning.**
