Preliminary Information

PIT5700 Service Front Camera Message

Brand:		Model:	Model Years:	VIN:		Engine	Transmissions:
				from	to	Engine:	Transmissions.
Chevro	let	Blazer	2019	All	All	All	All

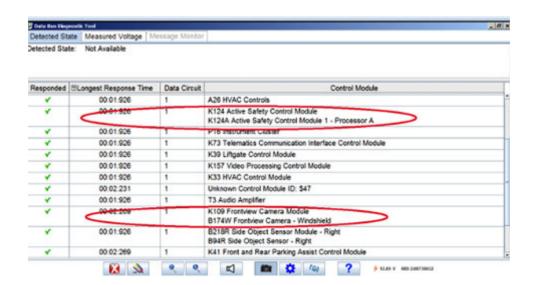
To confirm communication connect the data bus diagnostic tool to the vehicle, select the "detected state" tab and select "DLC terminal 1". Look through the list of communicating modules and ensure that the B174W and K124 are both on the list.

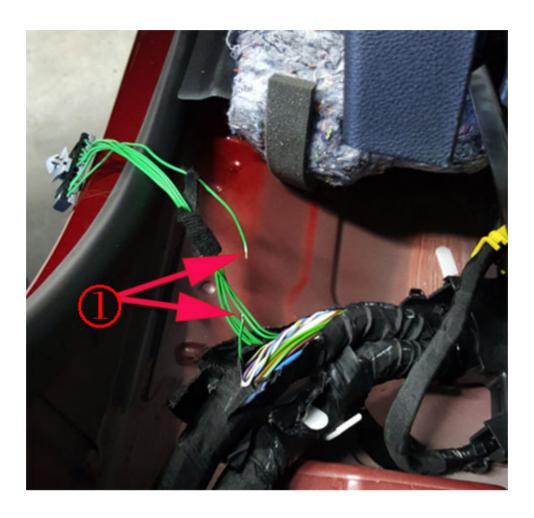
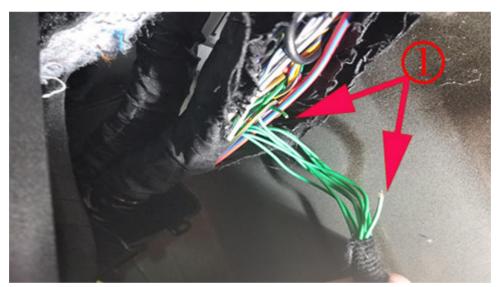
See # 1 below:

If it is found that the ASCM is not communicating on low speed inspect circuit 5060 for an open in the harness near JX300 which is located at the base of the left B pillar.

If an open is found repair the circuit following SI Serial Data Circuit Wiring Repairs.
