# Preliminary Information

**PIT5288G RKE / Passive Entry And Start / No Audio / SWC / Touch Screen / Display Blank/ Rear Wiper And Rear Power Windows Inoperative / Dead Battery / Service Tire Pressure System / SES MIL DTC B3101 B144C C0710 C0544 P0106 P0107 P2122 P2123 P2127 P2128 P2138 U0028 U0029 U0077 U0126 U0151 U0415 U1548 U1549 U154A**

Product Investigation Review Required

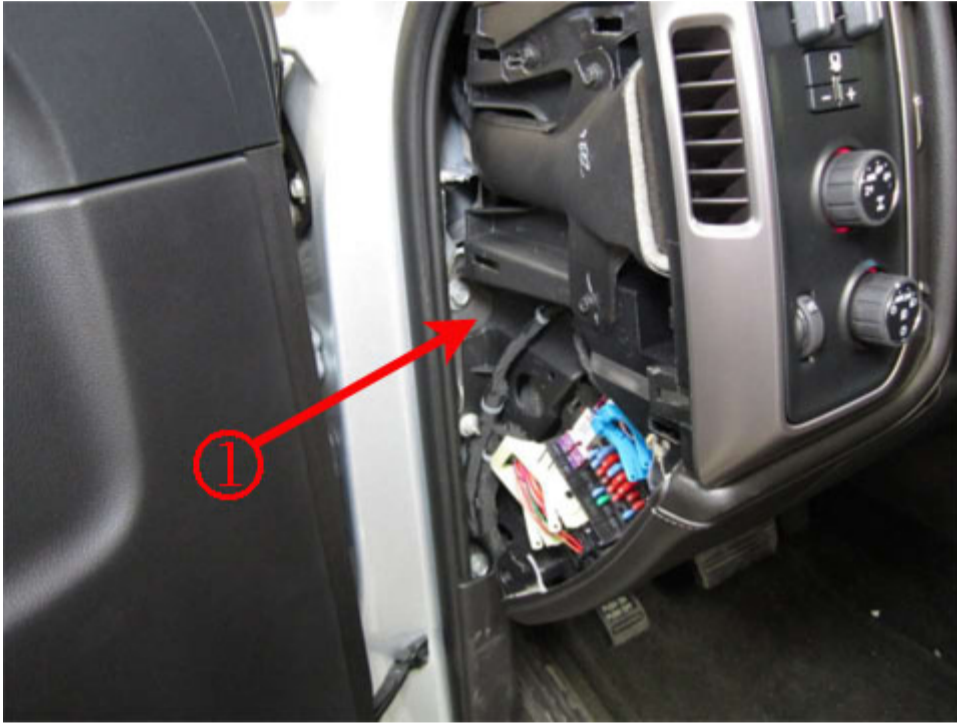
These concerns could be caused by the dash harness being pinched between the left I/P dash mounting bracket (1) and the body. Shown below, is the left I/P mounting bracket (1) as seen when the I/P fuse block cover is removed from the end of the dash. This picture is for reference only and the wiring must be inspected from under the dash.

**To repair this concern, loosen the left I/P dash mounting bracket bolts and pull the harness free. Open the harness and repair any damaged wires as necessary.**

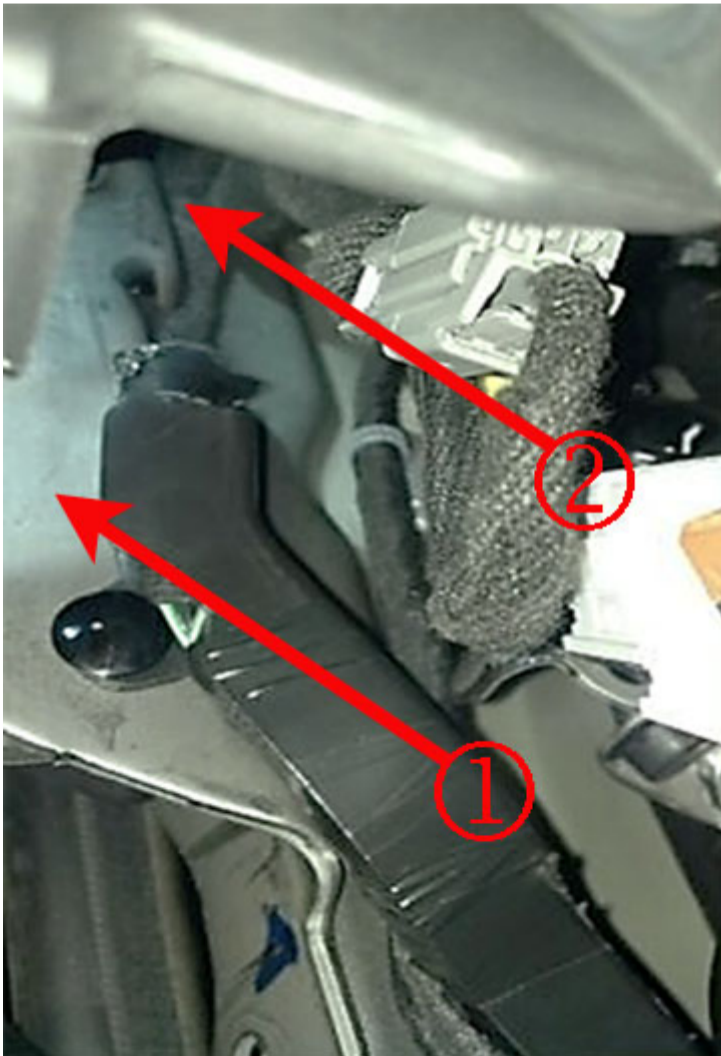
As shown below, the wiring harness (2) is pinched at the upper portion of the I/P mounting bracket (1). In many cases, the complete harness may not be pinched and it can be difficult to see that the harness is damaged. When inspecting for a pinched harness, make sure the harness can be moved freely away from the bracket to body interface.

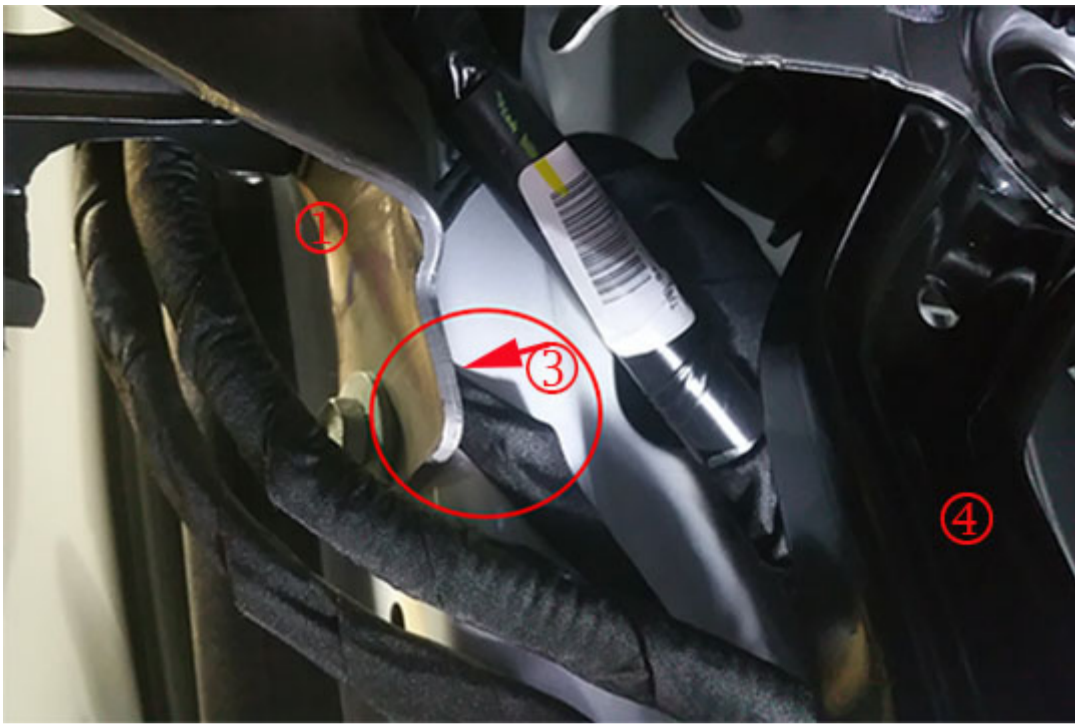
As shown below, the wiring harness (3) is pinched at the lower portion of the left I/P mounting bracket (1). For reference only, call out (4) is the parking brake pedal.
