Preliminary Information

PIT5323C Normal Characteristic - Appearance of Uneven Bed or Accessory Rails after Installation of Accessory Tonneau Cover

Models

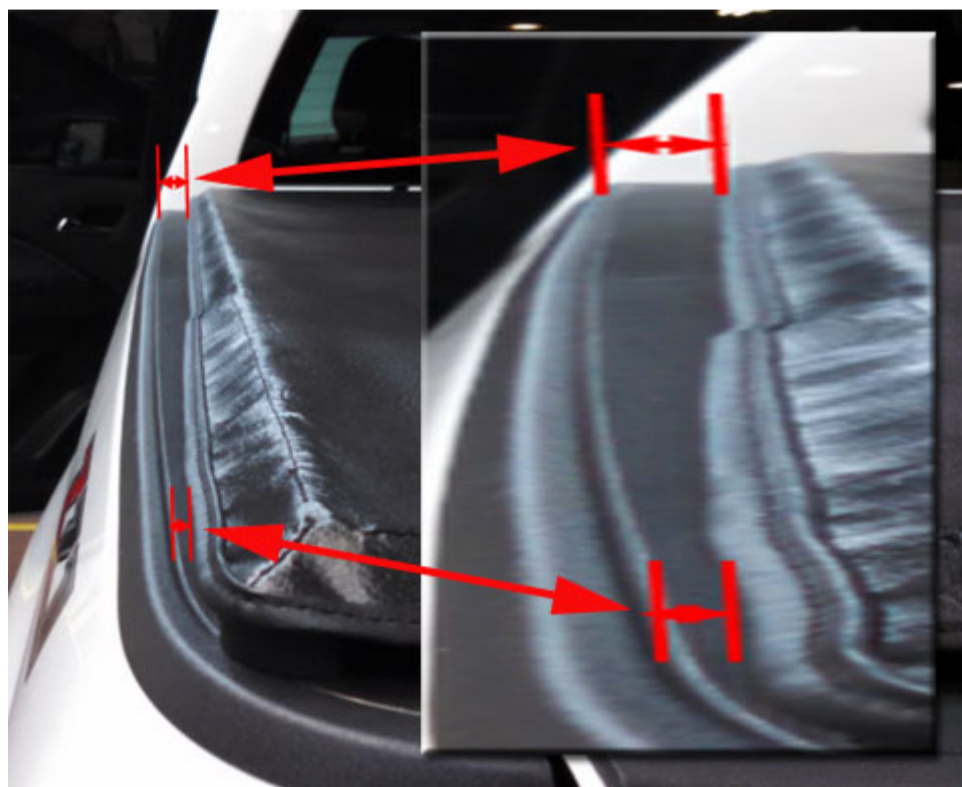
A customer or technician installing accessories on the bed rail caps may notice the rails are not as wide at the rear of the pickup bed as they are at the front of the bed. This is typically noticed after the installation of GM Accessory Soft Folding or Soft Roll-Up Tonneau Cover rails.

Some may think the accessory install was incorrect or that parts of the accessory kit are damaged.

The changing width of the bed rail cap is by design and part of the sleek appearance of the truck; no repairs are necessary to correct it.

Because the bed rail caps narrow as they go toward the rear of the vehicle, and the tonneau cover rails maintain a rectangle shape, the narrowing of the bed rail caps is highlighted and more noticeable.

IMPORTANT: Do not attempt to repair or replace parts for this condition.

Please communicate to the customer this condition is a normal design characteristic of their vehicle. It will not impact the designed performance or reliability of the vehicle. Please share this information with the customer, including a copy of this message.
