Bulletin No.: PIT5704  
Published date: 08/16/2019

## PIT5704 Seat Back Lift Assist Spring Detached

Brand:	Model:	Model Years:	VIN:		Engine:	Transmissions:
			from	to		
Cadillac	XT6	2020	All	All	All	All
Chevrolet	Blazer	2019	All	All	All	All

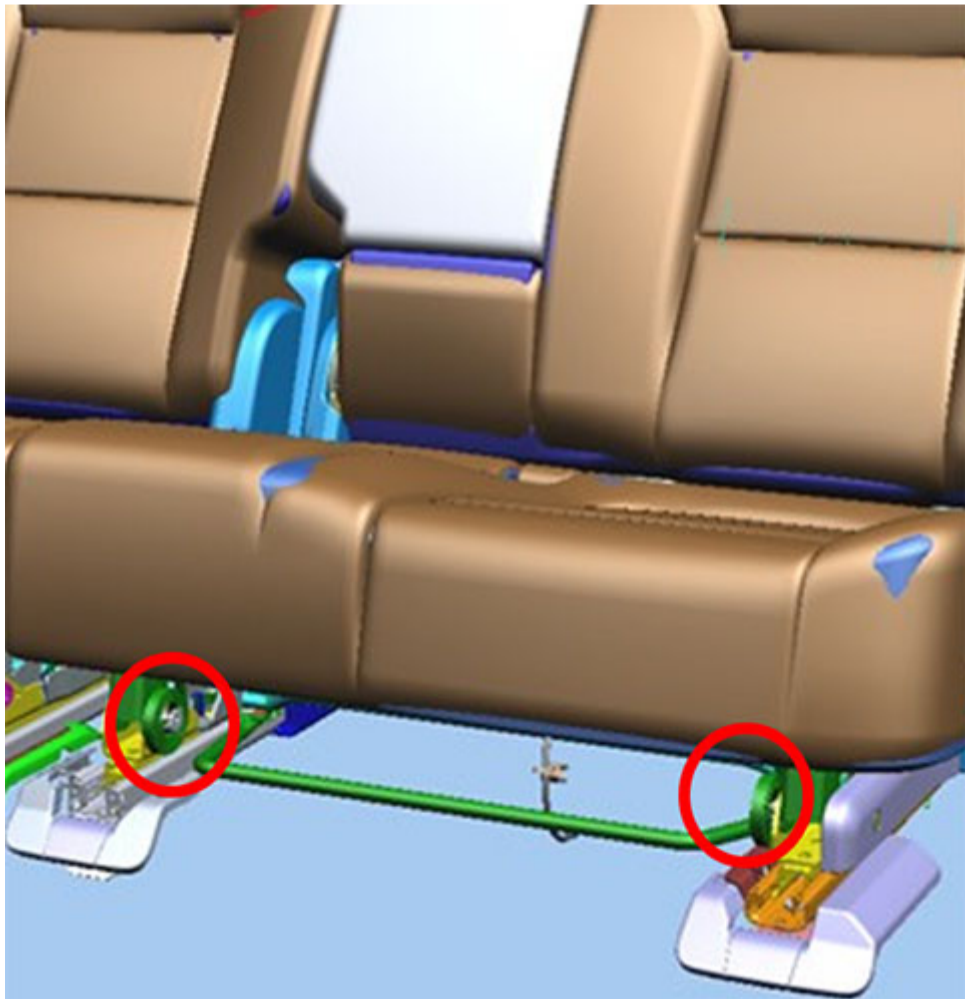
<b>Involved Region or Country</b>	<b>North America</b>
<b>Condition</b>	A customer or dealer may find a spring lying on the passenger side floor or it may be noticed that a spring has become detached from the rear 60% seat.
<b>Cause</b>	Poor retention of the rear seat back lift assist spring to the seat structure.

Reinstall the outboard spring on the 60 percent seat in the area shown below.

Reinstall the spring as demonstrated in the video.
