Preliminary Information

PIT5675B Diagnostic Tip: Loss of Power Steering Assist May Have Chassis Bus Communication Codes or C0800 in The PSCM

Models

Brand:	Model:	Model Years:	VIN:		Engine:	Transmissions:
			from	to		
Chevrolet	Equinox	2018 - 2020	All	All	All	All
GMC	Terrain	2018 - 2020	All	All	All	All

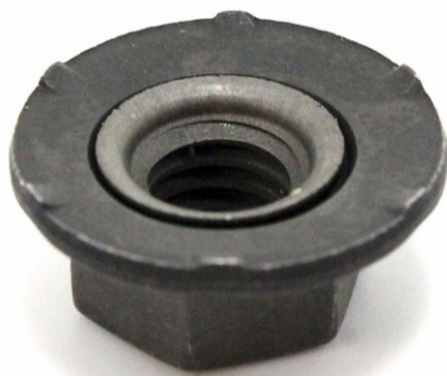
Involved Region or Country:	North America
Condition:	Loss Of Power Steering Assist May Have Chassis Bus Communication Codes Or C0800 In The PSCM.
Cause:	Inspect G112 for a standard nut versus a shouldered nut similar to the one shown below. If the standard nut is installed it will not provide proper clamp load on the ground lug.
