## MB Apps with limited functionality (NTG5.5 with code 506 and code 355 without plug-in SD card navigation installed)

| Topic number | LI82.85-P-070107 |
| Function group | 82.85 Navigation and Communication system (CNS, ICS, COMAND, FleetBoard) |
| Validity | All model series with NTG5.5 with code 506 (Audio20 NTG5.5 radio with navigation capability) and code 355 (pre-installation for navigation retrofit) |

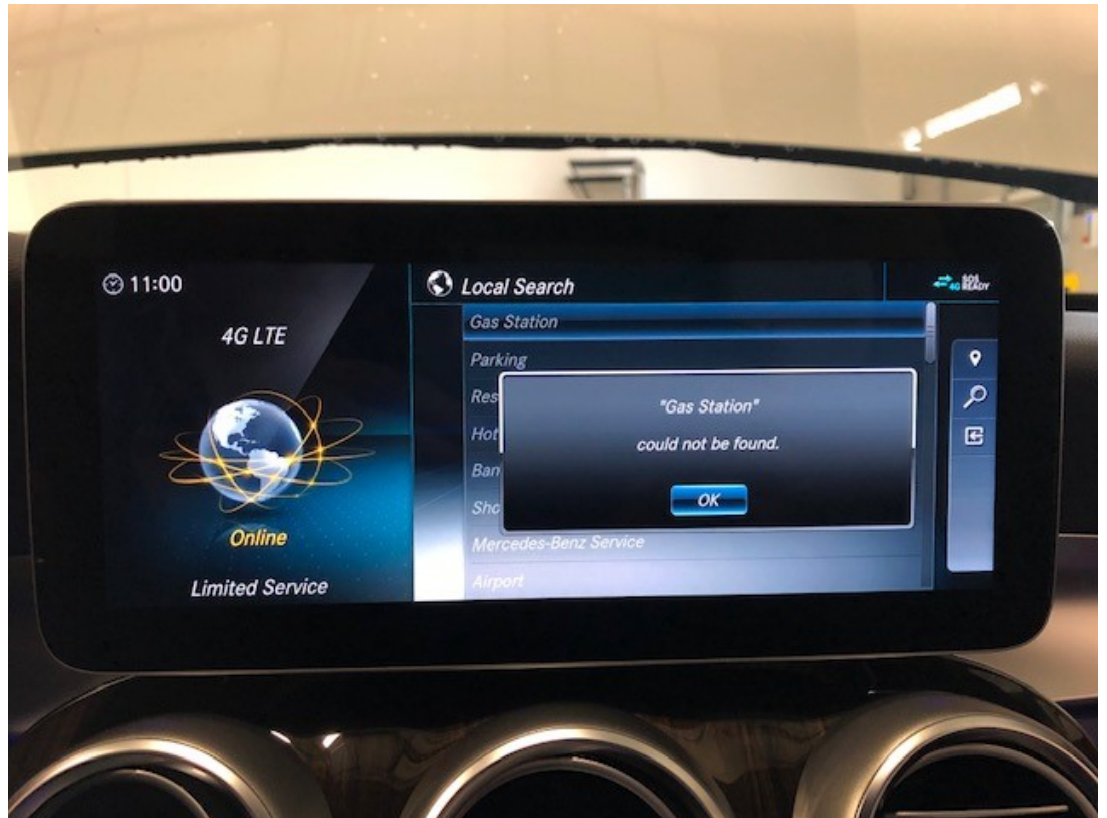
local search message.  
jpg:

- The Weather App will not populate local weather data based on "current position"
- TuneIn radio will not populate local radio station data when selecting "local stations" -> "show stations near me"
- When using Local Search, the message "[...] could not be found" is shown (see attached)

| Attachments | |
|---|---|
| local search message.jpg | Local search message |

Without SD card navigation (code 357) installed, the vehicle's position cannot be forwarded to MB Apps. This behavior is within the system specifications and is not a vehicle malfunction.

Explain the system behavior to the customer.
