Fraying Headliner Cords

Topic number	LI77.30-P-070145
Version	1
Function group	77.30 Vario roof, soft top - complete
Date	08-15-2019
Validity	205 and 238 cabrios produced before June 2019
Reason for change	
Reason for block

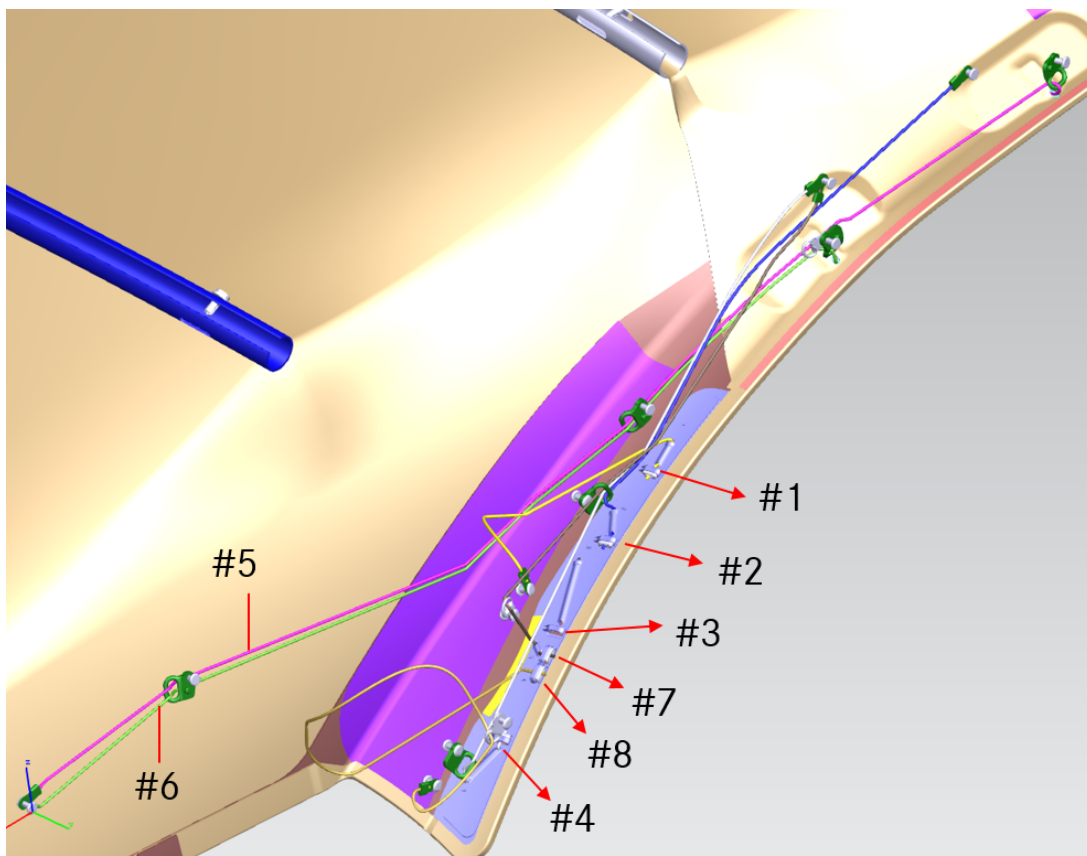
Abb.4.jpg:

If damage is found on one of the cords no. 3, 4 or 7 of the soft top interior trim, replace all the cords nos.3, 4 and 7 on the left and right as a preventive measure. See figure 4 for labelling of the cord.
