Throttle lift-off clunking noises at drive shafts of rear axle

Topic number	LI35.30-P-058566
Version	5
Function group	35.30 Final drive, drive shafts
Date	08-05-2019
Validity	Model 171,172,203,204,205,207,209,211,212, 213,215, 216,217,218,219,220,221,222,230,231,238,253,257,164, 166,167,292,293 Models 203, 209, 171 as of approx. week 21/04 coated as standard with Molykote paint
Reason for change	Validity for new model series updated.
Reason for block

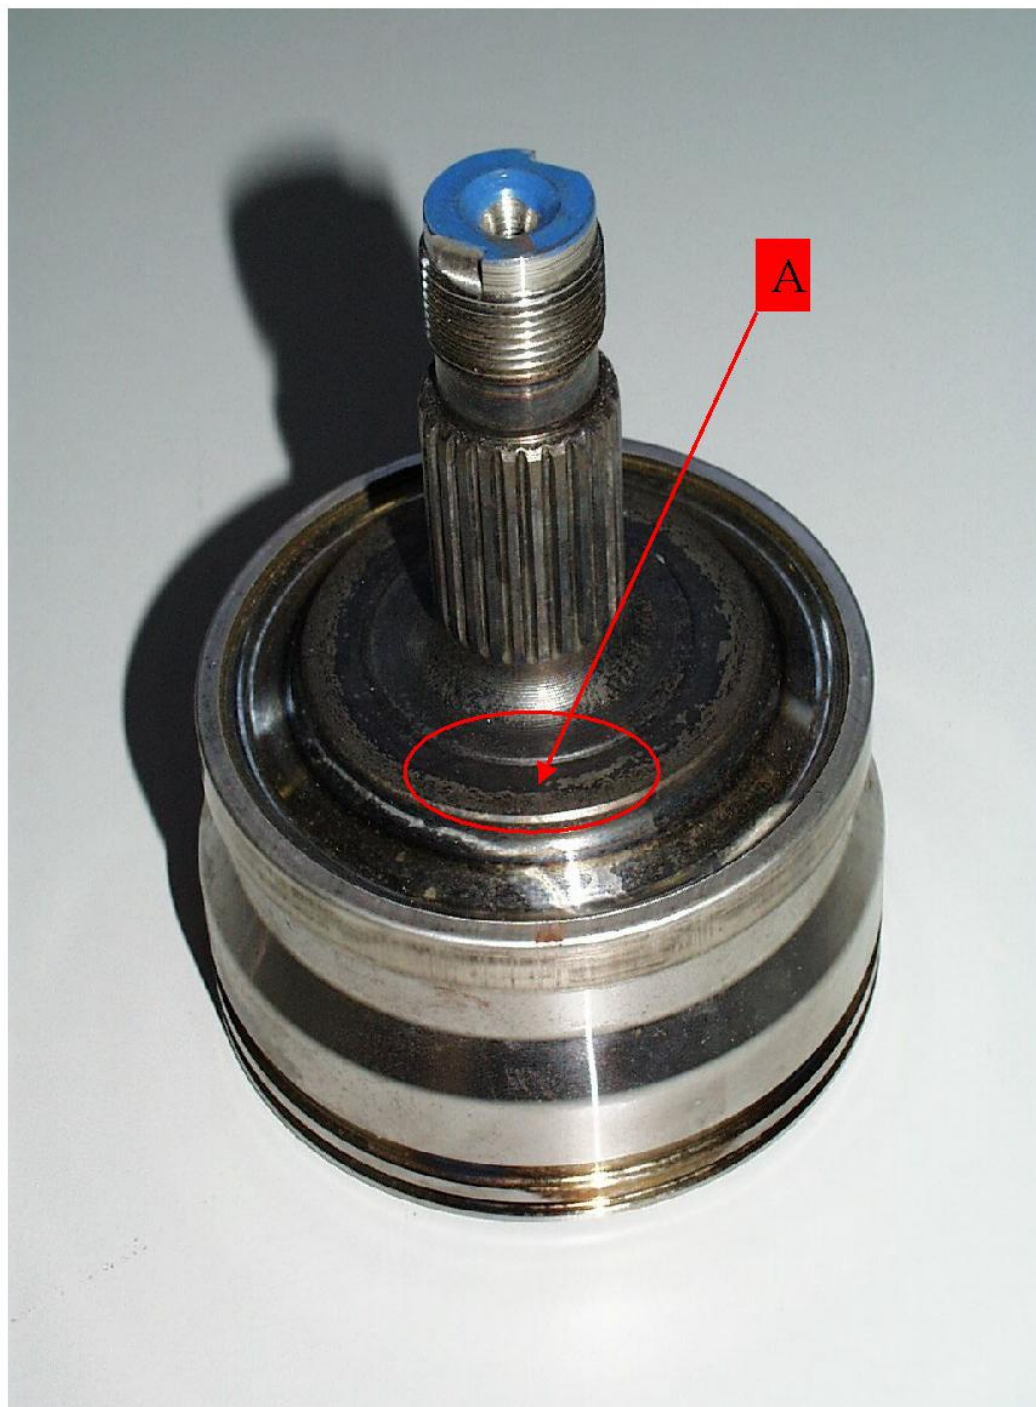
Gelenkgehäuse aussen
vor.jpg:

If the complaint is eliminated by experimentally loosening the outboard collar nut (by 1 turn), the concern may be due to cracking of the microweld between the wheel bearing inner race and the joint housing of the side shaft.

1. Remove side shafts
2. Clean contact surface A (see image file in attachment "Outer joint housing before") before coating with Molykote paint (free of dust and grease)
3. Coat contact surface A (see image file in attachment "Outer joint housing after") with Molykote and leave to dry for "one hour" in removed condition
4. Reinstall side shafts
