Technical Service Bulletin

SUBJECT:		No: TSB-19-42A-007	
2017 MIRAGE BODY REPAIR MANUAL INFORMATION - SMR - REVISED		DATE: August 2019	
		MODEL: 2017 Mirage	
CIRCULATE TO:	<input type="checkbox"/> GENERAL MANAGER	<input checked="" type="checkbox"/> PARTS MANAGER	<input checked="" type="checkbox"/> TECHNICIAN
<input checked="" type="checkbox"/> SERVICE ADVISOR	<input checked="" type="checkbox"/> SERVICE MANAGER	<input checked="" type="checkbox"/> WARRANTY PROCESSOR	<input type="checkbox"/> SALES MANAGER

A 2017 Mirage Body Repair Manual will not be issued. Use the 2014 Body Repair Manual (MSCD-016B-2014) along with this TSB for complete body repair information for the 2017 Mirage.

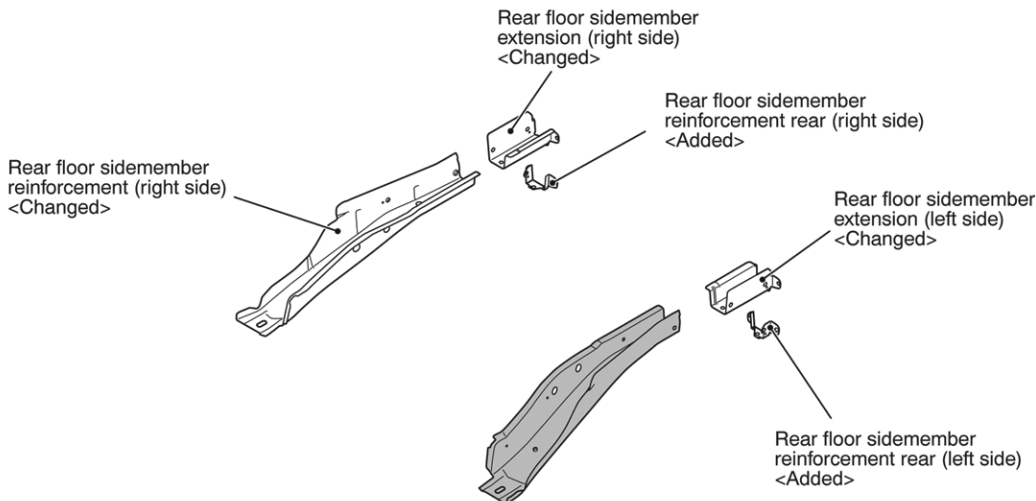
REAR FLOOR SIDEMEMBER REINFORCEMENT

The rear floor sidemember reinforcement (right side) and the rear floor sidemember extension (left and right side) has been reshaped. The rear floor sidemember reinforcement rear (left and right side) have been added.

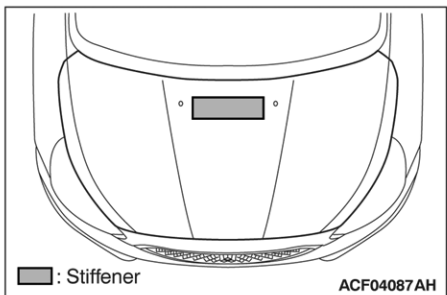
STIFFENER APPLICATION LOCATIONS

To increase the surface rigidity, the stiffener has been attached to the hood outer panel.

- The main contents of a stiffener are epoxy resin. It comes in a sheet form and contains a mixture of glass fiber and filler, and cures (stiffens) when heated.
- No spare part of the stiffener for repair is available in the field. If the stiffener is damaged, replace it together with the panel.

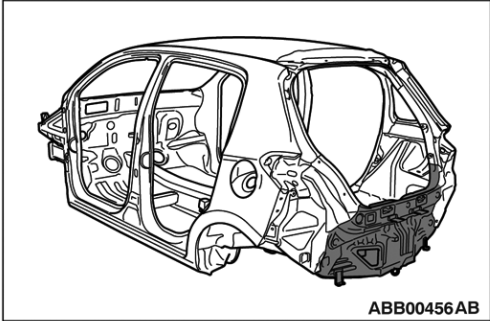
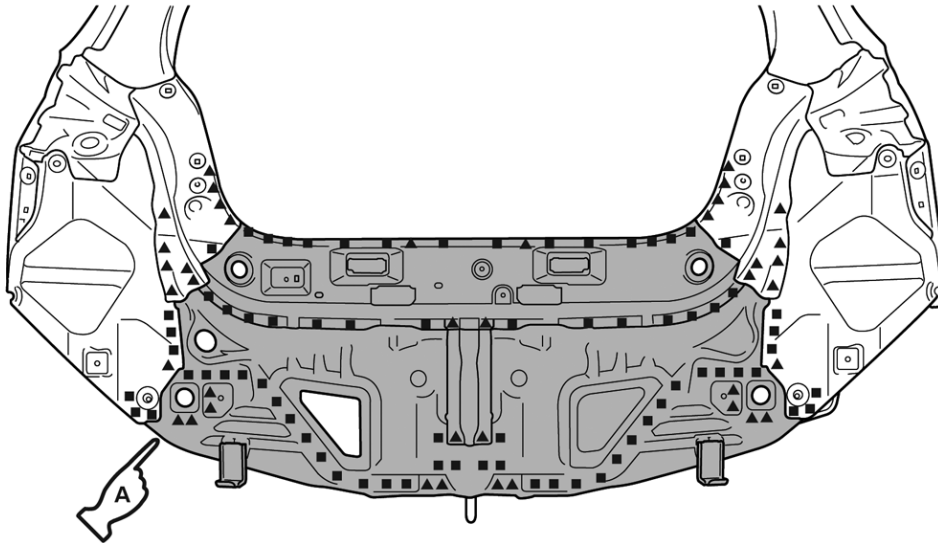
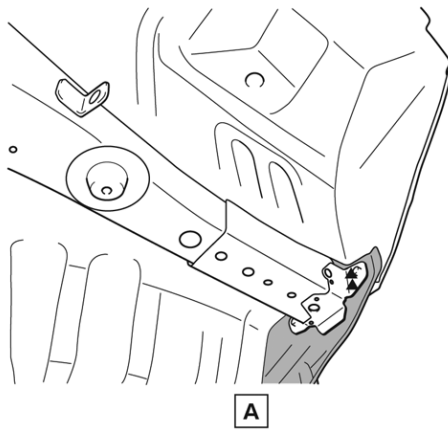
REAR END PANEL

As the rear floor side member has been changed, the welding points (6 points on the left and right sides) between the rear end panel inner and rear floor side member have been changed. The other service procedures are the same as before.

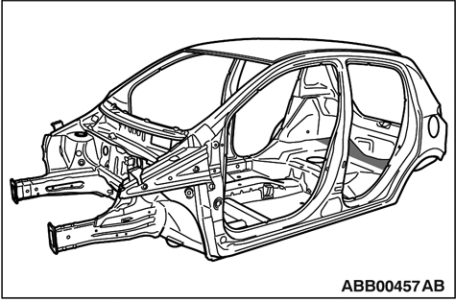
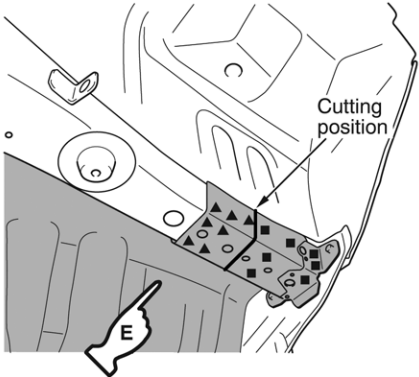
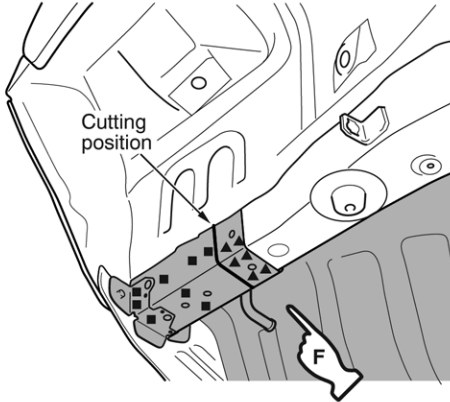
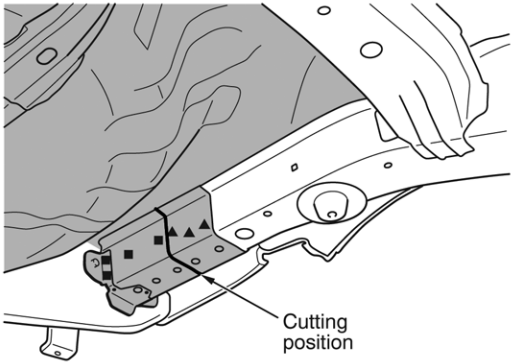
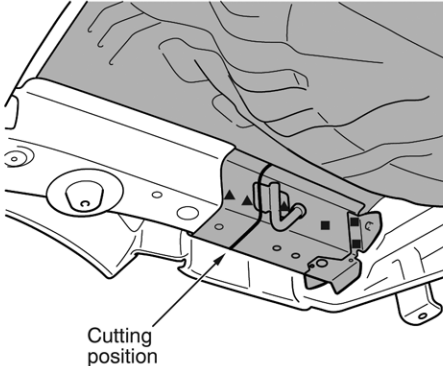
REAR FLOOR

As the components of the rear floor side member have been changed, the welding points have been changed. The other service procedures are the same as before.

NOTE: Refer to the Rear End Panel section on P.3-2 for the welding points with the rear end panel.

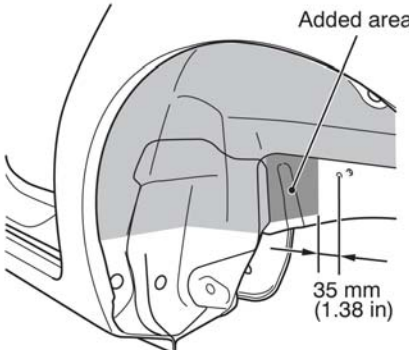
UNDERCOAT APPLICATION LOCATIONS

An undercoat has been added to rear floor sidemember.

■ : Undercoat [Film thickness is at least 0.8 mm (0.031 in).]
