Subject Blind Spot Monitor Axis Beam Adjustment Confirmation		Market USA
Service Category Audio/Visual/Telematics	Section Park Assist/Monitoring	
Applicability Models With Blind Spot Monitor System

2018-2019	Camry	2019	Avalon
2019	Avalon HV	2018-2019	Sequoia
2018-2019	Camry HV

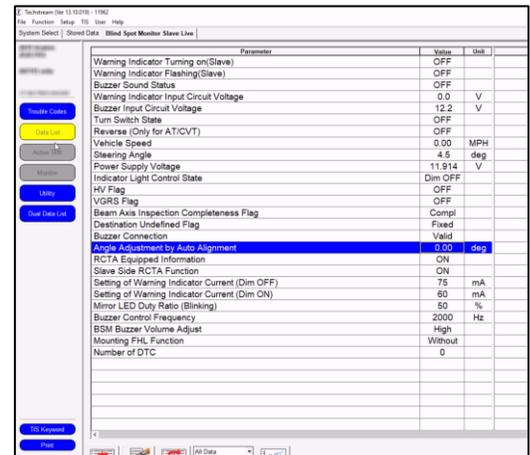
- Using Techstream, check the “Angle Adjustment by Auto Alignment” data list value in Blind Spot Monitor Master Live - Data List or Blind Spot Monitor Slave Live - Data List.
 - Take note of the angle value (Value A)

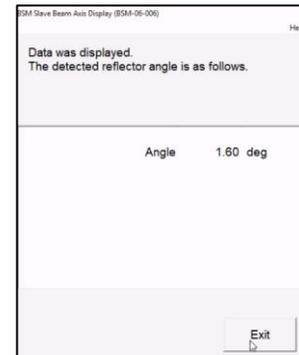
2. Perform PARK ASSIST / MONITORING: BLIND SPOT MONITOR SYSTEM: OPERATION CHECK **Blind Spot Monitor Beam Axis Confirmation** per repair manual instructions on TIS.
 - Take note of the angle value shown during the BSM Master/Slave Beam Axis Display Utility. (Value B)

- If the Angle Adjustment by Auto Alignment (Value C) has changed to be close to the Value B, then the Beam Axis has updated successfully.
- If the Angle Adjustment by Auto Alignment (Value C) has **NOT** changed and is still the same as Value A, the Beam Axis has **NOT** updated successfully. Confirm repair manual procedure and reflector placement are correct.
