Subject		Market
Intermediate Shaft Tightness		USA
Service Category	Section	
Steering	Steering Gear/Linkage	
Applicability		
2018-2019 Camry and Camry HV

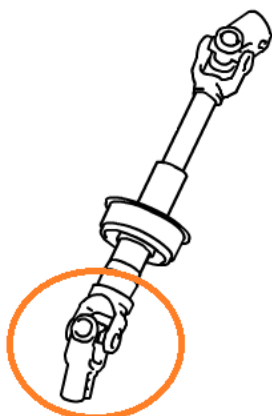
Some customers may experience “tightness” when turning the steering wheel. No Power Steering DTCs are recorded.

- Confirm that condition is isolated to the lower U-Joint of the Steering Intermediate Shaft.

- Follow Repair Manual instructions to replace the vehicle's Steering Intermediate Shaft Assembly.
