# Multimedia System Enhancements - Phase 3 (Pioneer)

**Section** Navigation/Multi Info Display

| YEAR(S) | MODEL(S) | ADDITIONAL INFORMATION |
|---|---|---|
| 2018 | Camry, Camry HV, Sienna | |

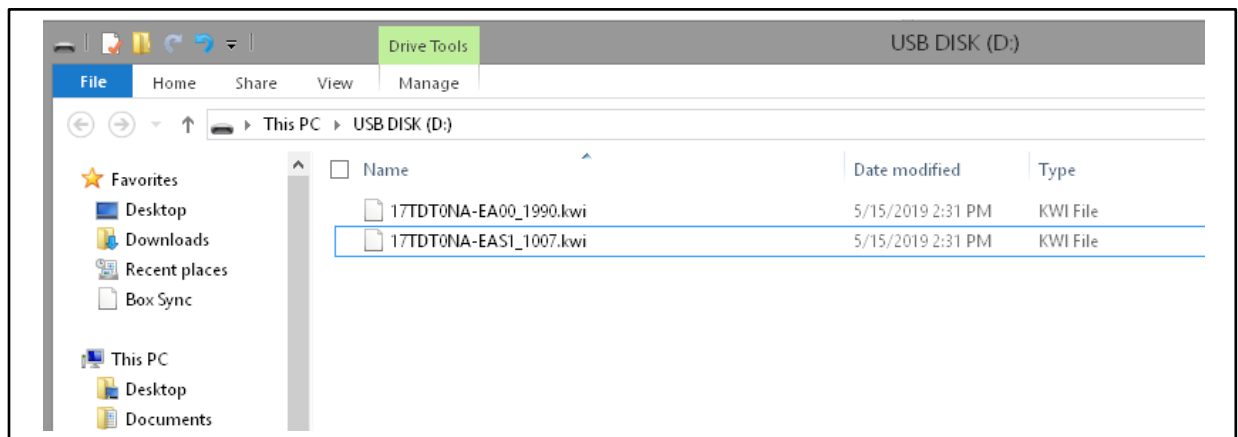
Figure 1.

The USB flash drive must NOT contain an additional folder name above the content folders and files (root directory). The audio head unit will NOT be able to search past an unrecognized folder name to view the internal folders and files. See the Entune 3.0 Audio example below.
