# Hesitation On Acceleration From a Slow Roll or Rolling Stop

YEAR(S)	MODEL(S)	ADDITIONAL INFORMATION
2019	RAV4

Some 2019 model year RAV4 vehicles may exhibit a hesitation on acceleration from a slow roll or rolling stop under the following conditions.

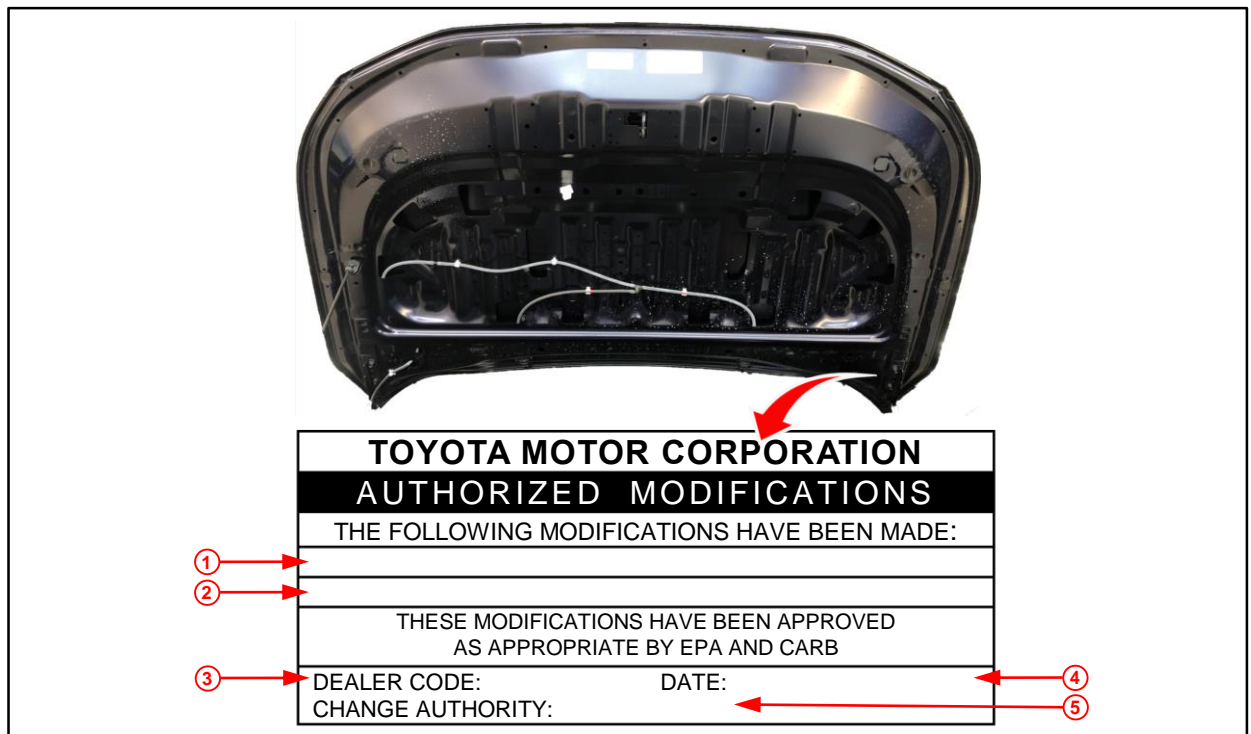
**Figure 1. Location of Authorized Modifications Label on 2019 RAV4**

- Use Techstream to confirm if the ECM (PCM) calibration has been updated and check for the Authorized Modifications Label affixed to the vehicle in the location shown below.

##### B. Install the Authorized Modifications Label onto the vehicle at the location shown in Figure 1. The Authorized Modifications Label is available through the MDC, P/N 00451-00001-LBL.
