Accessory Roof Rack Cross Bar Rattle While Driving Highway Speeds

2017-2019 Highlander and Highlander HV

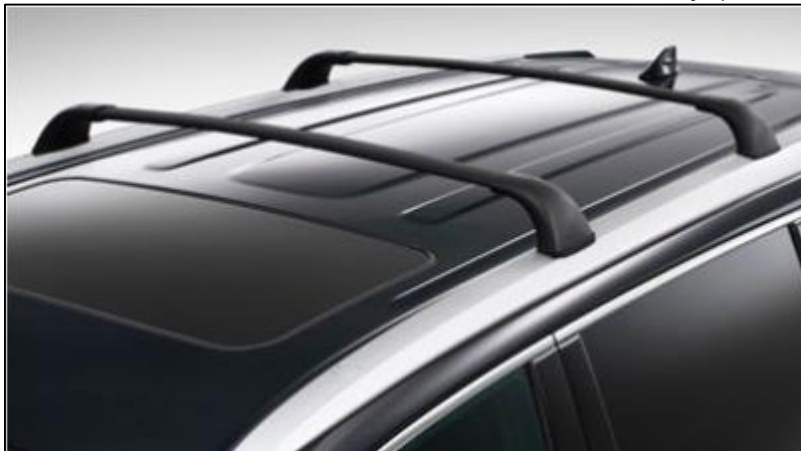
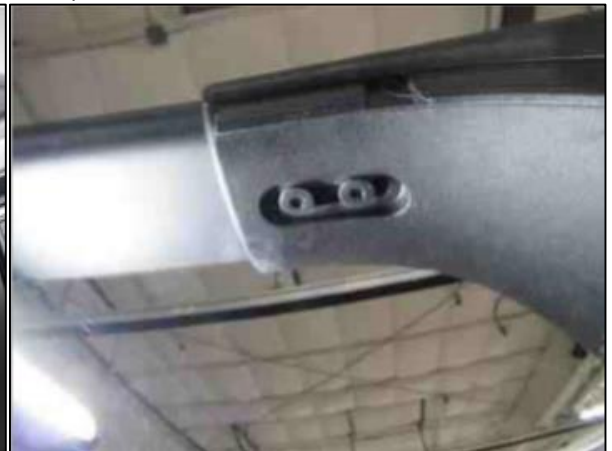
Some customers may experience a rattle noise from the roof area while driving at highway speeds, on vehicles equipped with Toyota Genuine Accessory Roof Rack Cross Bars. This noise may originate on the LH side of the cross bar, from cross bar sub-assembly to cross bar end support due to excessive free play.

- **Do not** attempt to tighten the 2 Torx head screws located on the bottom surface of the LH cross bar end support. These screws are preset during assembly, and cannot be tightened. Instead, replacement of the cross bar assembly is required.
- Please submit a DPR and include video/audio of the noise, as well as confirmation of the noise source.
