501-02

A-pillar Water Ingress

MODEL:	MODEL YEAR:	VIN:	ASSEMBLY PLANT:	APPLICABILITY:
XF (X260)	2018-2019	Y73060-Y76745	Castle Bromwich	Sportbrake

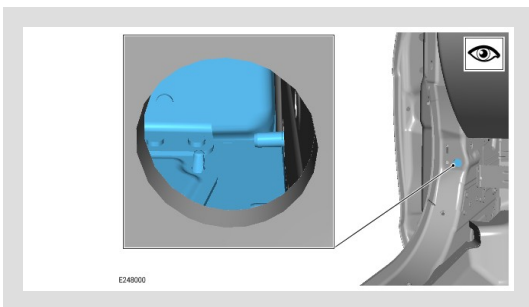
7.

Inspect for water ingress in the area shown highlighted in the illustration.

- If there **are** any signs of water ingress present, **continue to step 10.**
- If there **are not** any signs of water ingress present, **continue to step 8.**

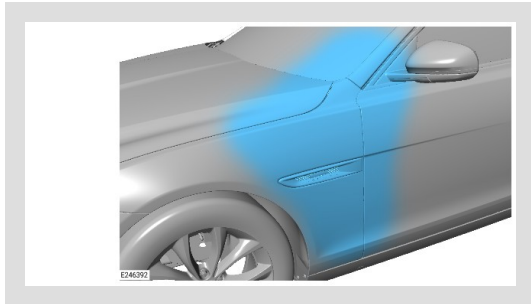
8.

Water test the area shown highlighted in the illustration.

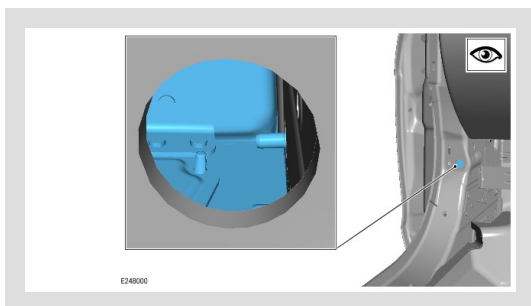
9.

Inspect for water ingress in the area shown highlighted in the illustration.

- If there **are** any signs of water ingress present, **continue to step 10.**
- If there **are not** any signs of water ingress present, **do not continue with this technical bulletin**, as the customer's concern does not directly relate to the vehicle fault present. **Reverse steps 1 - 6.**

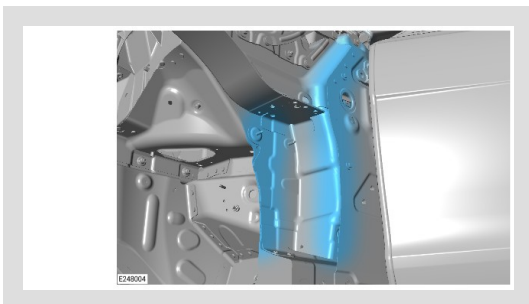
17.

Water test the area shown highlighted in the illustration.

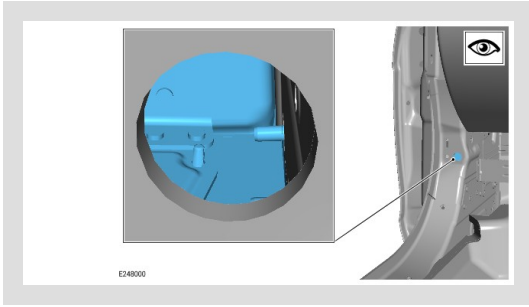
18.

Inspect for water ingress in the area shown highlighted in the illustration.

- If there **are** any signs of water ingress present, **raise a Technical Assistance (TA)** who will assist you further, if required.
- If there **are not** any signs of water ingress present, **continue to step 19.**
