# Newmar Corporation

**TSB 548**

## TECHNICAL SERVICE BULLETIN

## Replacing the HWH Step Miom

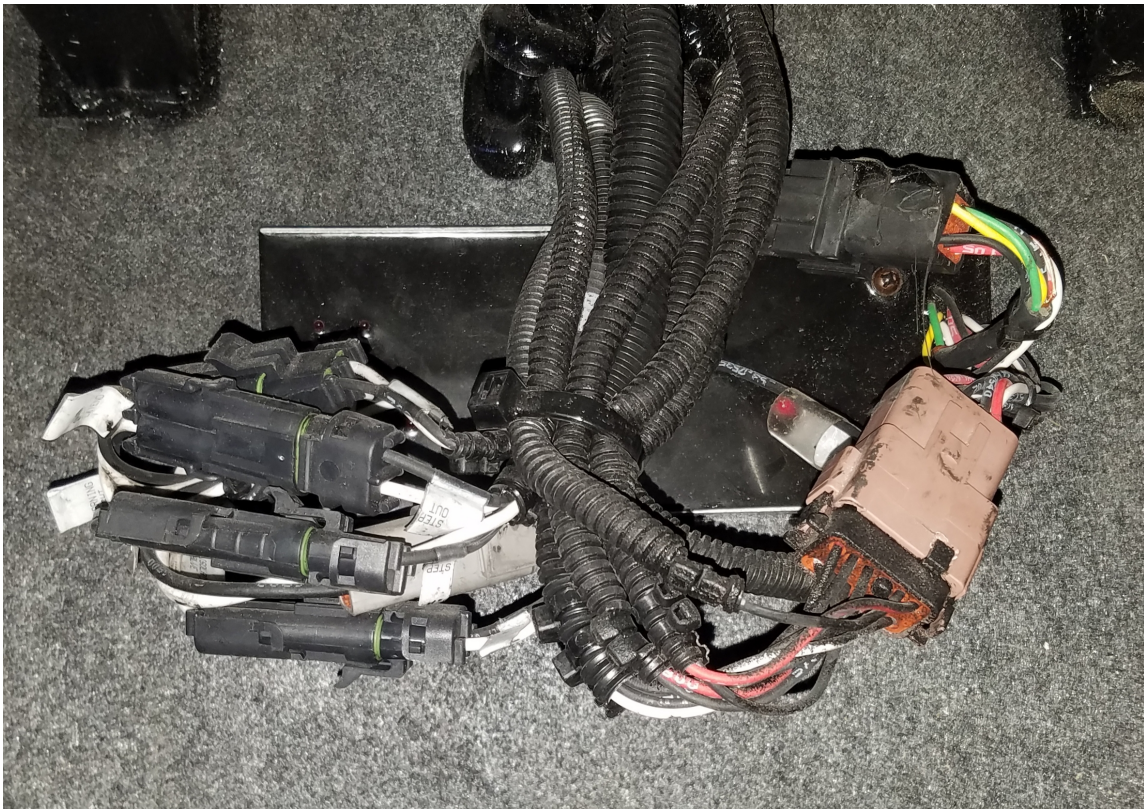
The Newmar Engineering Department discovered that HWH changed the step programming for 2020 coaches, causing the curb sensor not to function as originally designed.

1. Remove the two mounting screws.
2. Unplug the wire harness connectors.
3. Mount the new Miom.
4. Reconnect each wire harness connector to the new Miom. Make sure to match the harness connectors to the matching label on the Miom.
