# Newmar Corporation

**TSB 549**  
**Aug. 22, 2019**

## TECHNICAL SERVICE BULLETIN

# How to Seal the Hole on Early-Production 2020 New Aire Coaches

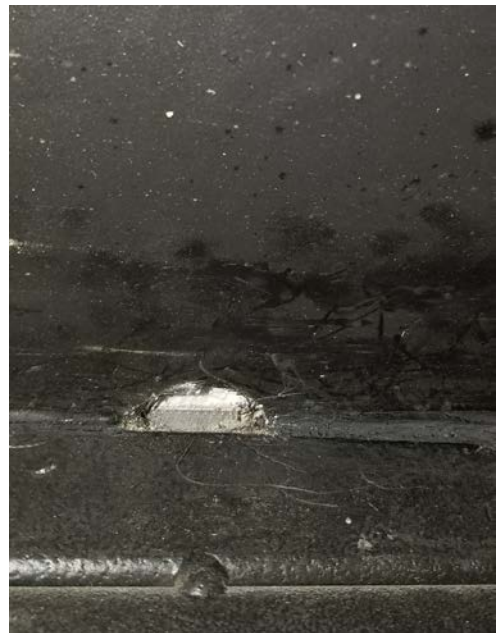
1. Air up the coach, and turn the wheels to the right.
2. Check in the wheel well for the hole (it will look similar to picture).
3. Cut the piece of aluminum into a 5 ½" square (approximately).
4. Remove some caulk on both sides of hole so the aluminum cover will sit flat against the wheel well all the way to the corner.
