September 12, 2019

Version 3

MIL Comes On with DTC P0716

Supersedes 19-003, dated July 12, 2019; to revise the information highlighted in **yellow**.

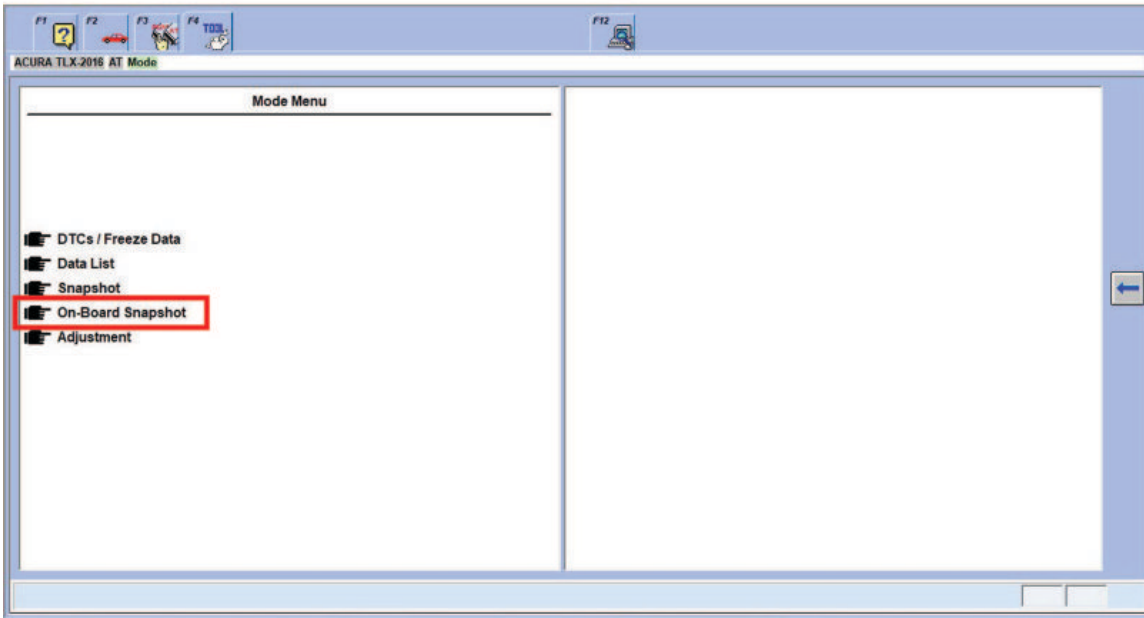
3. Select **Mode Menu**, then **On-Board Snapshot**.

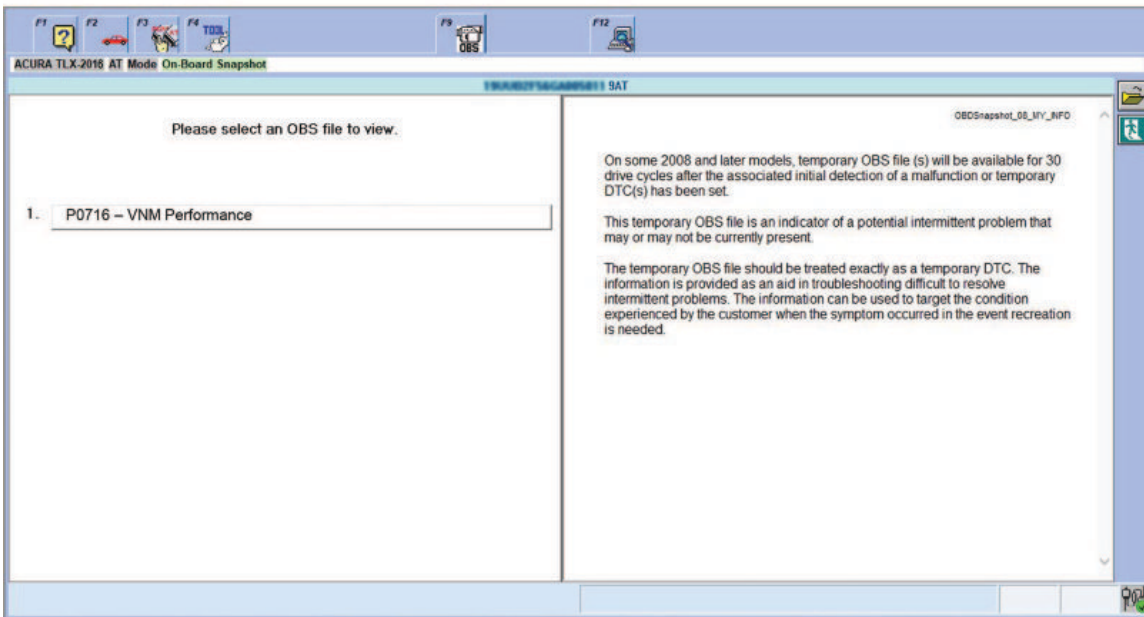
4. Select and view all available on-board snapshots for Automatic Transmission (EAT).

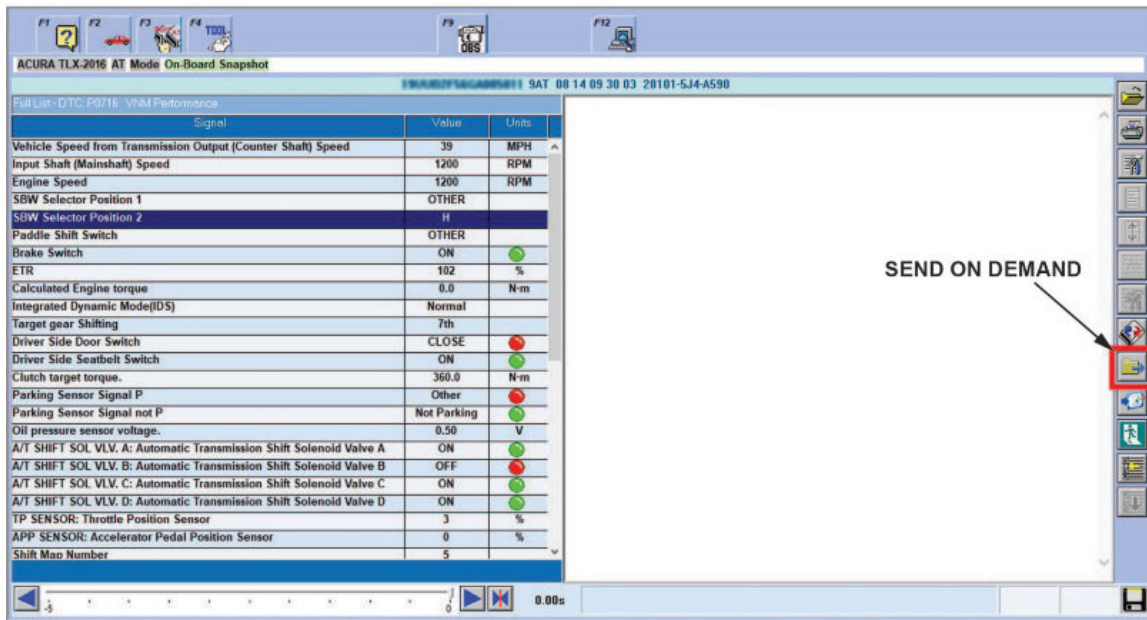
- If an on-board snapshot shows P0716, select **Send On Demand** to e-mail it to Tech Line, then go to step 5.

5. Update the TCM software using the i-HDS J2534 Rewrite software with the MVCI or DST-i. Refer to service bulletin 01-026, *Updating Control Units/Modules*.
