UPDATE Technical Bulletin

UPDATE – 55K5 Emergency Release for Rear Lid (NVLW)

UPDATE Code 55K5 Emergency Release for Rear Lid (NVLW)

Model(s)	Year	VIN Range	Vehicle-Specific Equipment
Arteon	2019 - 2020	See Campaign/Action screen in Elsa	None

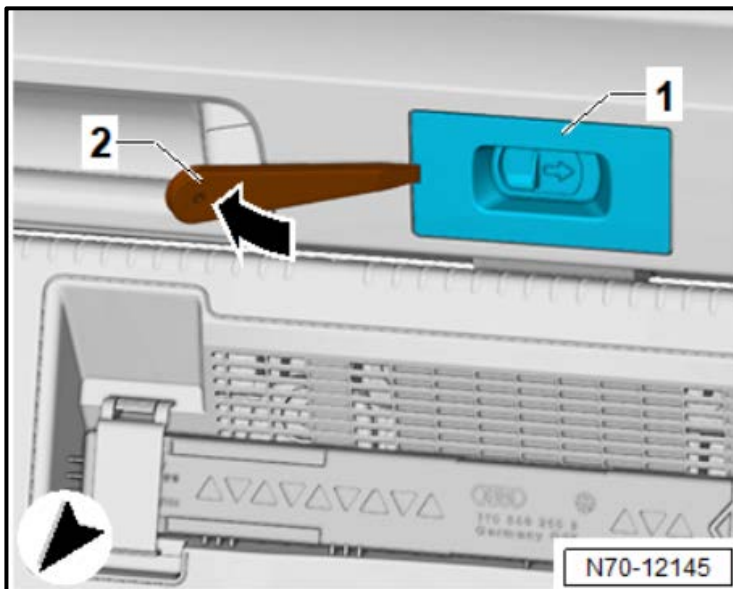
Remove emergency release for rear lid:

- Open the rear lid.
- Unclip the emergency release trim <1> with the Trim Removal Wedge -3409- <2> <arrow>.

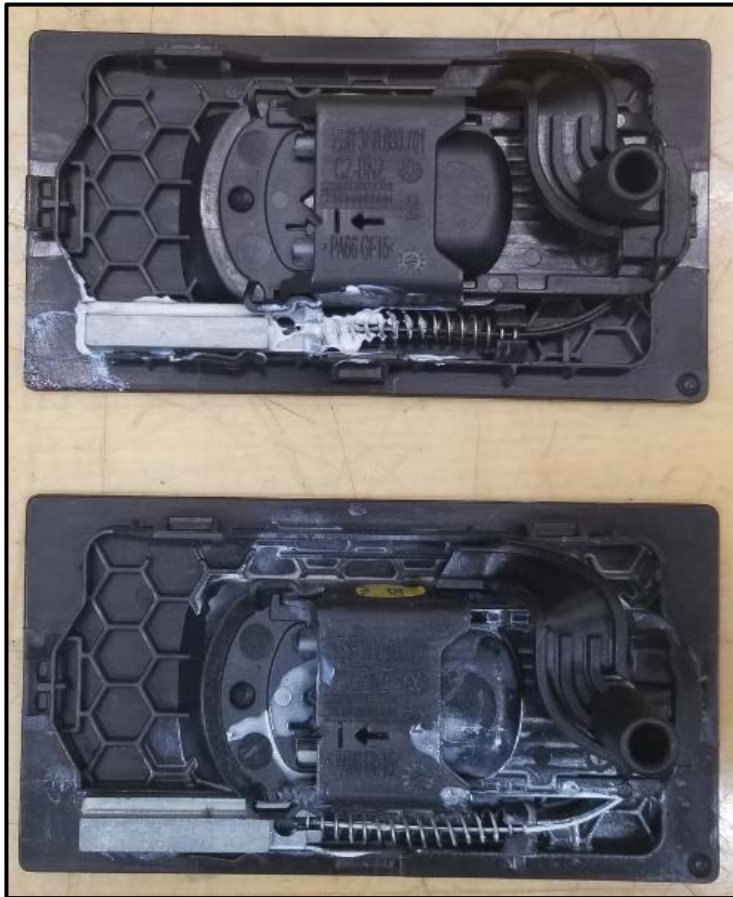
The emergency release for rear lid may already have some white paste applied in varying areas as shown. The 55K5 repair should still be performed in its entirety even if any white paste is already present.
