# Service Bulletin

Bulletin No.: 16-NA-042

**Subject:** Infotainment System Upgrade for Android Auto Feature

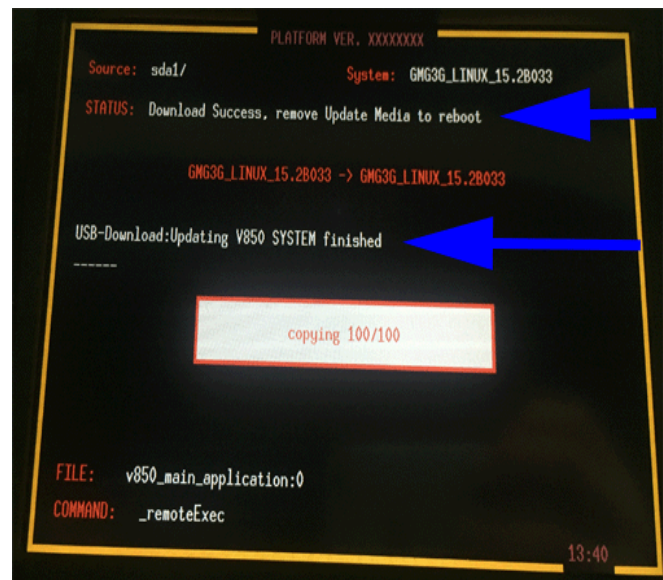
4448895

**Important:** Once the updating file hits 90% the screen may go blank. DO NOT REMOVE the USB at this time. The illustration above shows when the programming is complete. (See blue arrows above.)

8. The infotainment system will recognize that update files are available. Follow the infotainment display on-screen instructions and select Update when prompted. Programming will take several minutes.

9. Upon completion of programming, remove the USB drive. Follow the infotainment display on-screen instructions.
10. Access the Service Programming System (SPS) and follow the on-screen instructions.
11. On the SPS Supported Controllers screen, select K74 Human Machine Interface Control Module – Programming and follow the on-screen instructions.

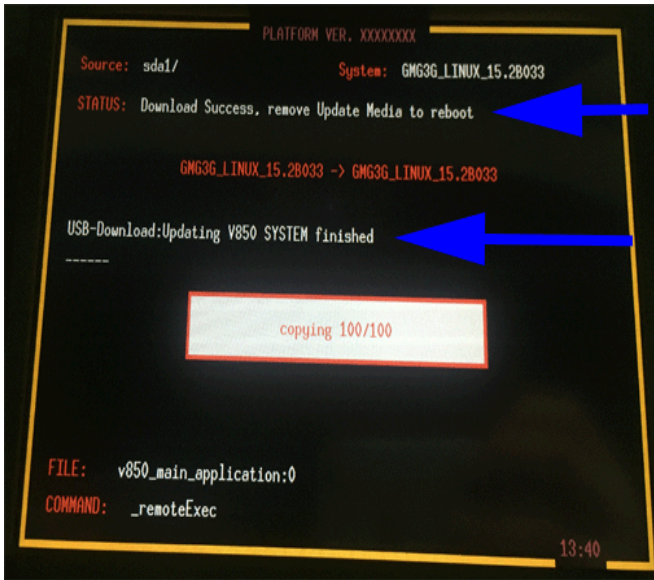
4448895

**Important:** Once the updating file hits 90% the screen may go blank, DO NOT REMOVE the USB at this time. The illustration above shows when the programming is complete. (See blue arrows above.)

7. Connect the USB drive to the USB port in the vehicle.
  8. The infotainment system will recognize that update files are available. Follow the infotainment display on-screen instructions and select Update when prompted. Programming will take several minutes.

9. Upon completion of programming, remove the USB drive. Follow the infotainment display on-screen instructions.
10. Access the Service Programming System (SPS) and follow the on-screen instructions.
11. On the SPS Supported Controllers screen, select K74 Human Machine Interface Control Module – Programming and follow the on-screen instructions.
