Service Bulletin

Bulletin No.: 18-NA-148

Subject: Glove Box (I/P Compartment) Misaligned, Gapping Concern

Brand:	Model:	Model Year:		VIN:		Engine:	Transmission:
		from	to	from	to		
Buick	Regal	2018	2019			All	All

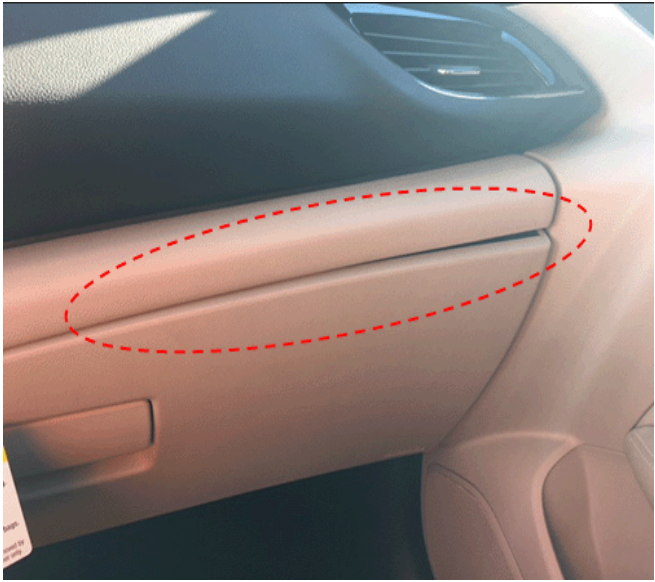
<p>5051802</p>

<p style="text-align: right;">5064694</p> <p>Note: Examples of glove box misalignment are shown in the graphics above. Some customers may comment on seeing a misalignment or gapping concern on the glove box (I/P compartment). In some cases, the glove box may not close properly.</p>
<p>Cause</p>	<p>The cause of the condition may be that the I/P compartment was not installed properly at the assembly plant.</p>
<p>Correction</p>	<p>Note: It is NOT necessary to replace the I/P compartment door to correct this issue. Remove and reinstall the I/P compartment following the Service Procedure below.</p>
