Service Bulletin

Bulletin No.: 19-NA-087

Subject: Radio Software Version V805 Over-the-Air Update

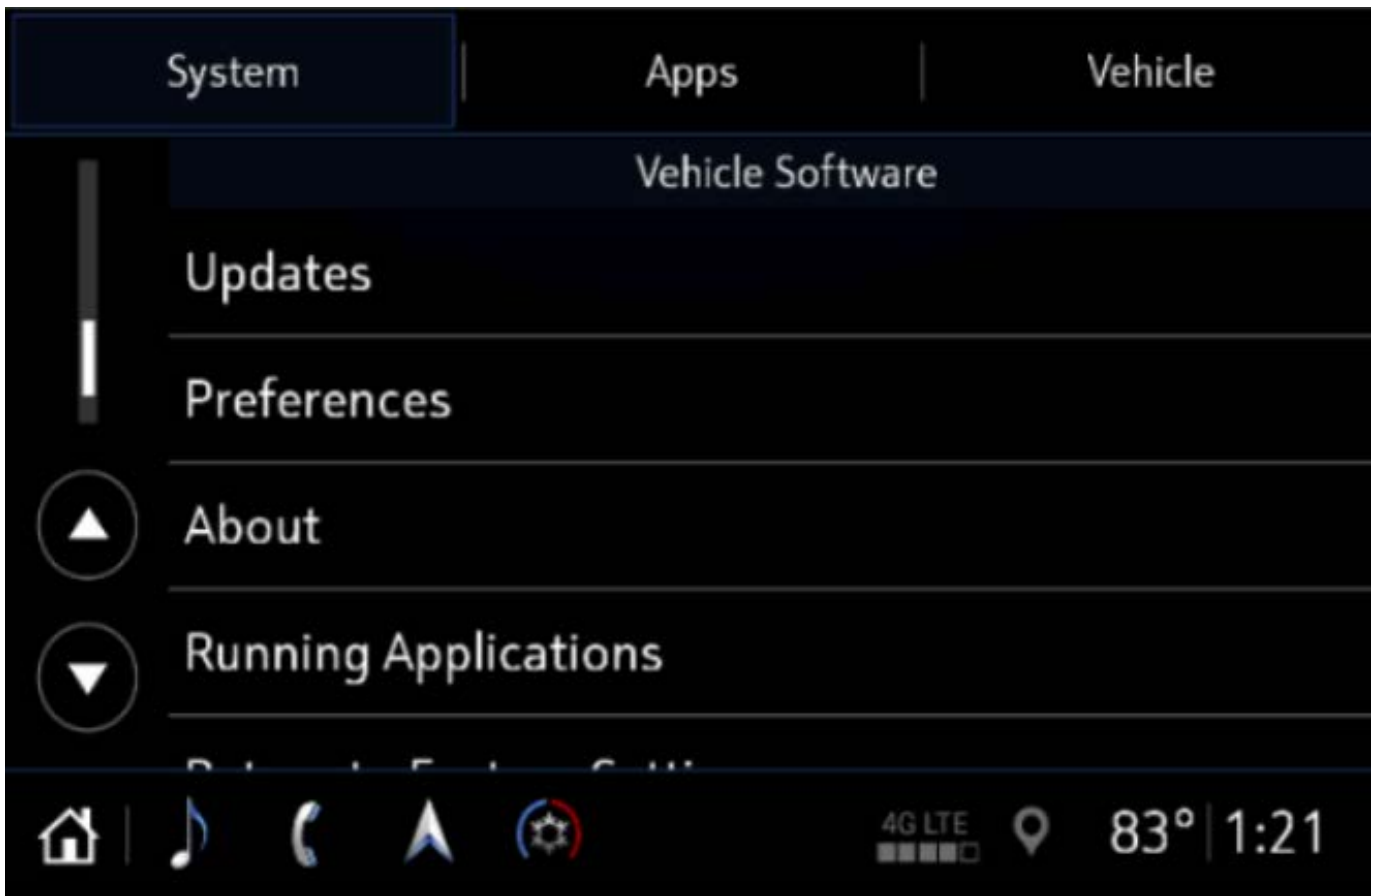
5313331

The process used for this update is dependent on the status of the software on the module and if the module already has a remote install package downloaded. To verify if an update package is already on the vehicle, open “Settings” and then scroll to “Updates” on the radio screen. If an update is shown under the “Updates” screen, proceed to the **Update Procedure Using Remote Vehicle Update** section of this document.

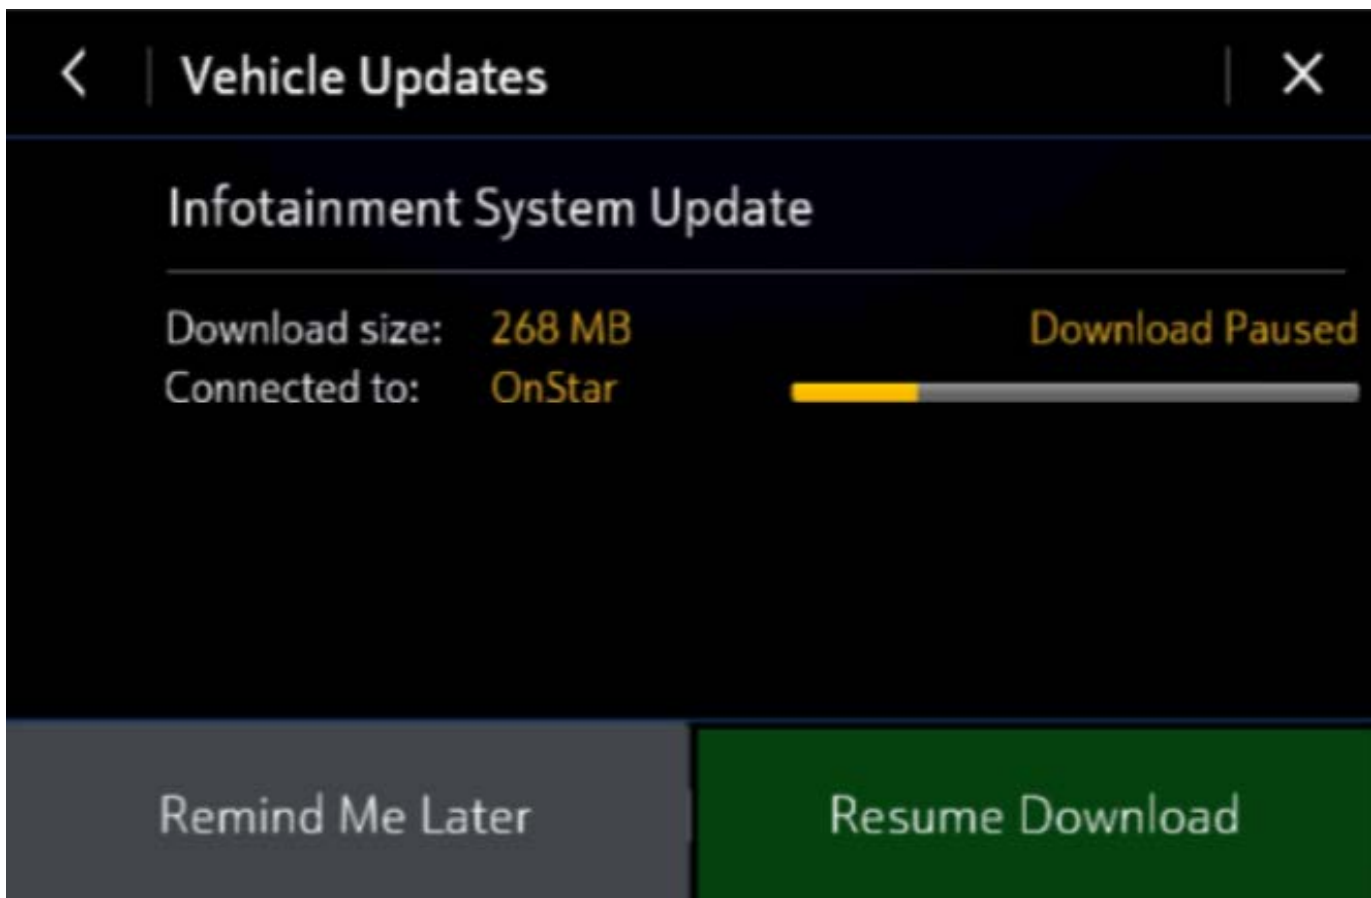
5313332

If no update is shown (see “No Updates Available” image in next section), go to the “About” screen and verify the build number (i.e., L206, V507, V509, V803 etc.). If the build number is less than V805, proceed with the software update following the **Update Procedure Using TIS2WEB (USB Download)** section of this document.

Caution: If Vehicle Update screen shows “Infotainment System Update” (such as the screen above) do not use TIS2WEB or insert a USB stick. Use of the USB stick when the Remote Update has already been downloaded, installed, or paused during installation could result in program failures or module lockup condition. The update should be completed using the Remote Vehicle Update procedure, following prompts on the infotainment screen. Refer to Update Procedure Using Remote Vehicle Update after reading the remaining information in this section if the Remote Update has already been downloaded to the radio.

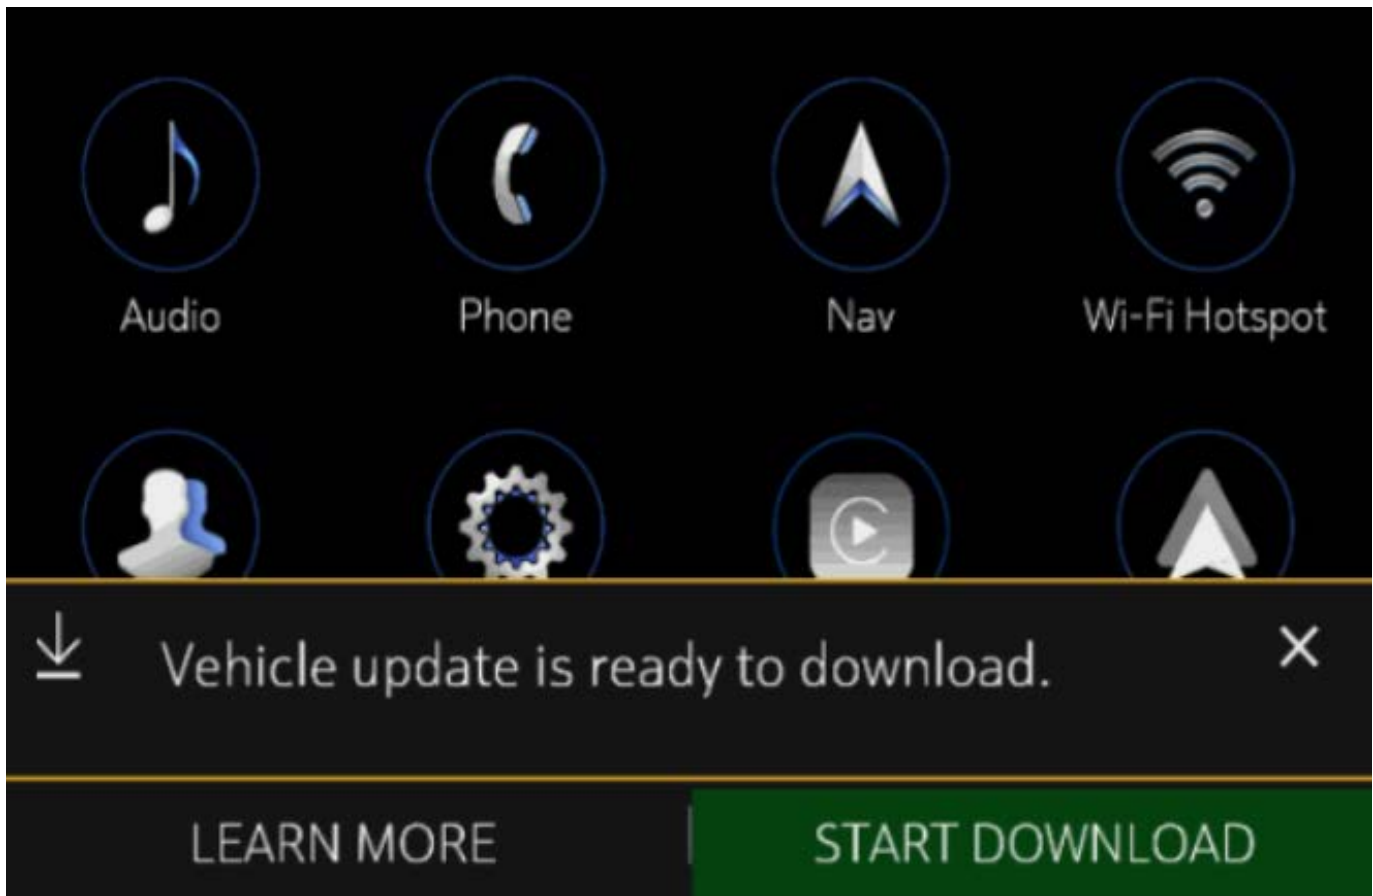
5313328

1. If a remote package is on the system, you may see the below pop up.
 - If the remote vehicle update has not been downloaded, select “Start Download,” wait for the download to complete and then follow the prompts to complete installation.

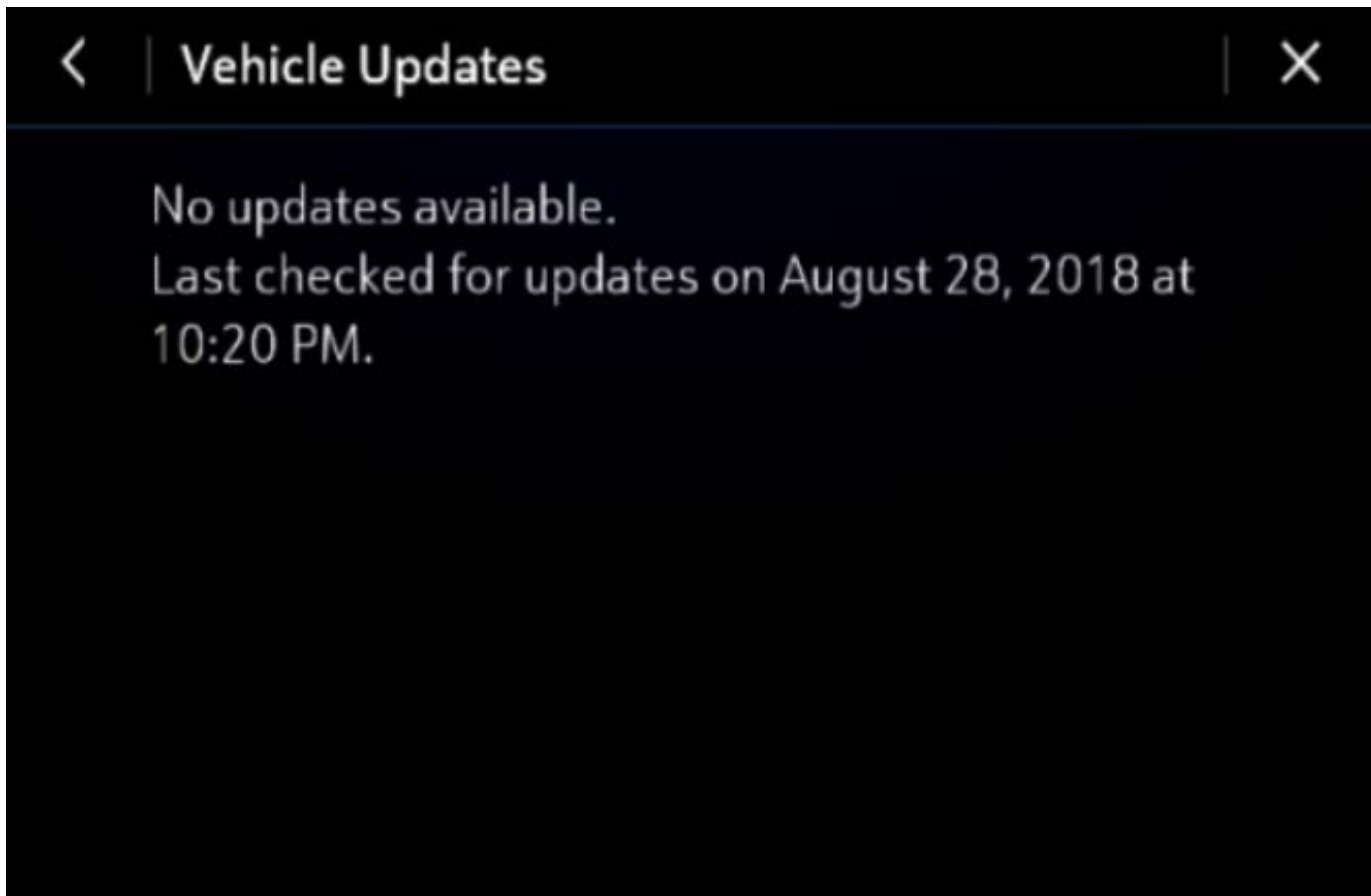
5313324

2. If no "Start Download" or "Install Now" pop up is displayed, navigate to "Settings" -> "Updates." If there is a remote package on the system, it will display "Install Now" Or "Start Download." If the screen below is shown, then there is no remote update package on the system. Navigate to Settings -> About to verify the software version. If the build number is not V805 or greater, update via USB.

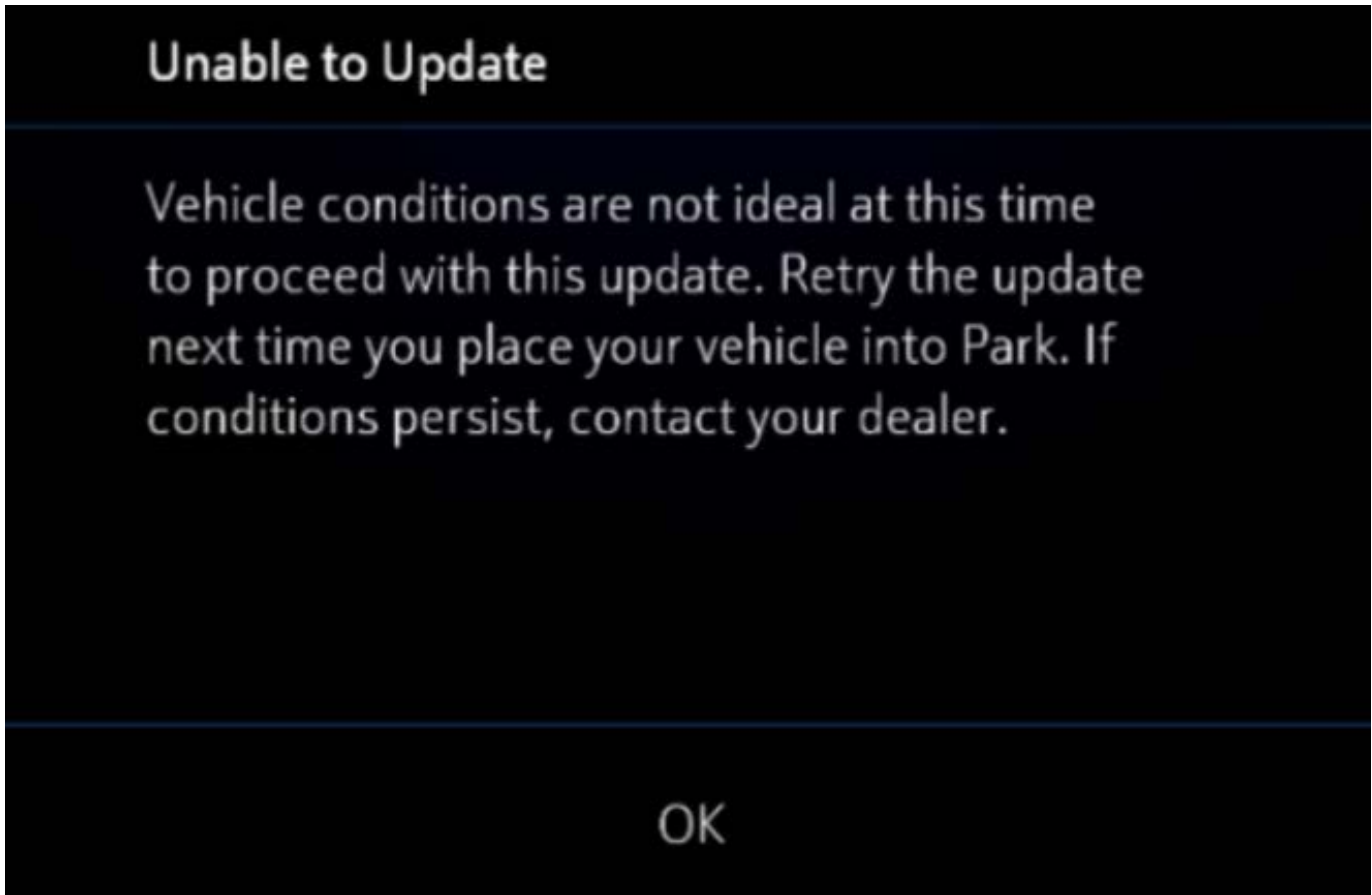
5313329

Scenario 1: Vehicle conditions are not ideal.

If the above screen is shown, download the update through TIS2Web and perform USB update. Upon USB insertion while vehicle is running, the "Install Now" pop up will be presented. Ensure the vehicle battery is being maintained (using EL-49642 or battery maintainer) while performing this update.

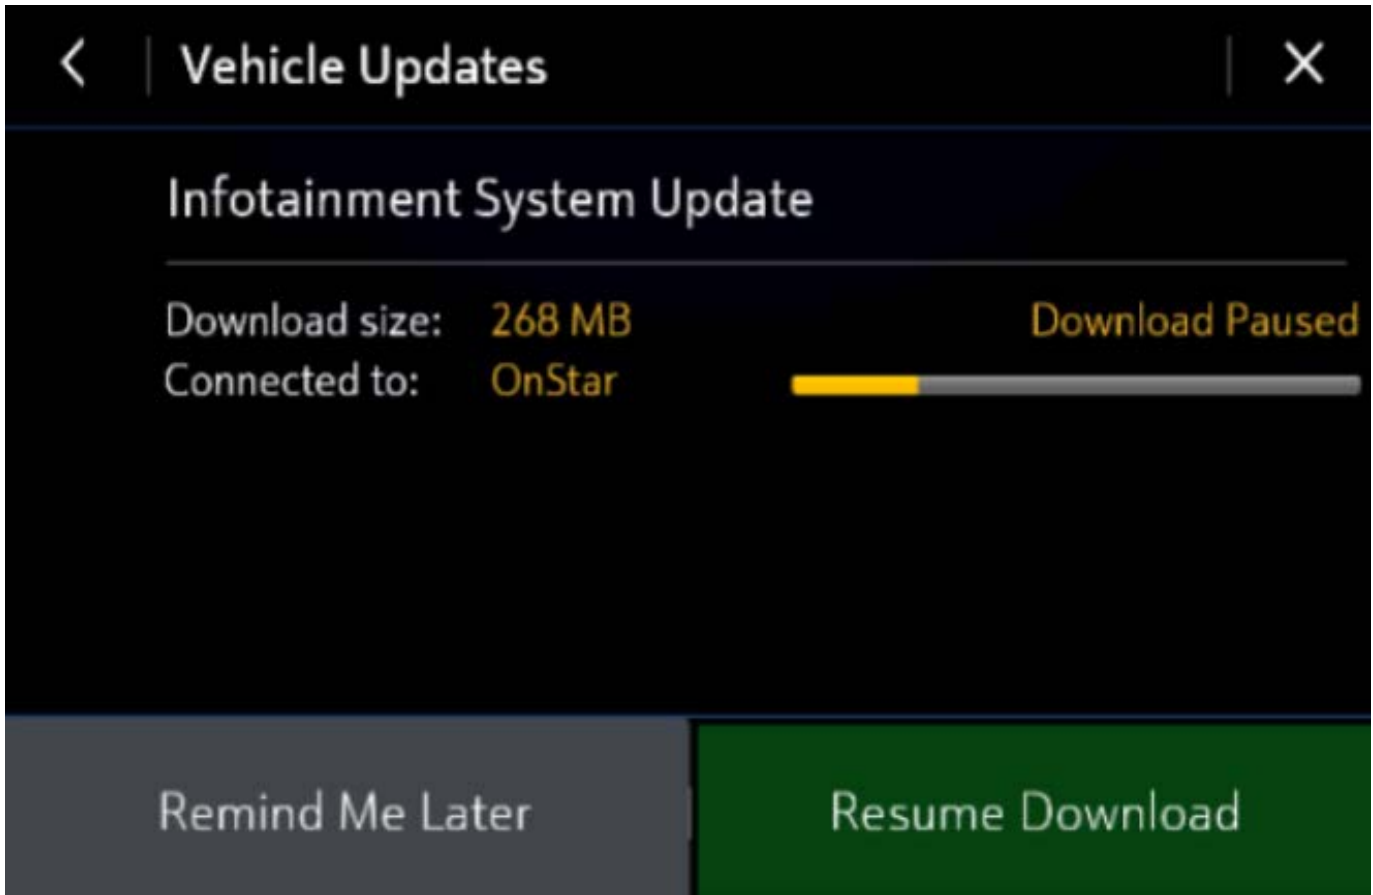
5313326

Scenario 2: Consistently Paused Download

If the above screen is shown and resuming the download repeatedly fails, a USB update will need to be performed. Turn the vehicle on, return to the home screen, and insert USB stick (see previous section). A pop up should be shown to "Install Now." Click "Install Now", verify the part number is correct and follow on screen prompts.

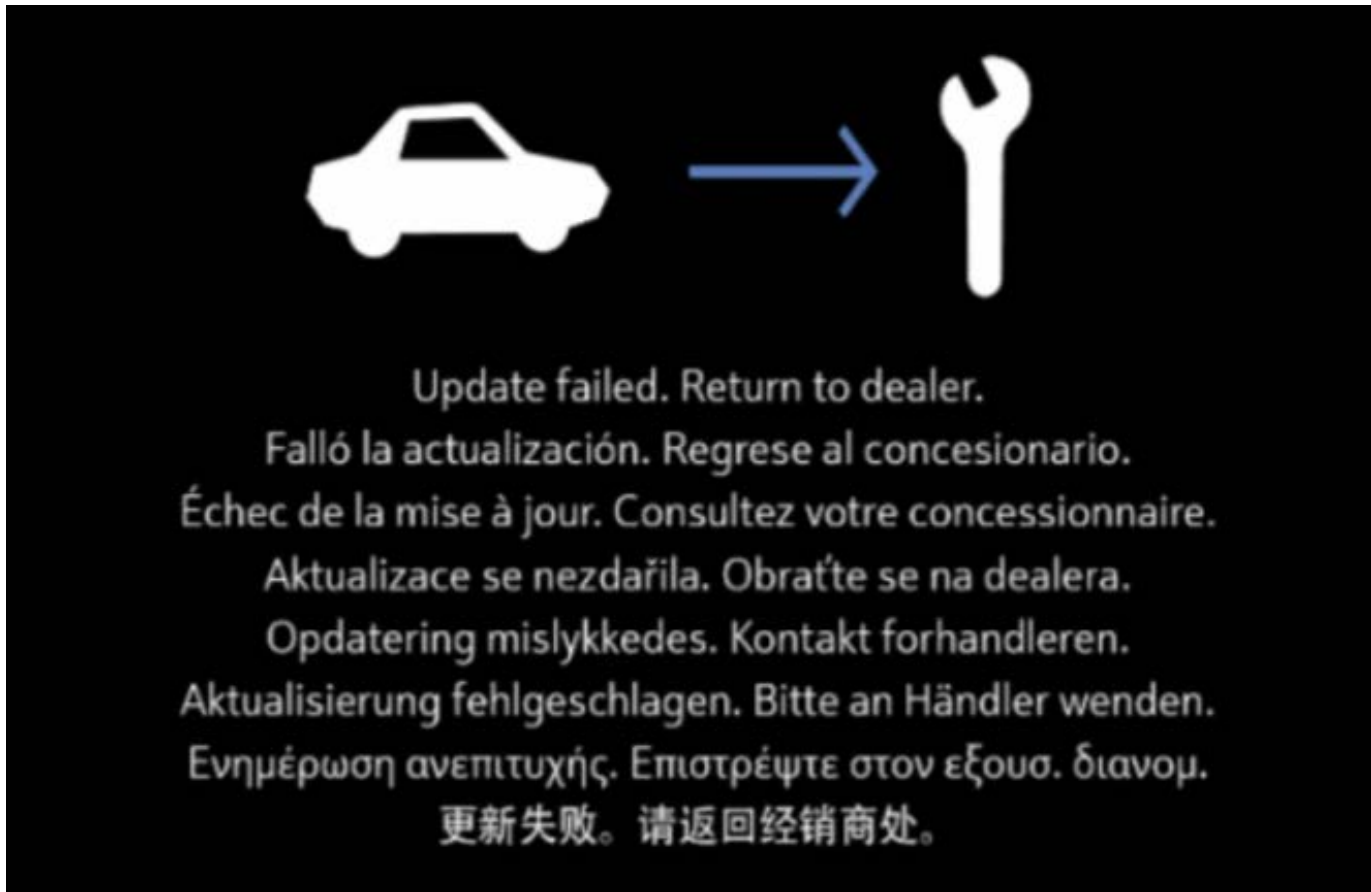
5313330

Scenario 3: Update Failed. Return to dealer screen.

1. If the above screen is shown, download the update through TIS2Web and insert USB stick into the radio **twice** (USB stick is not recognized on first insertion). A blue progress bar should come on the screen and update will proceed. If this screen above is shown when trying to update the radio through USB, reformat to FAT32 on your PC, and then try to download the update through TIS2WEB again.

2. After selecting USB File Transfer, if you are prompted by TIS2Web to select a software P/N then follow the on-screen instruction to attempt to gather the software P/N from the A11 Radio using GDS2 scan tool. If GDS2 indicates the radio is not communicating, go back to TIS2Web, select A11 Radio, and select when radio displays "**Update failed. Return to dealer.**" to complete the USB File Transfer programming event.

3. If the screen above is shown again, contact Technical Assistance (TAC) for further assistance.
