Service Bulletin

Bulletin No.: 19-NA-178

Subject: Transmission Fluid Leak on Driver Side Near Front Wheel

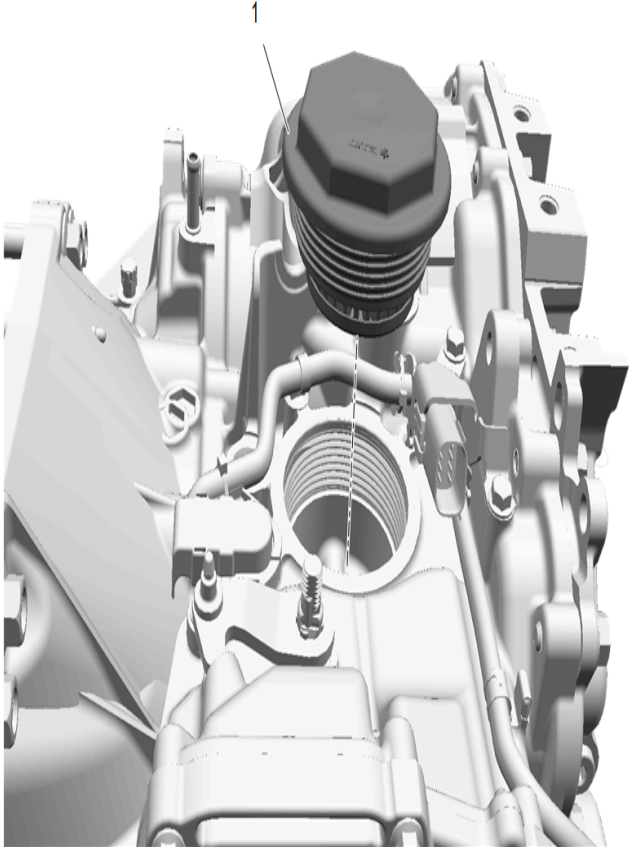
Involved Region or Country	North America, Israel
Condition	Some customers may comment that a fluid is leaking on the driver side inboard of the wheel. – The fluid may have a greenish tint.
Cause	This condition may be caused by the transmission fluid filter assembly not sealing properly.

<p>5206407</p>
	<p>Inspect the filter assembly (1) for a fluid leak around it. ⇒ If fluid has been verified to be leaking from the filter assembly, replace the filter assembly.</p>

Refer to *Transmission Fluid Filter Replacement* in SI.
