Service Bulletin

Bulletin No.: 19-NA-179

Subject: Air Conditioning Blows Cold then Warm, Intermittently

Brand:	Model:	Model Year:		VIN:		Engine:	Transmission:
		from	to	from	to		
Chevrolet	Express	2017	2019			LWN	All
GMC	Savana

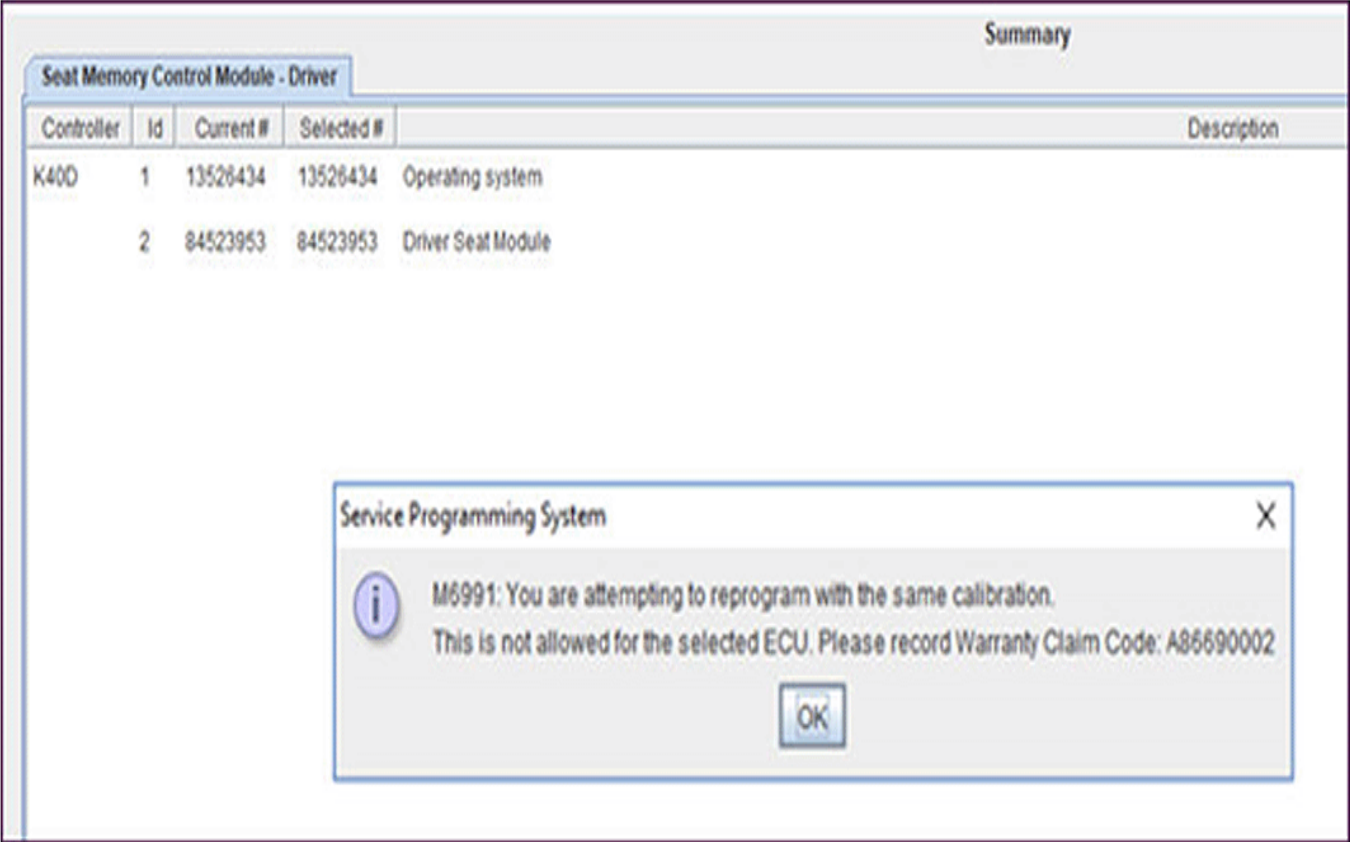
5164840

Note: If the Same Calibration/Software Warning is noted on the SPS Summary screen, record the warranty claim code (WCC) and select OK and follow screen instructions. After a successful programming event, the WCC is located in the Service Programming

System dialogue box of the SPS Summary screen. No further action is required. Refer to the Warranty section of the bulletin
