Service Bulletin

Bulletin No.: 19-NA-181

Subject: Multiple Electrical Concerns, Intermittent Multiple Instrument Panel Cluster (IPC) Warning Lamps Illuminated, Intermittent Multiple Message on Drivers Information Center (DIC) and Malfunction Indicator Lamp (MIL) Illuminated - DTC P057D, P057E, P0658, P0700, P073D P07E4, P16F4, P175F, P1778, P1789, P2760, U0073, U0101 and/or U0121

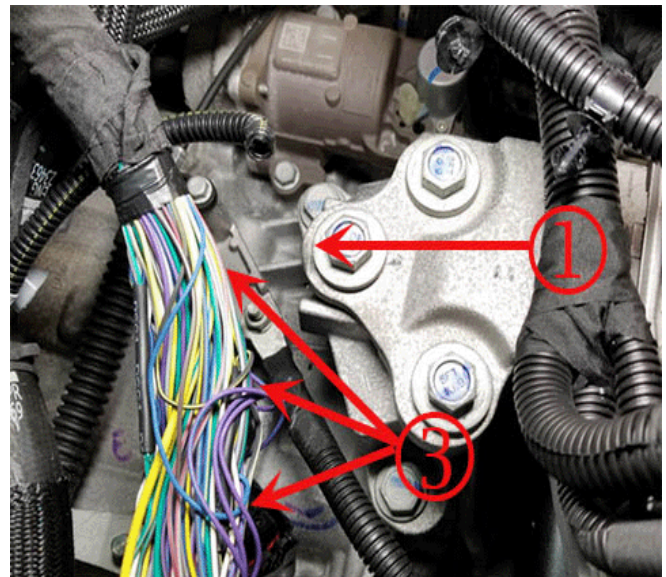
1. Inspect engine harness for proper routing and circuit 6387 for damaged wiring.
 - Wrap removed, point of contact (1) and chafed wire.

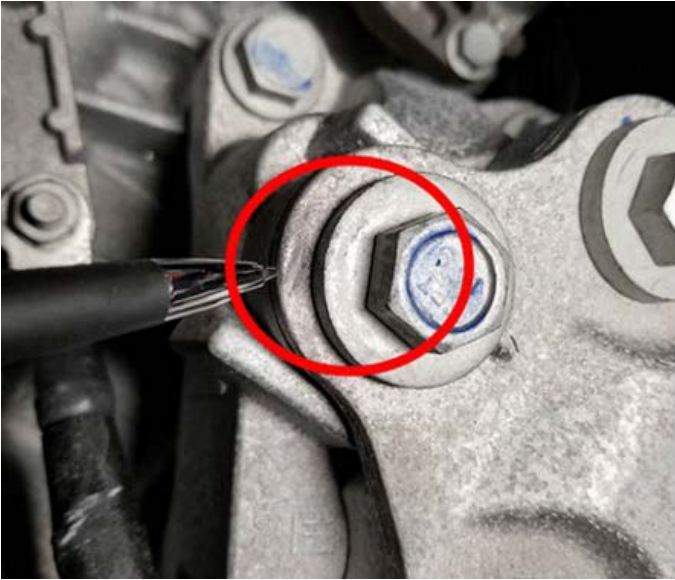
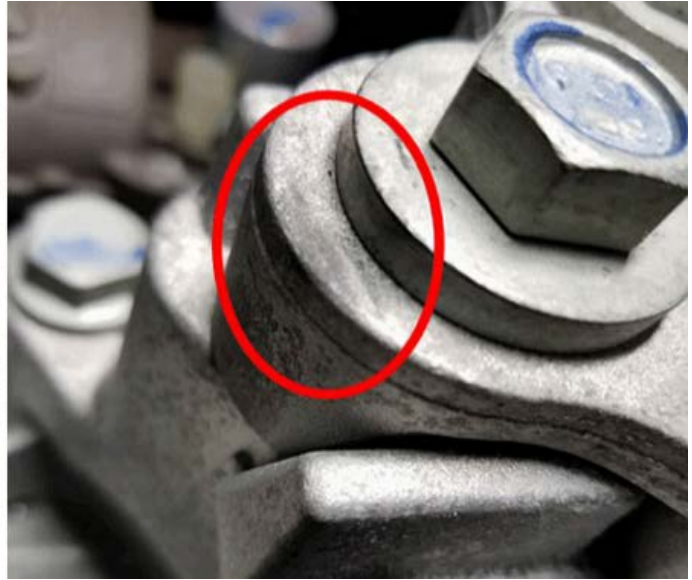
5394518

- Witness mark from point of harness contact.

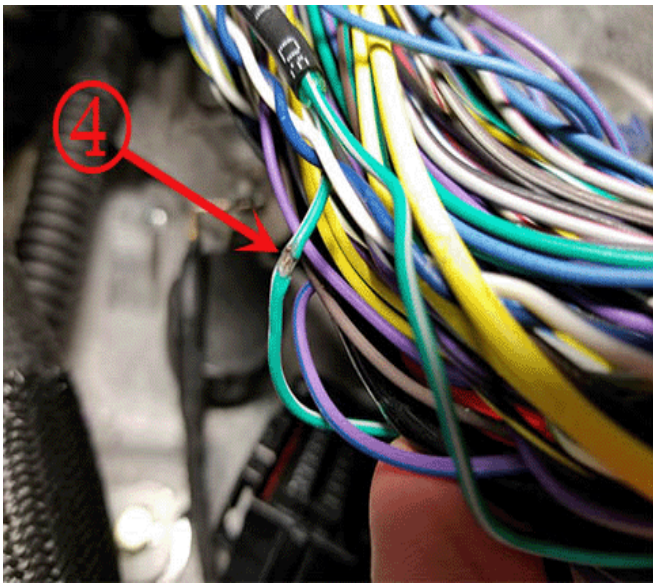
5023199

- Damaged wire (4) at circuit 6387 TCM high side driver.

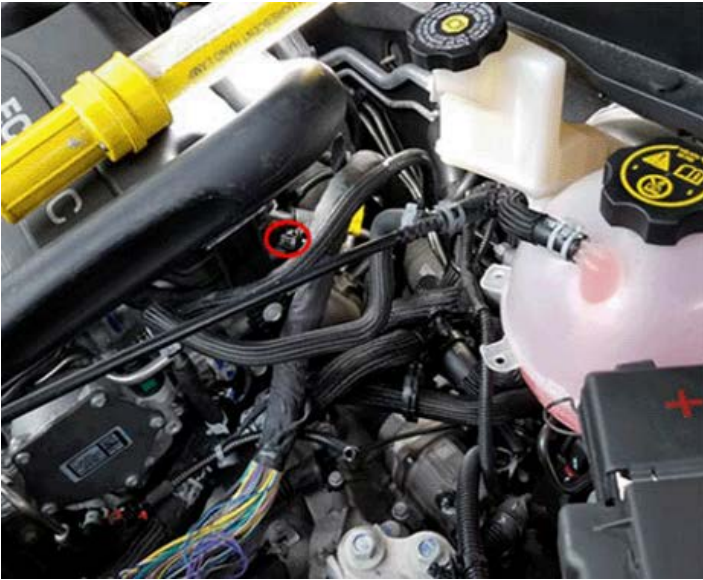
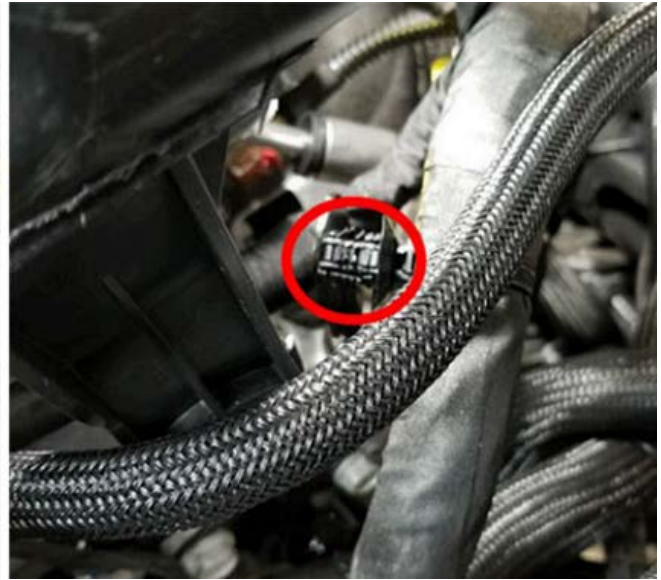
5394519

- Wire harness retainer not installed into bracket.

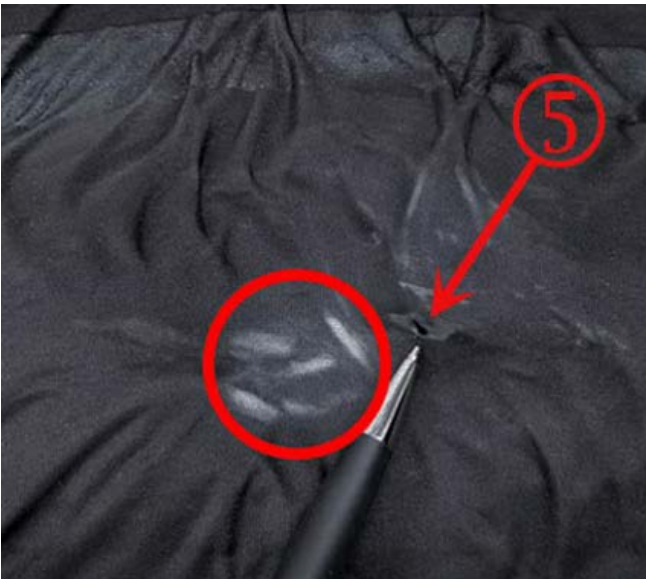
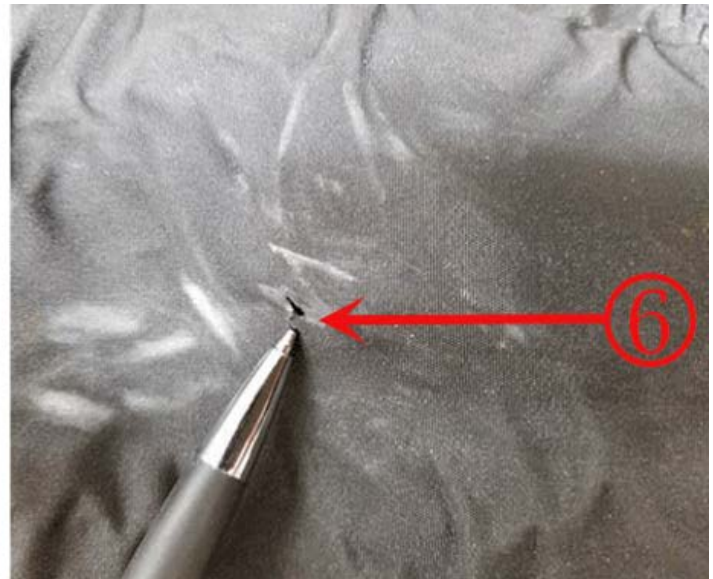
5394520

- Witness mark (hole) from removed wrap (5, 6).
2. Repair the wires per the *Wiring Repairs* procedure in SI.
 3. Using Woven Polyester Electrical Tape (PET), tape all the contact points of the engine harness ensuring that the tape is applied in a double layer extending along the harness past the splice sleeves.
 4. Verify all straps are secured and retainers are installed.

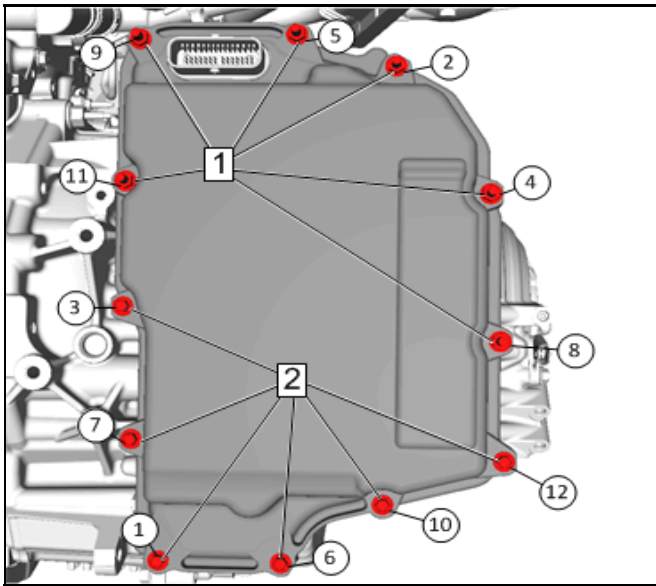
4489055

1. Inspect the engine wiring harness conduit and wires for chaffing around the #2, 5, and/or 9 stud of the transmission control valve body cover.

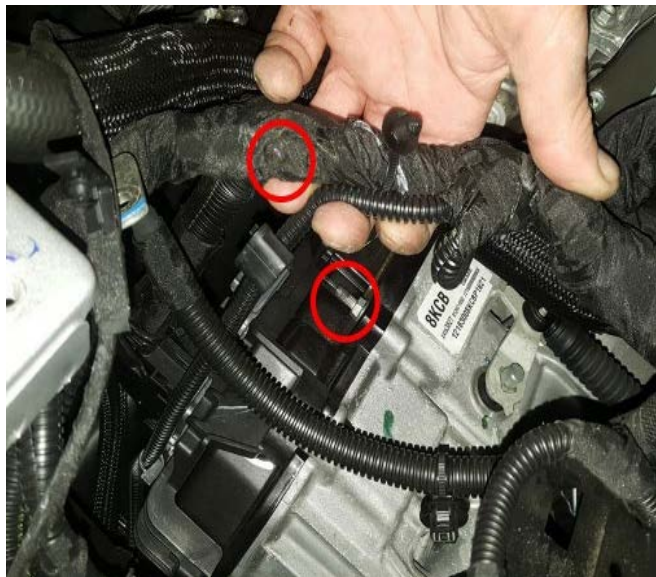
5387842

- Point of contact and chaffed wire.

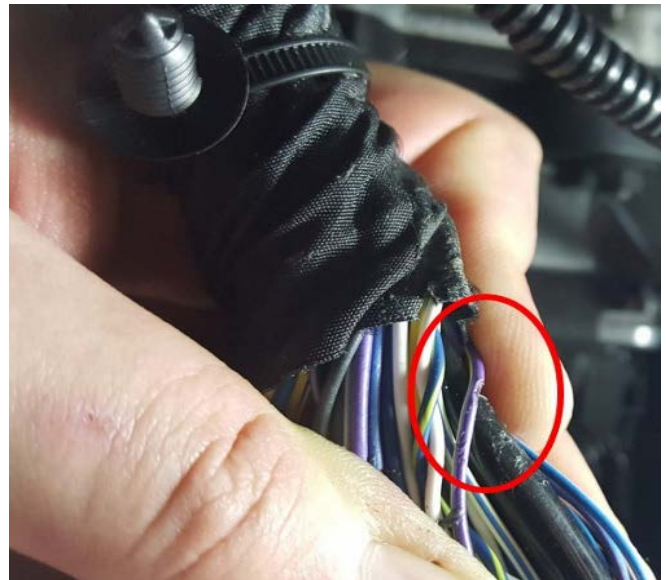
5387909

- Wrap removed, close-up picture.
2. Repair the wires per the *Wiring Repairs* procedure in SI.
 3. Using Woven Polyester Electrical Tape (PET), tape all the contact points of the engine harness ensuring that the tape is applied in a double layer extending along the harness past the splice sleeves.
 4. Verify all straps are secured and retainers are installed.
