68/19 ENU 1901

Complaint - Coolant Pipe at Front of Cylinder Head Leaking: Installing coolant pipe with toothed ring (68/19)

Vehicle Type:	Cayenne (9YA)
Model Year:	As of 2018
Equipment:	3.0-liter 6-cylinder gasoline engine (engine code: DCBE)
Subject:	Coolant pipe at front of cylinder head

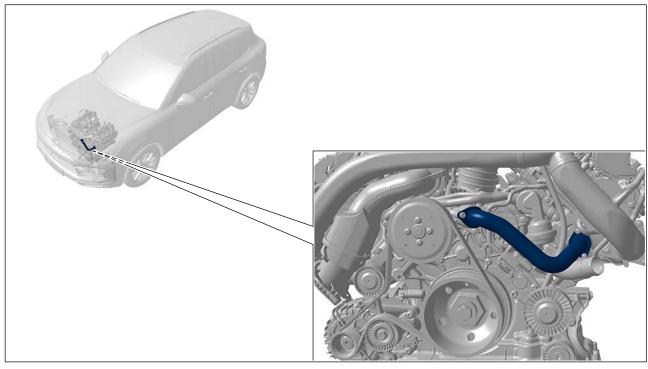
Coolant pipe at front of cylinder head

Information: Coolant pipe in cylinder head flange area leaking

Leak

Remedial In the event of a complaint, replace coolant pipe on cylinder head with a modified coolant pipe with Action: toothed ring (Part No. PAC121507).
