**Symptom in Vehicle Interior - Red or Yellow Hybrid Warning Message Appears in the Instrument Cluster: Re-programming control unit for high-voltage power electronics (SY 66/19)**

Vehicle Type: **Cayenne S E-Hybrid (92A II)**

Model Year: **As of 2015 up to 2018**

Subject: **High-voltage power electronics**

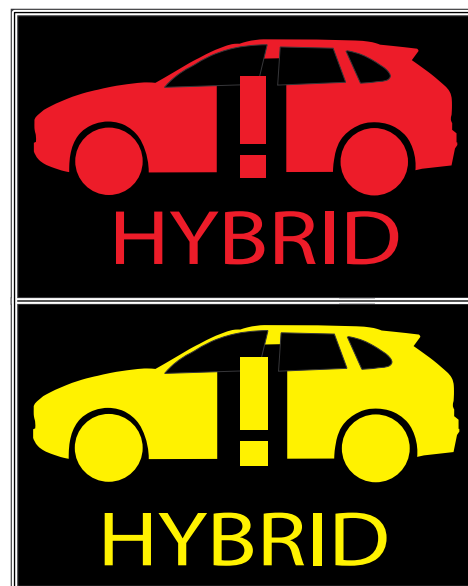
- Symptom:
- The red warning message "**Hybrid system failure**" or the yellow warning message "**Hybrid system fault**" appears in the instrument cluster. ⇒ *Hybrid system warning messages*
  - The vehicle no longer starts the engine from Start Stop mode; it can only start driving after the ignition has been switched off and on again.

*Hybrid system warning messages*

- Cause:
- Due to a software error in the high-voltage power electronics, a fault memory entry (POA1B00 - High-voltage power electronics – function restriction) can be set at times in the control unit for high-voltage power electronics, resulting in the symptoms described here. The fault memory entry is deleted by switching the ignition off and on again.
  - A highly discharged high-voltage battery increases the probability that the fault memory entry will be set.

Remedial Action: In the event of a customer complaint and if a software version lower than "P630" is installed in the control unit for high-voltage power electronics, re-program the control unit for high-voltage power electronics.
