**Symptom in Vehicle Interior - Red or Yellow Hybrid Warning Message Appears in the Instrument Cluster: Re-programming control unit for high-voltage power electronics (SY 66/19)**

Vehicle Type: **918 Spyder**

Model Year: **As of 2012 up to 2018**

Subject: **High-voltage power electronics on front axle/High-voltage power electronics on rear axle**

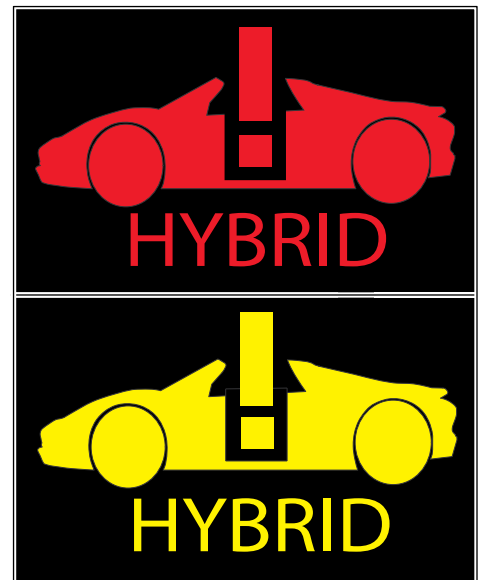
- Symptom:
- The red warning message "**Hybrid system failure**" or the yellow warning message "**Hybrid system fault**" appears in the instrument cluster. ⇒ *Hybrid system warning messages*
  - The vehicle no longer starts the engine from Start Stop mode; it can only start driving after the ignition has been switched off and on again.

*Hybrid system warning messages*

- Cause:
- Due to a software error in the high-voltage power electronics, a fault memory entry (POA1B00 - High-voltage power electronics – function restriction) can be set at times in the control units for high-voltage power electronics on front axle or high-voltage power electronics on rear axle, resulting in the symptoms described here. The fault memory entry is deleted by switching the ignition off and on again.
  - A highly discharged high-voltage battery increases the probability that the fault memory entry will be set.

**Remedial Action:** In the event of a customer complaint and if a software version lower than "F640" is installed in the control unit for high-voltage power electronics on the front axle or lower than "R640" is installed in the control unit for high-voltage power electronics on the rear axle, re-program the control units for high-voltage power electronics on front axle and high-voltage power electronics on rear axle.
