Symptom in Vehicle Interior - Red or Yellow Hybrid Warning Message Appears in the Instrument Cluster: Re-programming control unit for high-voltage power electronics (SY 66/19)

Vehicle Type: **Panamera S E-Hybrid (970)**

Model Year: **As of 2014 up to 2016**

Subject: **High-voltage power electronics**

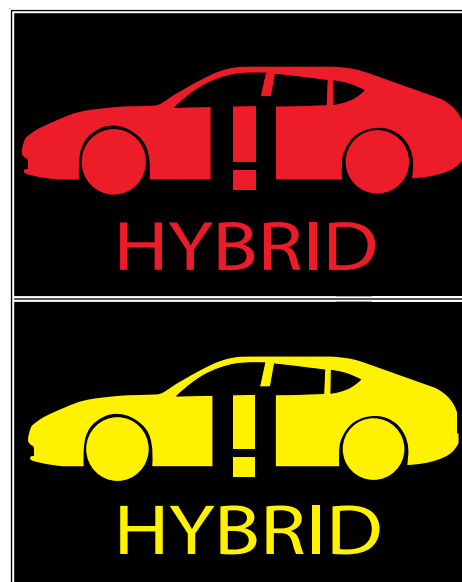
Hybrid system warning messages

- Symptom:
- The red warning message "**Hybrid system failure**" or the yellow warning message "**Hybrid system fault**" appears in the instrument cluster. ⇒ *Hybrid system warning messages*
 - The vehicle no longer starts the engine from Start Stop mode; it can only start driving after the ignition has been switched off and on again.

- Cause:
- Due to a software error in the high-voltage power electronics, a fault memory entry (POA1B00 - High-voltage power electronics – function restriction) can be set at times in the control unit for high-voltage power electronics, resulting in the symptoms described here. The fault memory entry is deleted by switching the ignition off and on again.
 - A highly discharged high-voltage battery increases the probability that the fault memory entry will be set.

Remedial Action: In the event of a customer complaint and if a software version lower than "P630" is installed in the control unit for high-voltage power electronics, re-program the control unit for high-voltage power electronics.
