Clicking Noise From Front PCCB Rotors

Revision: **This bulletin replaces bulletin Group 4, #1503, dated May 10, 2017.**
"of the braking system." was added to the end of the first note under Information. New note was added to page 3.

Vehicle Type: **911 Turbo / Turbo S (991)**

Model Year: **2014 to present**

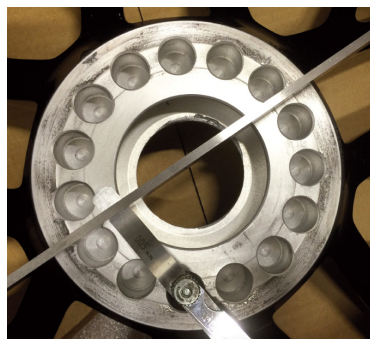
Wheels - Before rotors are replaced, it is necessary to check the mating surface of the wheels with a straight edge (12" Starrett 380) to insure flatness of the surface. Imperfections in the surface may have an influence on the rotor and cause noise.

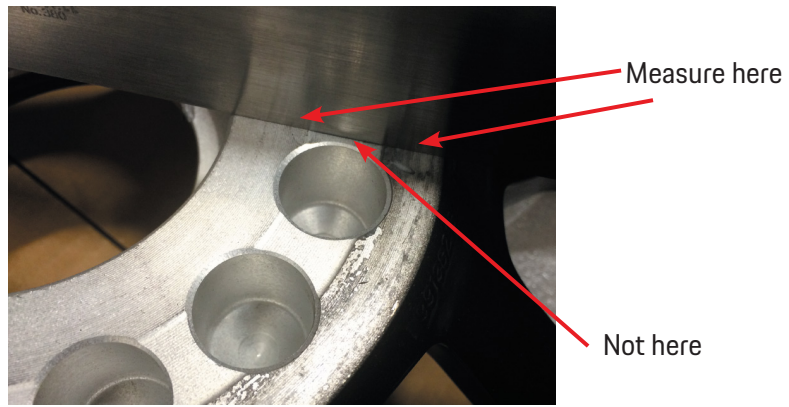
The mating surfaces at the outer and inner areas of the mounting circle need to be checked for flatness. The recessed area in between (photo below) is not a part of the measurement.
