LTB01304NAS1

TECHNICAL BULLETIN

01 AUG 2019

Outer Tail Lamps Water Ingress/Cracking lenses/Noise When Driving

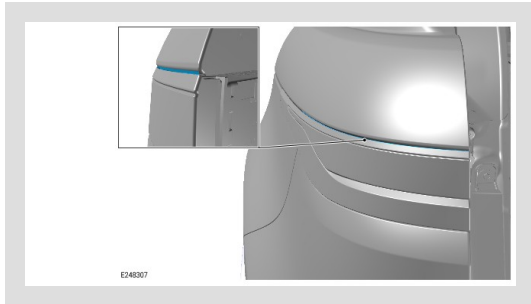
1.

Inspect the outer tail lamp and rear quarter panel gap on both sides of the vehicle.

- If **either** of the outer tail lamp and rear quarter panel gaps are less than 1 mm, continue to 'Outer Tail Lamp Alignment'.
- If **neither** of the outer tail lamp and rear quarter panel gaps are less than 1 mm, this is not the cause of the customer's concern. Continue diagnosis using the TOPIx Workshop Manual (see TOPIx Workshop Manual 501-00: Body System - General Information - Squeaks and Rattles).

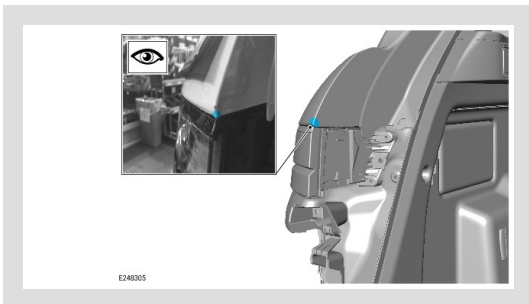
4.

Visually inspect the area of the rear quarter panel shown.

- If there **is** excessive paint in the area shown or the outer tail lamp has cosmetic cracks and / or water ingress, continue to step 5.
- If there **is not** excessive paint in the area shown and the outer tail lamp does not have cosmetic cracks and / or water ingress, continue to step 8.
