LTB01309NAS1

TECHNICAL BULLETIN

Rattling Noise From Engine And Malfunction Indicator Lamp (MIL) Illuminated

MODEL:	MODEL YEAR:	VIN:	ASSEMBLY PLANT:	APPLICABILITY:
Range Rover Sport (LW)	2019	813622-871409	Solihull	INGENIUM I6 3.0L Petrol

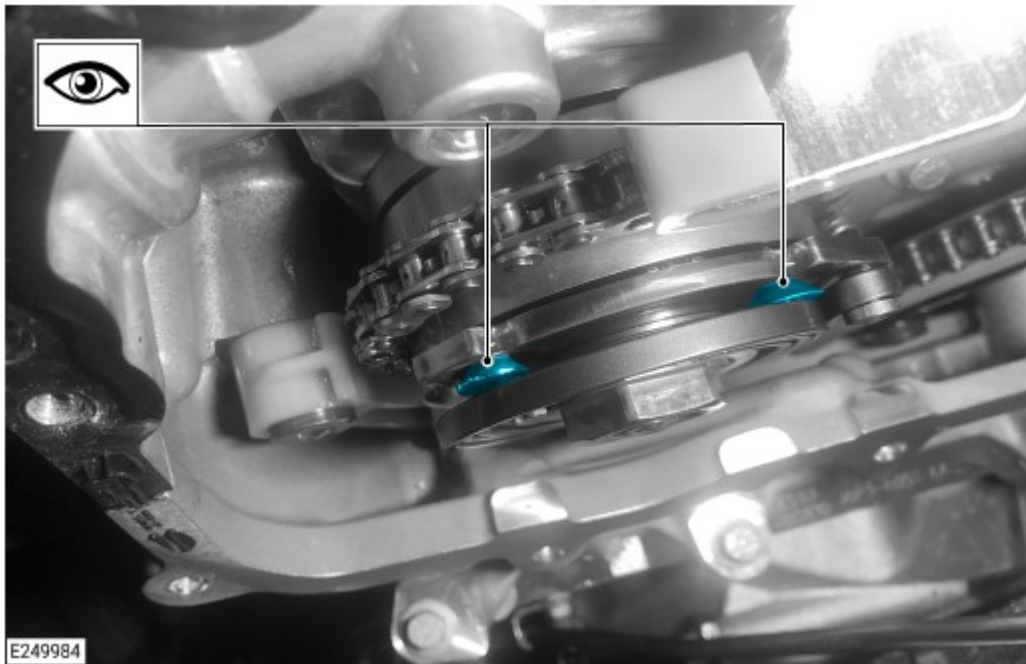
2.

The retaining bolt(s) for the inlet Variable Camshaft Timing (VCT) actuator have become loose.

To assist with diagnosis, the image shows the loose VCT actuator bolt(s) on the inlet camshaft.

Also renew the exhaust VCT actuator due to potential consequential damage caused by the chain rattling.

1. Renew the inlet and exhaust VCT actuators, (see TOPIx Workshop Manual section 303-01F: Engine - INGENIUM I6 3.0L Petrol - Repairs - Variable Camshaft Timing Actuator - Engine Set).
