Park Assistance “Sensor Blocked” warning message, XC90 R-design

REF NO: TJ 34922.1.0	ISSUING DEPARTMENT: Technical Service	CAR MARKET: United States and Canada	
PARTNER: 3 US 7510 Volvo Car USA		ISSUE DATE: 2019-08-22	STATUS DATE: 2019-08-30
FUNC GROUP: 3871	FUNC DESC: Parking assistance	Page 1 of 3

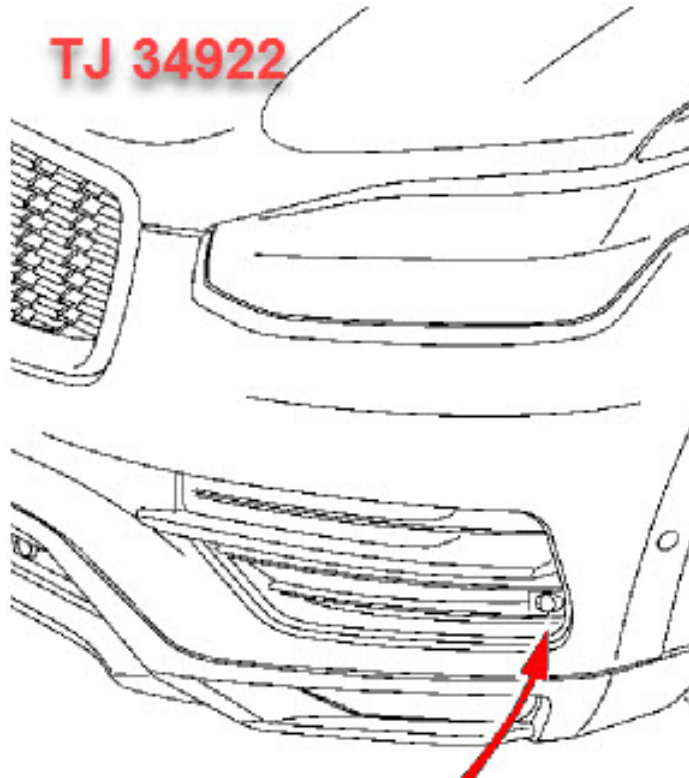
TJ 34922

If there is message in the DIM about "Sensor Blocked" and the car has DTC CEM B1B3629 and/or B1B4029, follow instructions under "Service".

Replace the left and right front outer parking assistance sensors with the latest part number according to VIDA instructions. See attachment TJ 34922_1.jpg to correctly identify affected sensors.
