**Campaign code.**L73X-A.09.19.**Subject.**Pydos ECU replacement and ECU 17 update.**Model.**Aventador S.**Model year.**MY 18.**Special or Limited Versions.**All.**Markets.**Korea.**VIN Identification.**

As a result of continuous product monitoring, Automobili Lamborghini S.p.A. has discovered that the Pydos system may not be accurate in detecting the car tilt level. The root cause of this problem is the wrong parameter setting and the scope of this service is to replace the Pydos ECU. If not repaired the system could be activated also when tilt level does not require the activation. The campaign will be open until all vehicle will be updated.

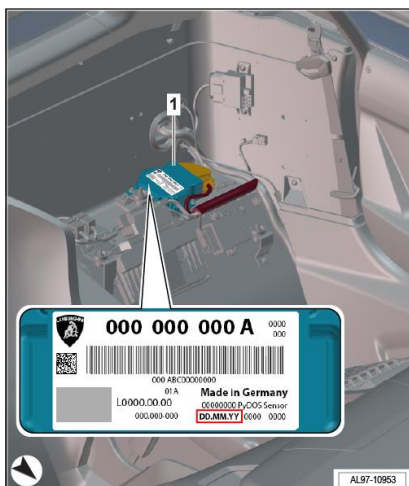
The expiry of the Pydos battery must be set according to the production year of the Pydos control unit fitted in the car and previously annotated. Refer to the following image to identify the position of the production data label.

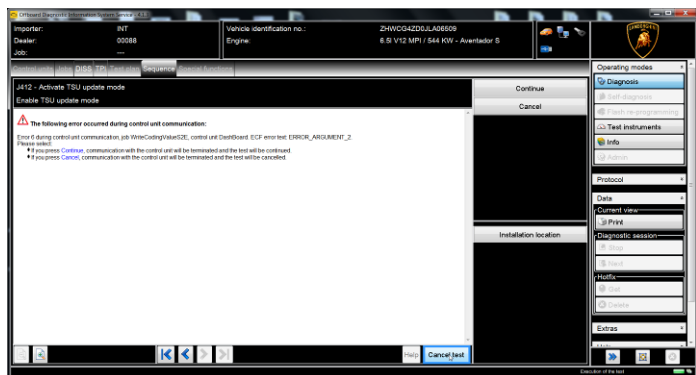
- i. If the following error page is shown, you shall abort the procedure clicking on “Cancel Test” and contact the Technical Support.

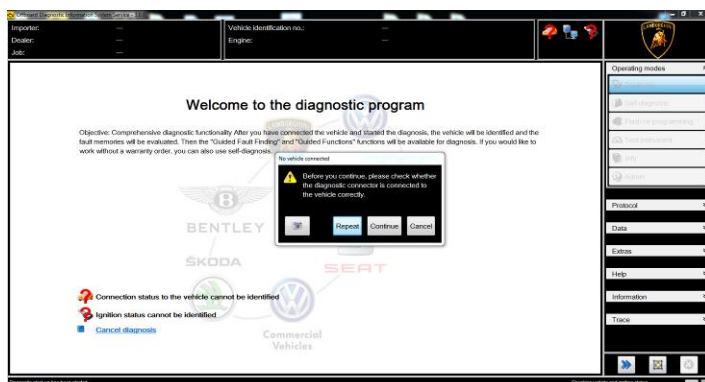
- ii. If the error message regarding the VAS5054 interface and the two icons for status of on board connection and key ON are shown as in the picture below:

- Click “Cancel”;
- Repeat the VAS5054 HW interface installation following the procedure (\*) “VCI Manager v2.0”, by entering in the menu “Extras” on the right side and clicking on “Diagnostic interface”.

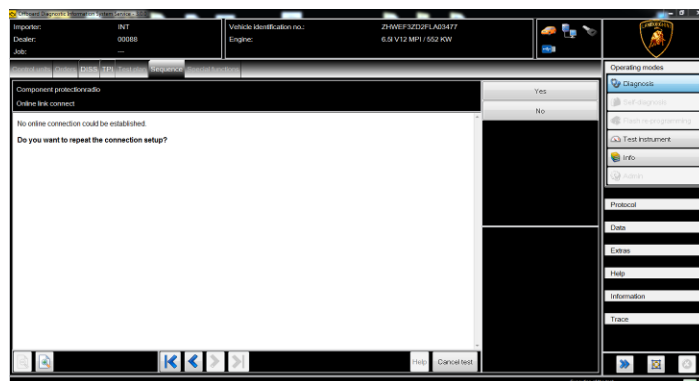
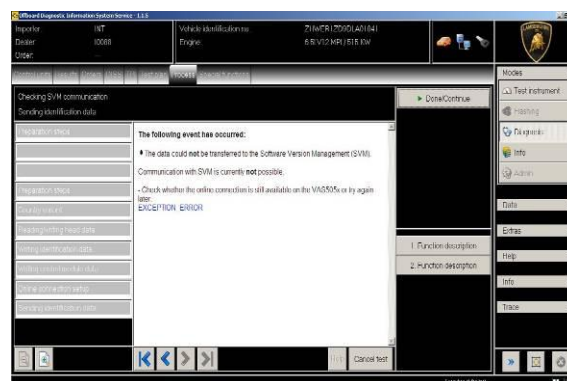
- iii. If one of the connection error screens is shown as in the pictures below:

- it is not possible to establish a connection with the central server. Please check carefully that the diagnosis laptop is properly connected to the internet network and retry clicking “Yes” or “Done/Continue”.

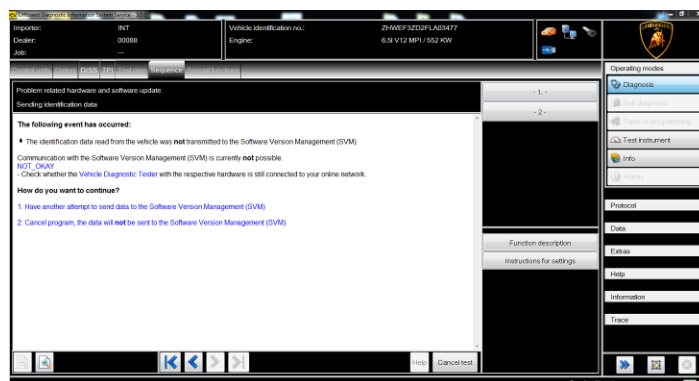
- iv. If the loss of connection happens during the target/actual comparison during SVM procedure:
- It is not possible to connect to central server, check the working connection of internet and retry by clicking “1”.

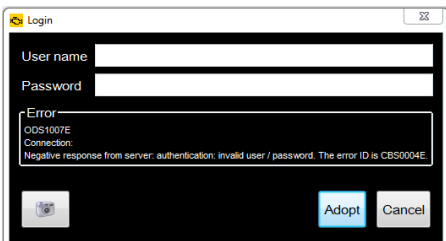
- v. If the incorrect identification message is shown as in the picture below (error code: ODS1007E):
- be sure that your Geko account is valid;

- be sure that the label “Geko” is written on the token that you are using for the authentication;
- be sure the Password inserted is correct;
- click on Cancel and perform the application test (see document “ODIS\_Checking\_ConnectionServer\_SVM\_2.0” (\*)).

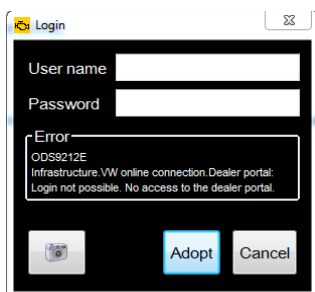
vi. If the infrastructure error message is shown as in the picture below (error code: ODS9212E):

- be sure that your Geko account is valid
- be sure that the label “Geko” is written on the token that you are using for the authentication
- verify in ODIS settings you have “Internet” instead of “CPN” (see document “ODIS\_Initial\_Setup\_2.0” (\*))
- click on Cancel and perform the application test (see document “ODIS\_Checking\_ConnectionServer\_SVM\_2.0” (\*))
