## SIM 51 01 19 WIND NOISE FROM SIDE VIEW MIRRORS

2019-08-02

| Engineering Designation | Model Description | Production Date |
|---|---|---|
| F60 | MINI Countryman | From July, 2019 |

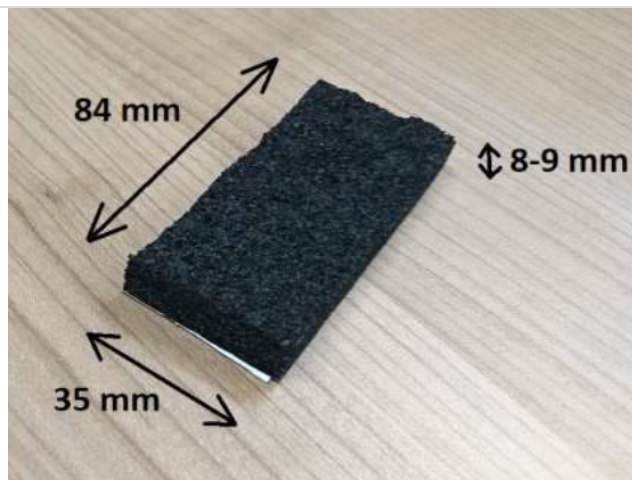
3. Remove the foam corner insulation from the attachment area of the side view mirrors.

4. Cut 2 strips of foam (PN 51 77 7 445 425).

Note: Foam should be cut into pieces 84mm x 35mm x 9mm as shown to the left.
